San Antonio Basin Groundwater Sustainability Agency

2021 Annual Groundwater Level Monitoring Report

January 28, 2022

GSI Water Solutions, Inc.

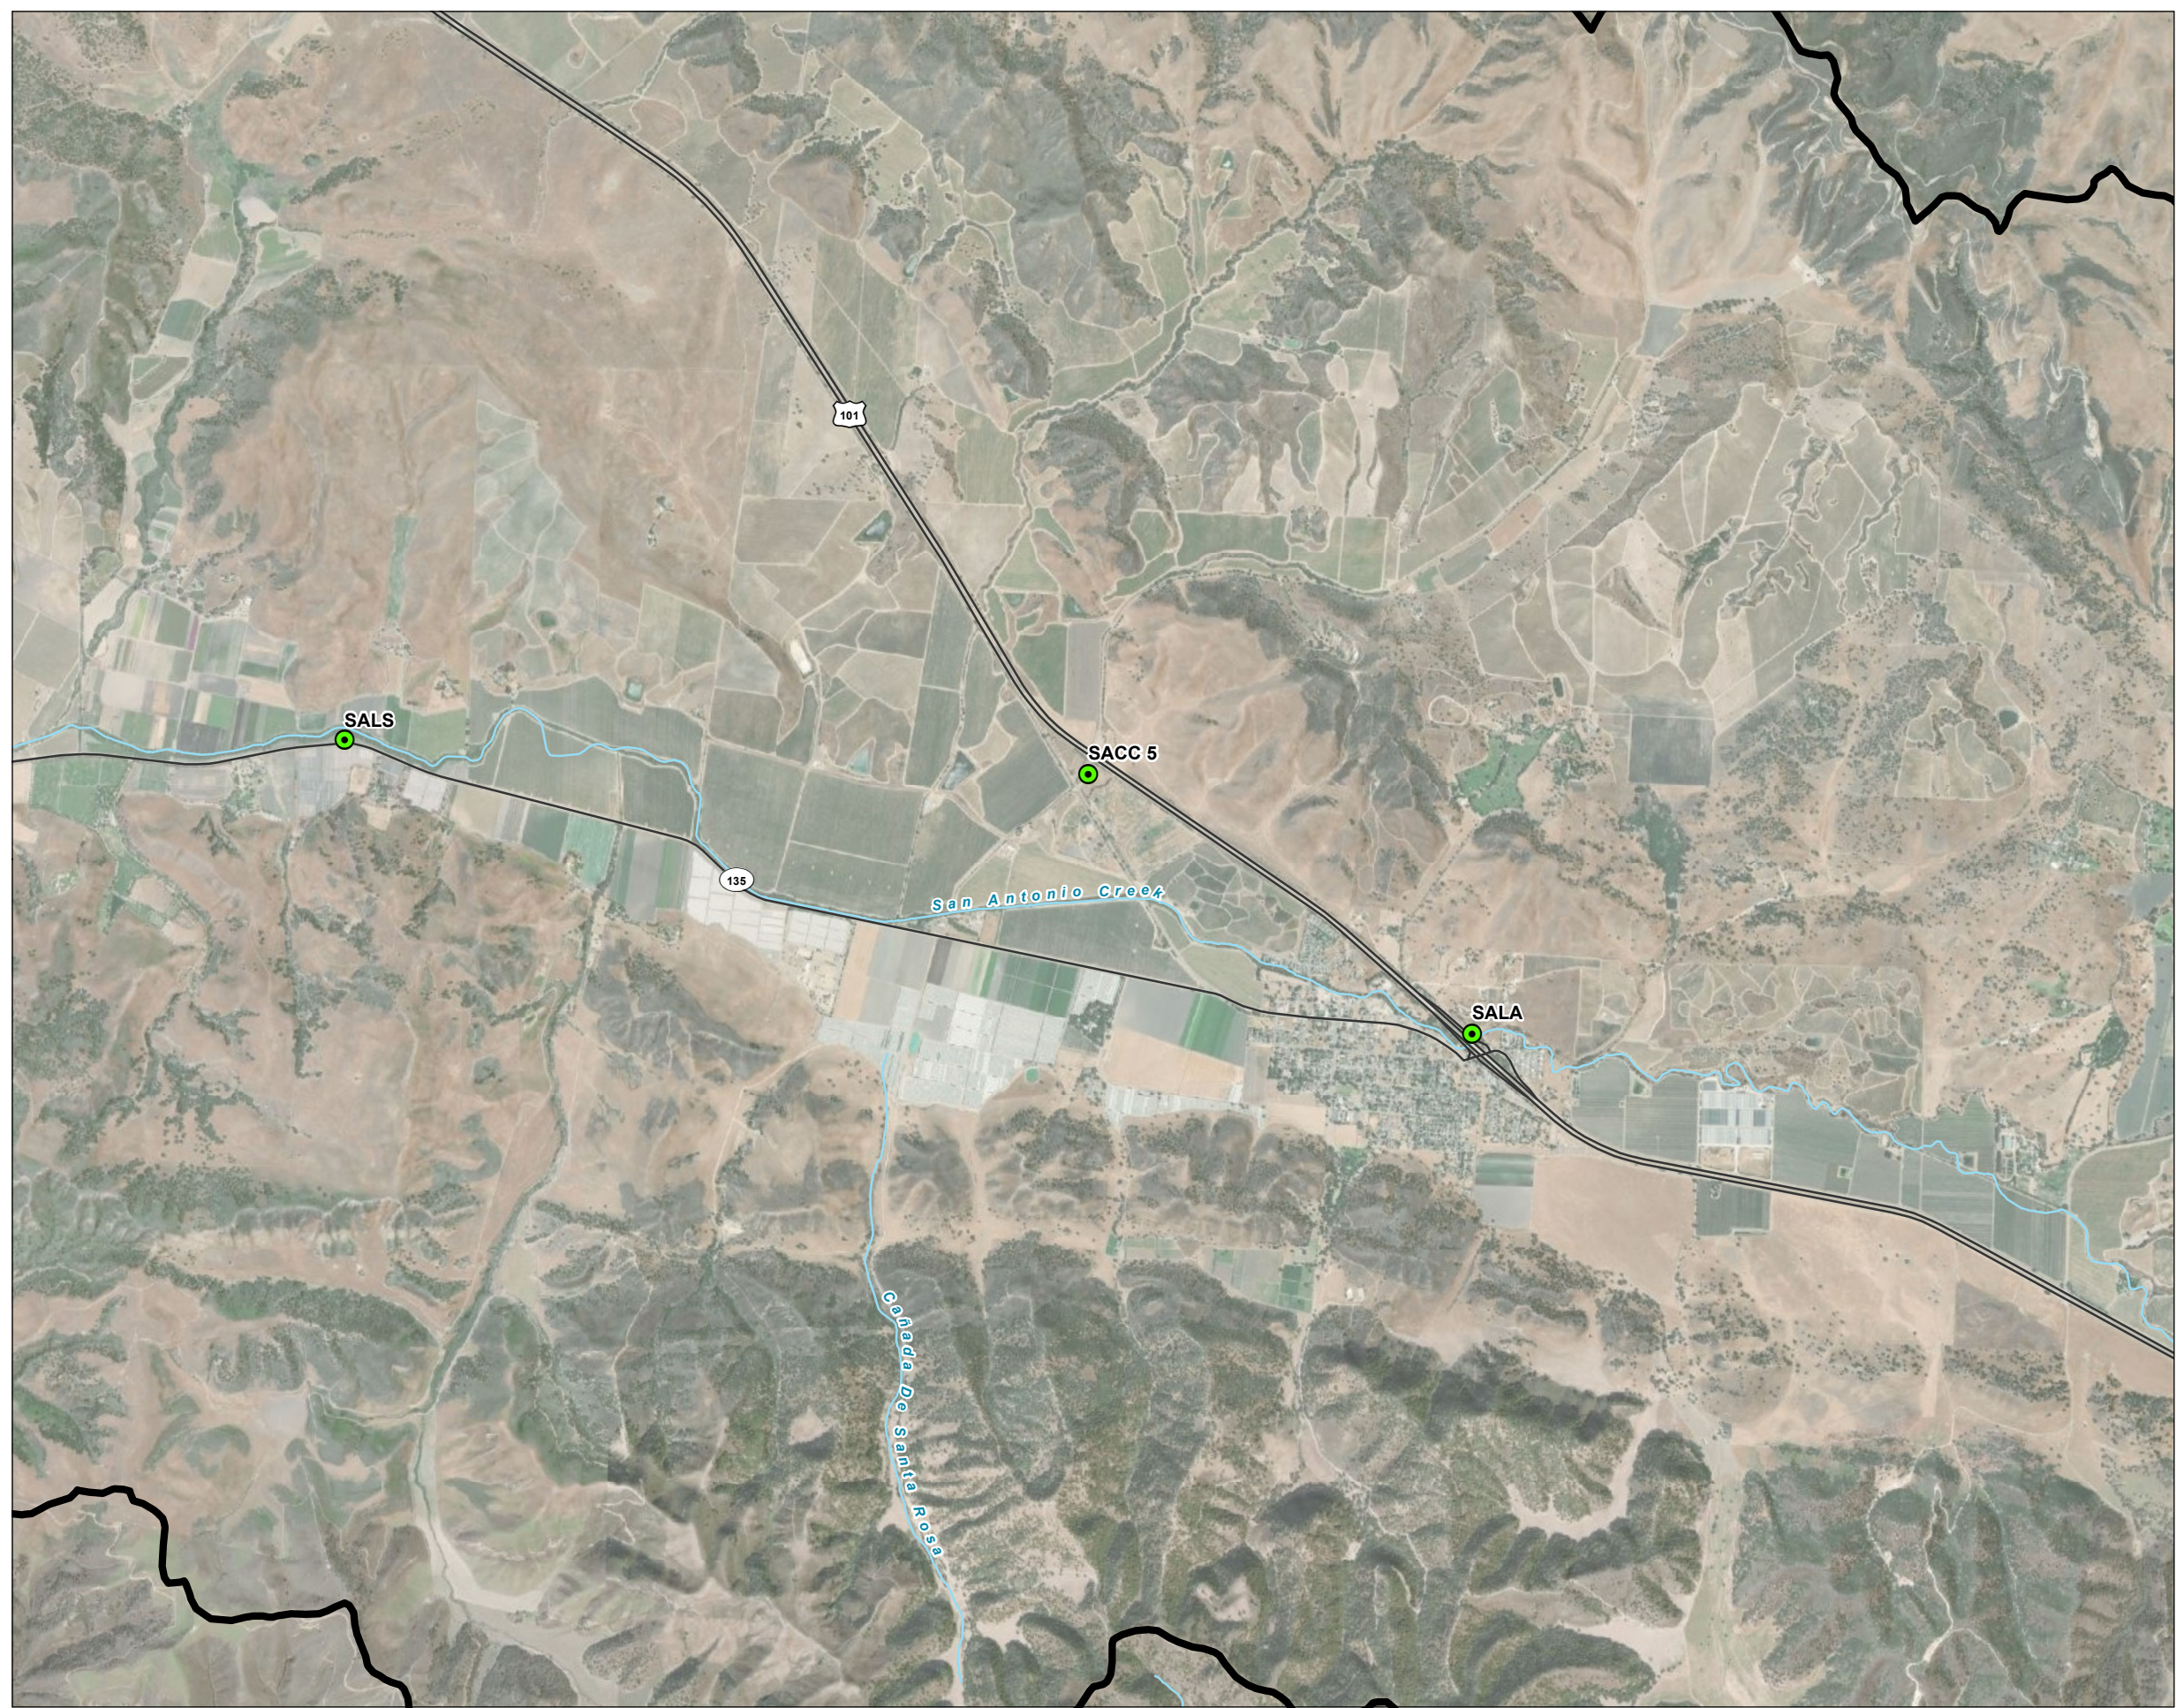
FIGURE 4

**Wells with Transducers in
Eastern Portion of
San Antonio Basin**

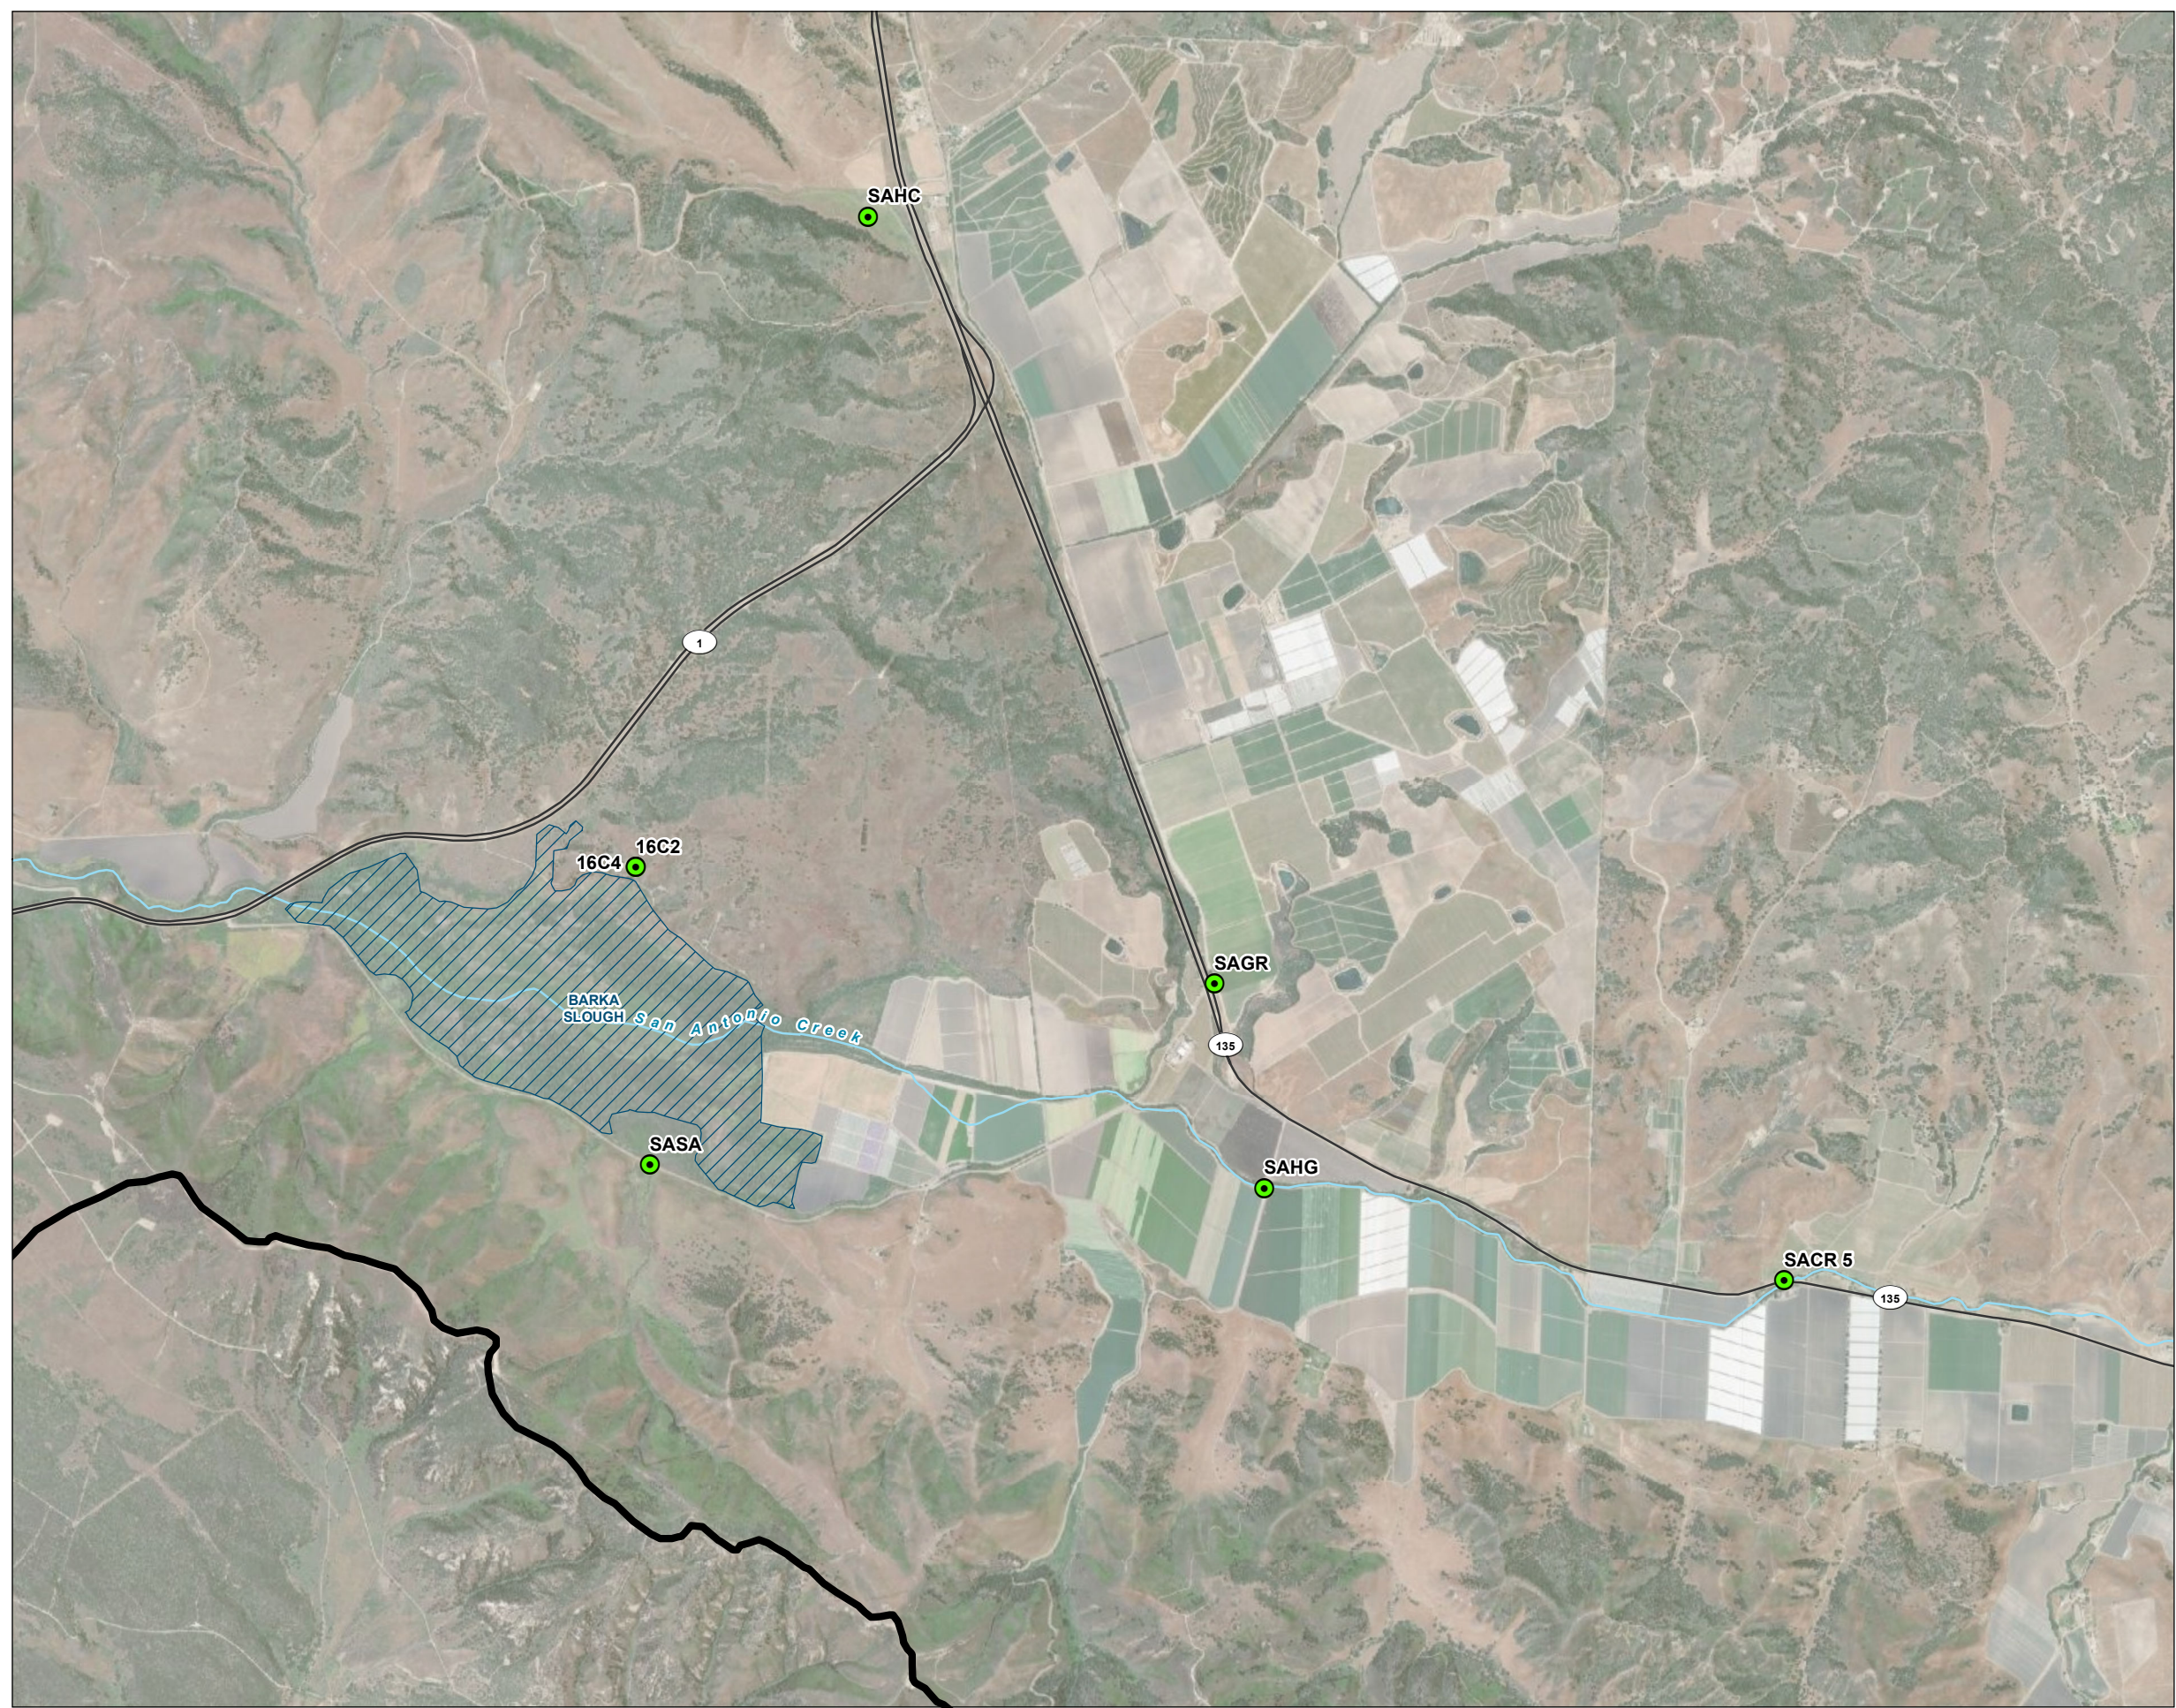
FIGURE 5

**Wells with Transducers in
Western Portion of
San Antonio Basin**

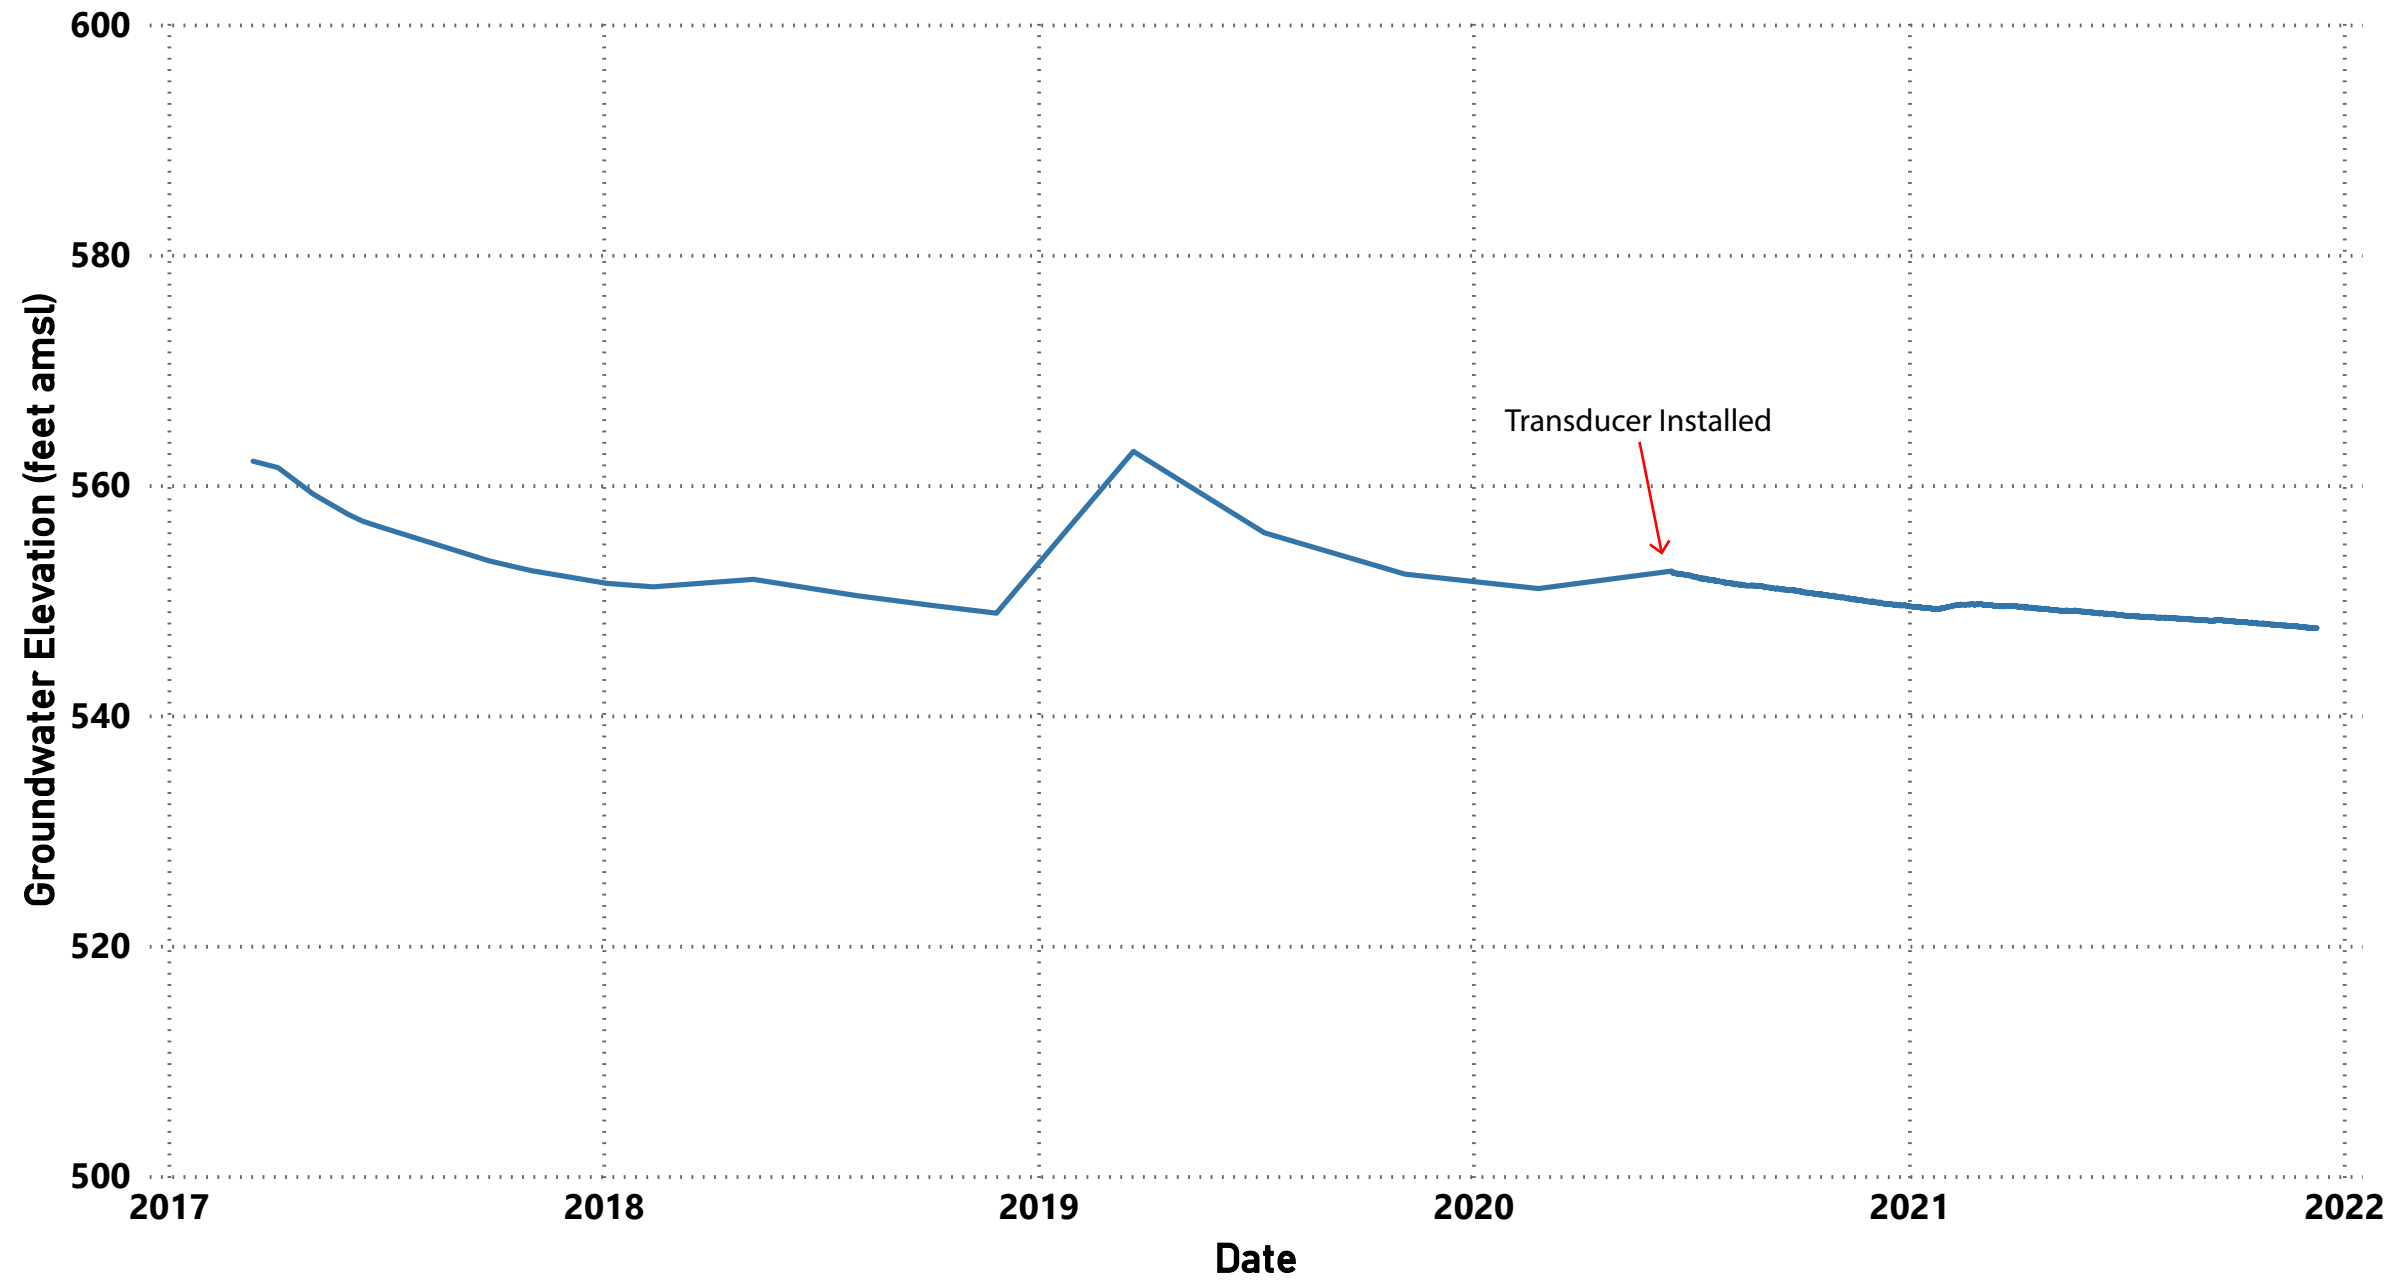
FIGURE 6
Hydrograph for Well SALA
Paso Robles Formation Aquifer
San Antonio Basin GSA
2021 Annual Groundwater
Level Monitoring Report

Following each quarterly monitoring event, groundwater level data are provided to the SABGSA in an email monitoring report. Groundwater level measurements are housed within the SABGSA Data Management System and available upon request. Groundwater level trends observed since November 5, 2019, are consistent with historical trends; exhibiting a general decrease of groundwater elevations across the Basin. Water level measurements are presented in Table 1. Hydrographs from the wells in the monitoring network are included as Figures 6 through 43. The following noteworthy trends are observed in the hydrographs:

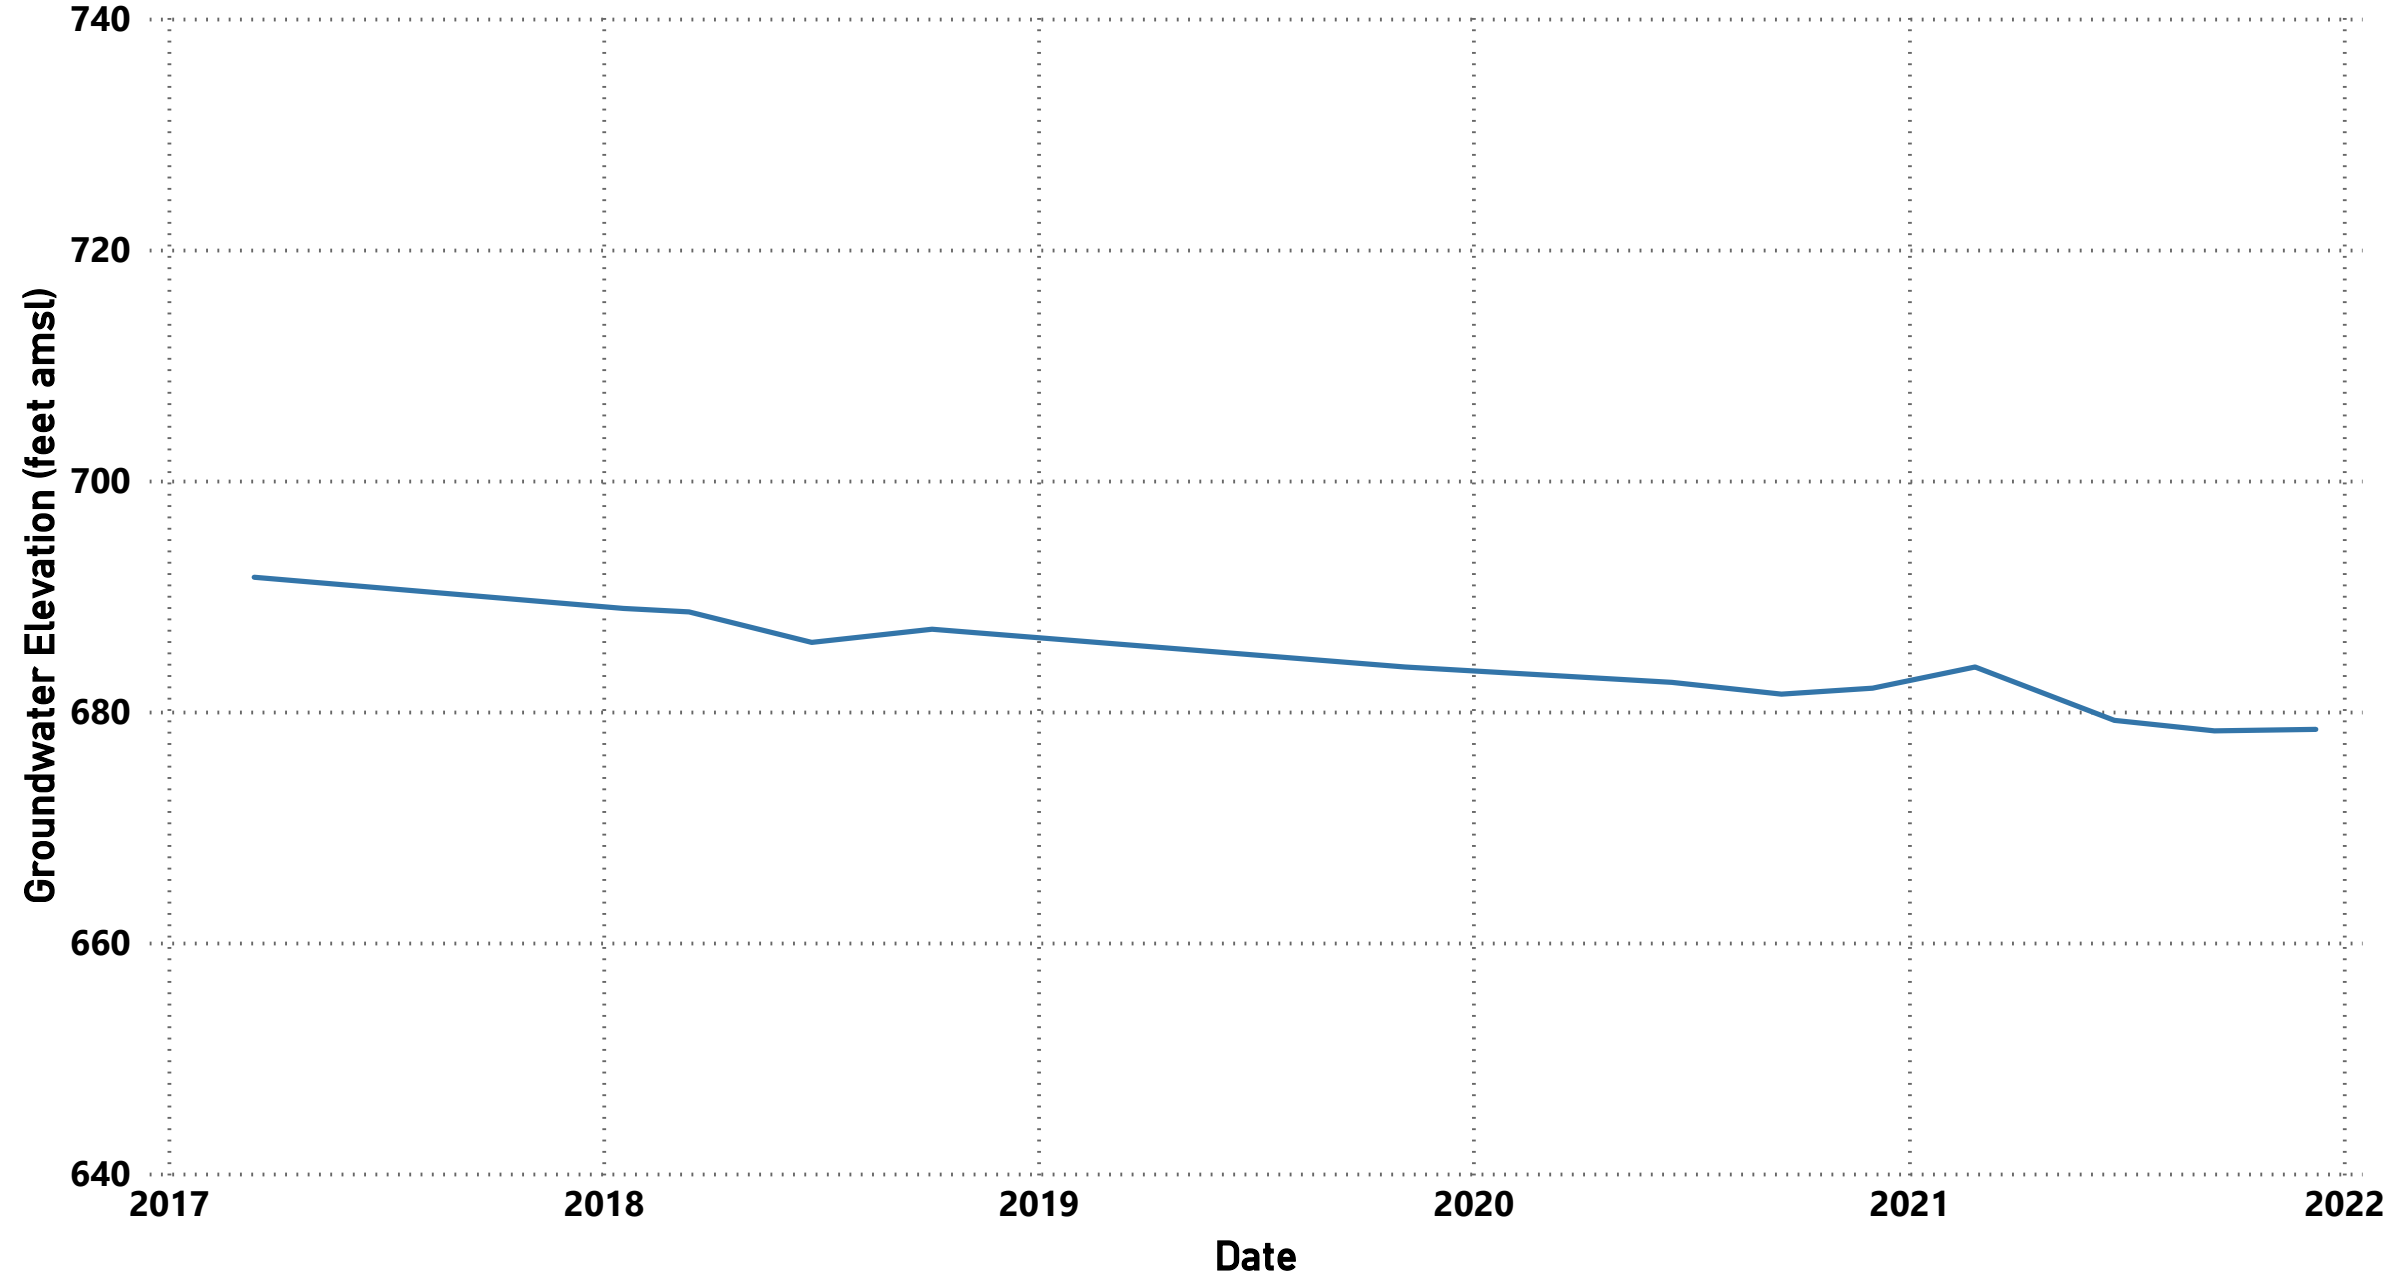
FIGURE 7
Hydrograph for White Hawk 1 Well
Careaga Formation Aquifer
San Antonio Basin GSA
2021 Annual Groundwater
Level Monitoring Report

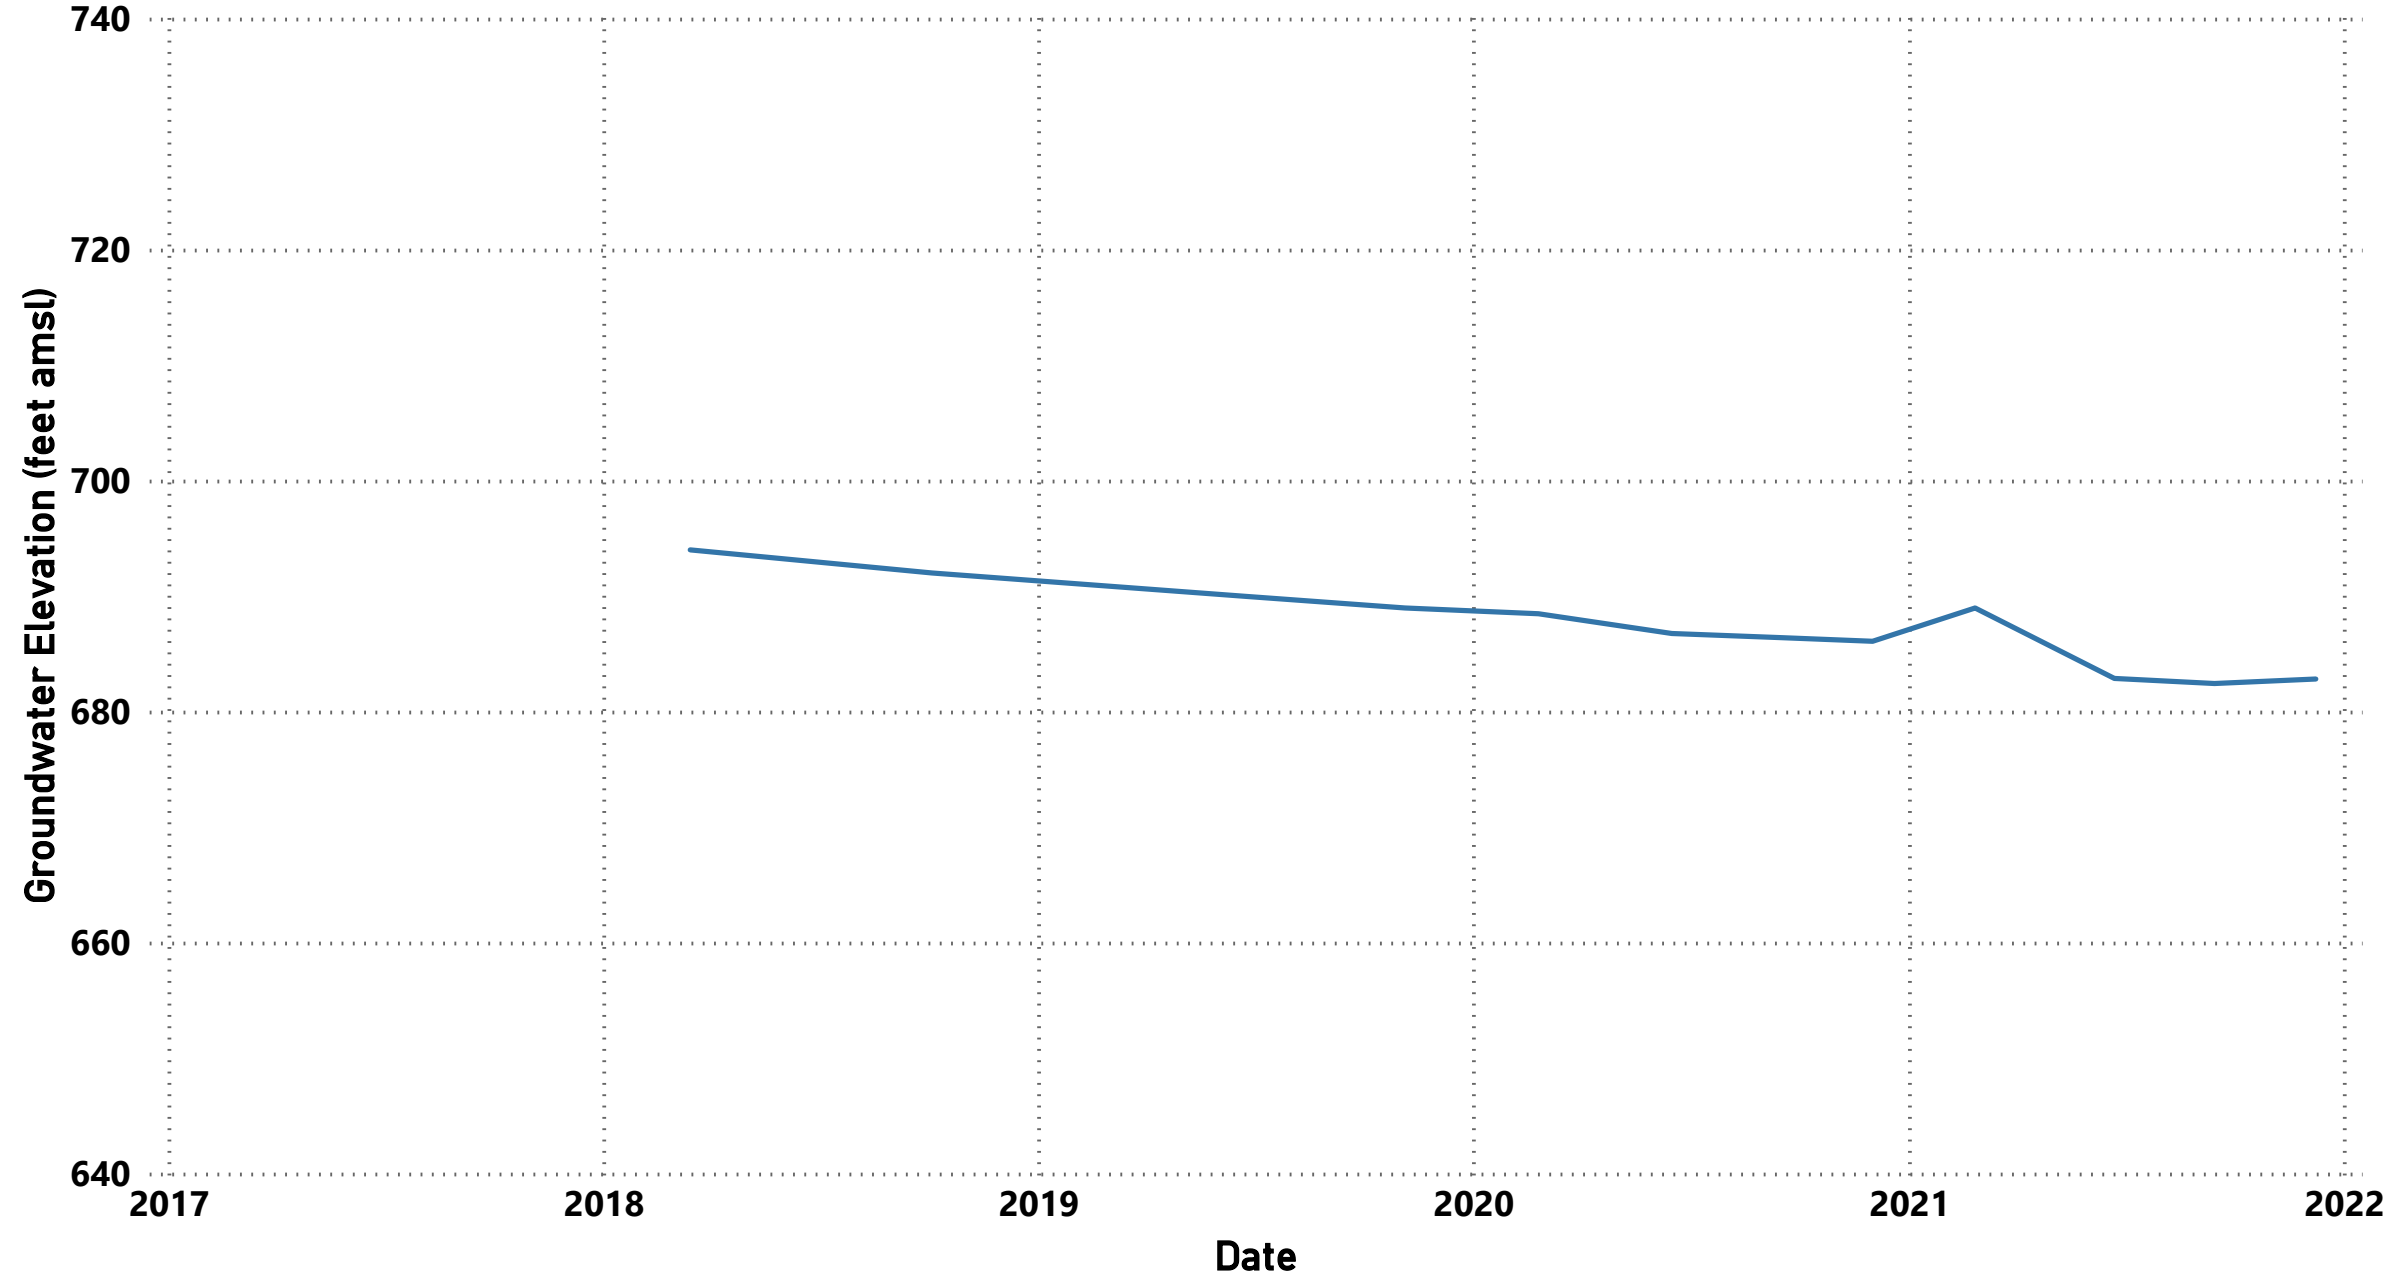
FIGURE 8
Hydrograph for White Hawk 4 Well
Careaga Formation Aquifer
San Antonio Basin GSA
2021 Annual Groundwater
Level Monitoring Report

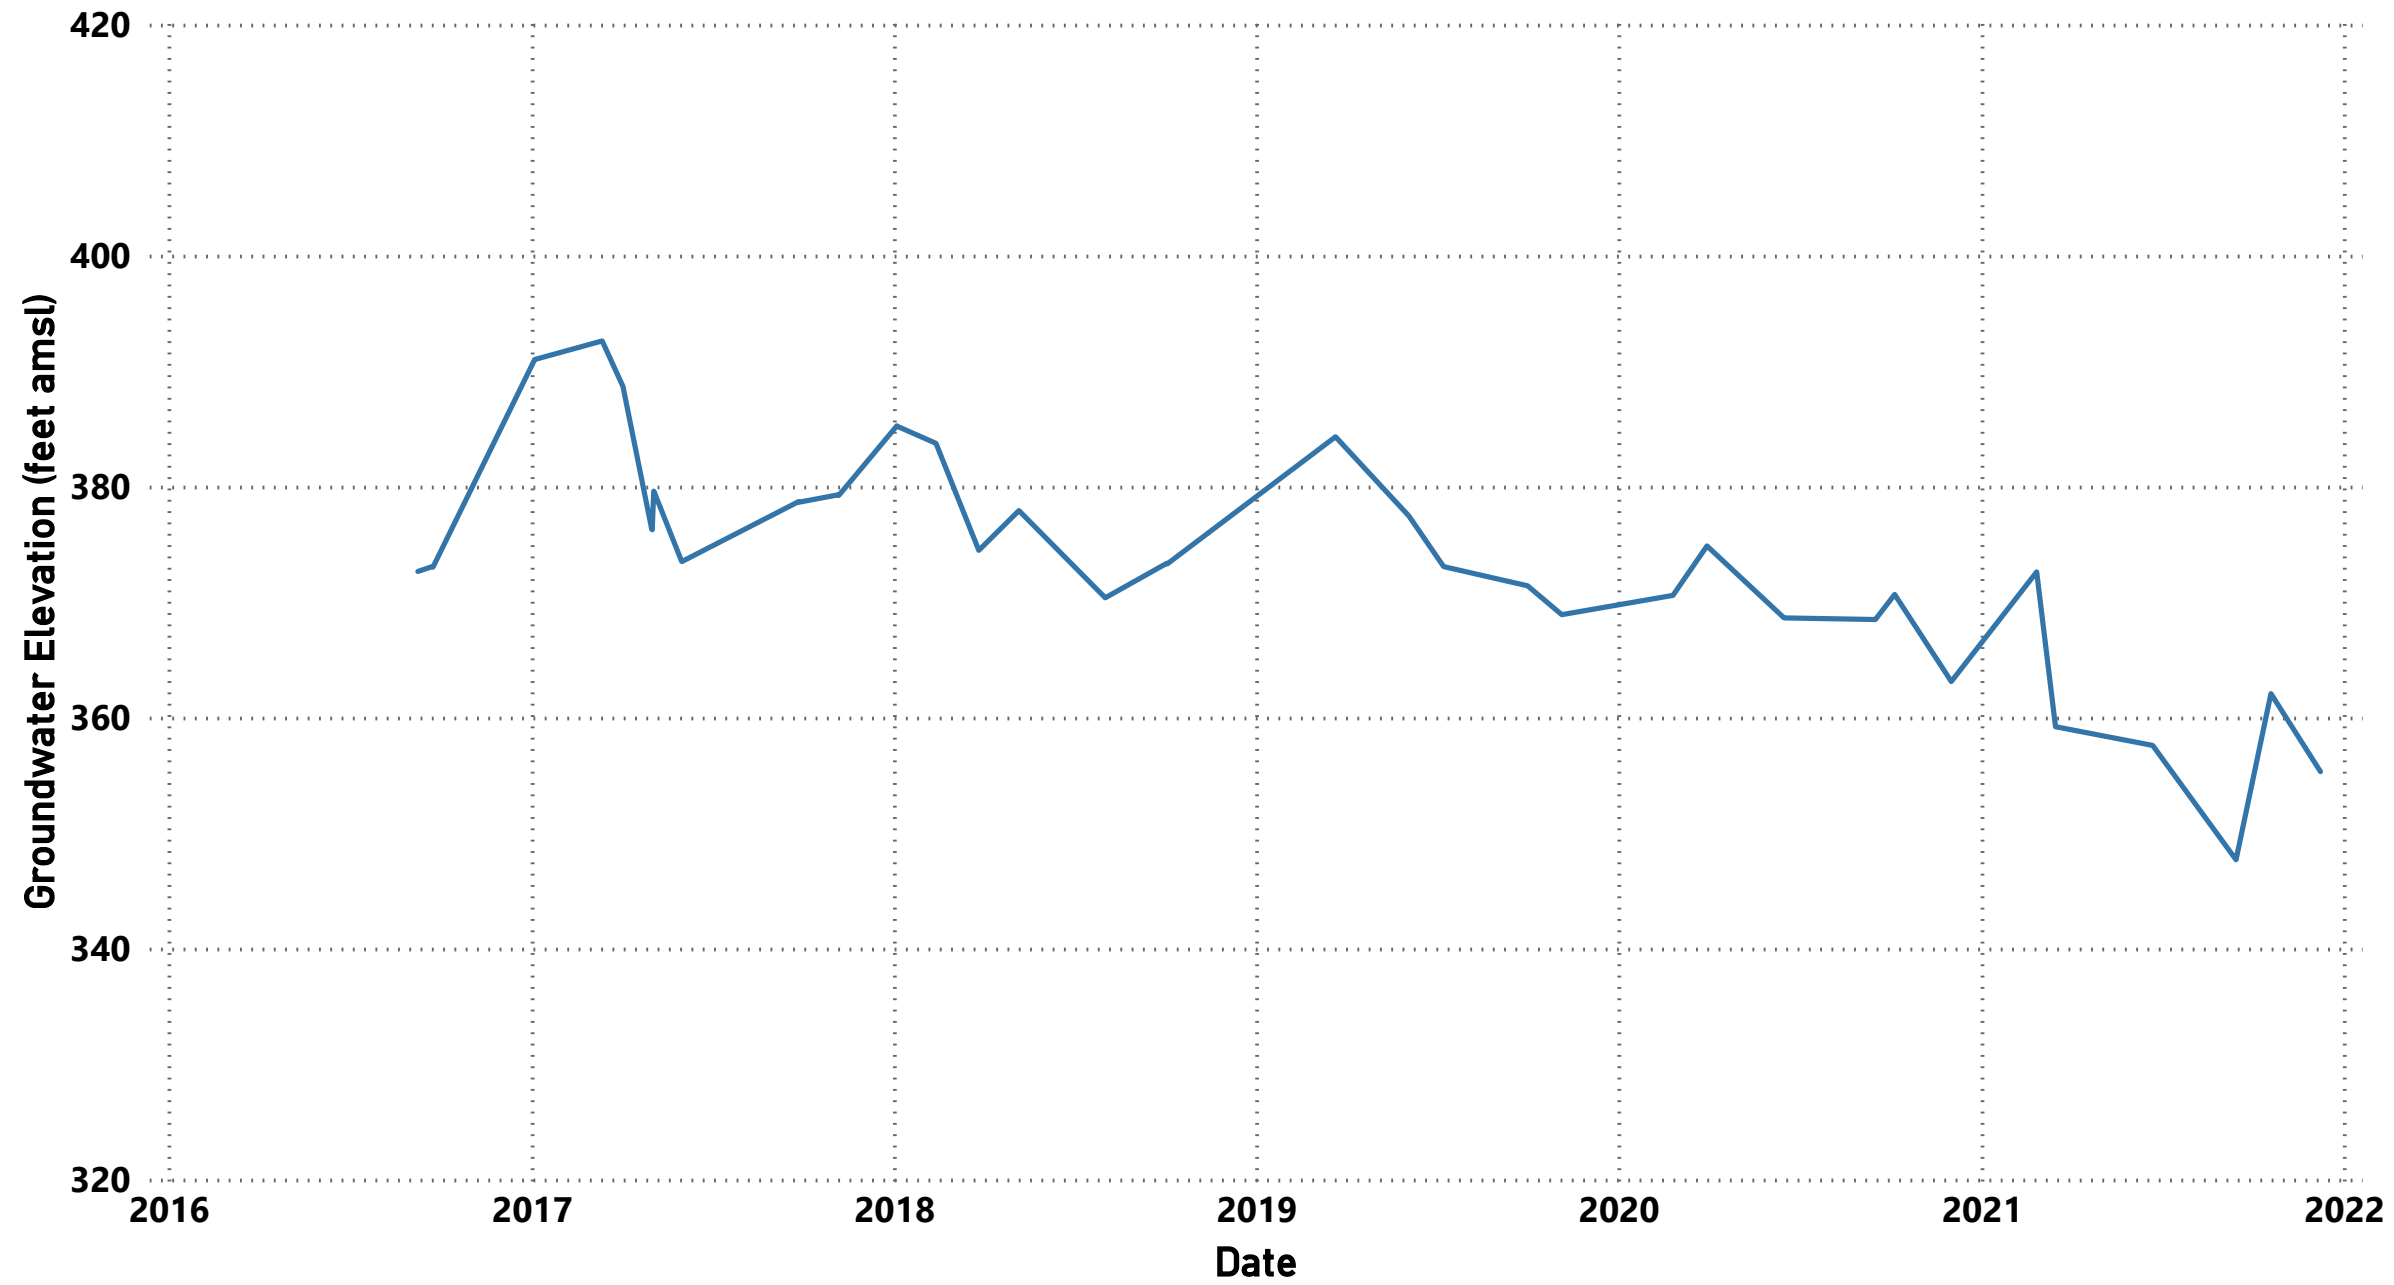
FIGURE 9
Hydrograph for Well SACC1
Paso Robles Formation Aquifer
San Antonio Basin GSA
2021 Annual Groundwater
Level Monitoring Report

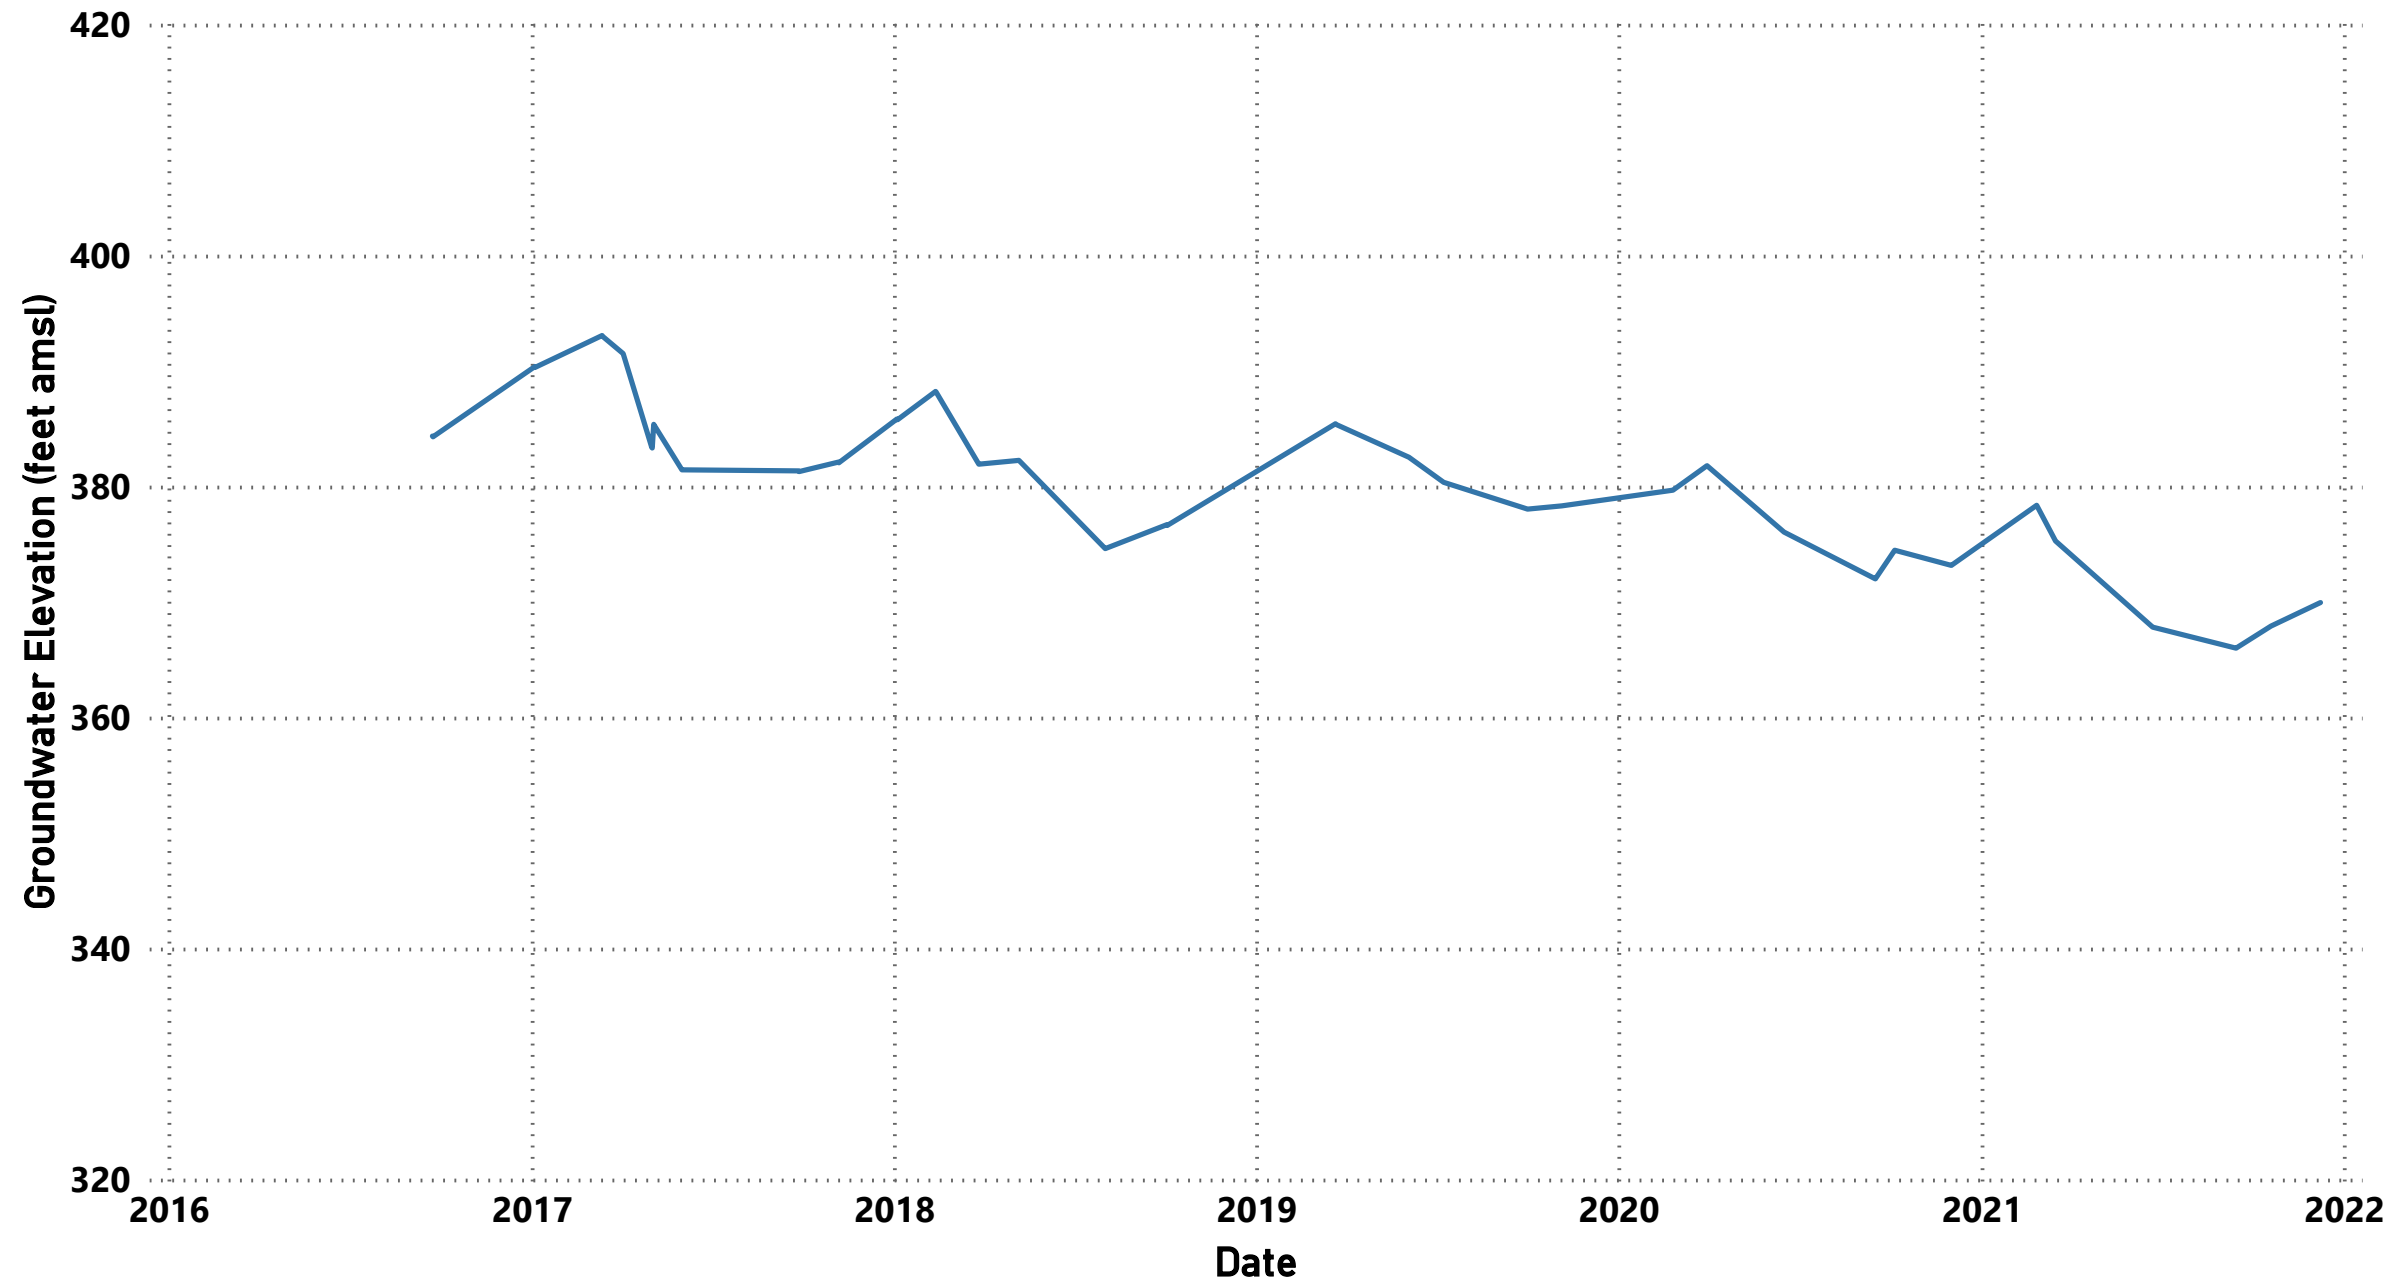
FIGURE 10
Hydrograph for Well SACC2
Paso Robles Formation Aquifer
 San Antonio Basin GSA
 2021 Annual Groundwater
 Level Monitoring Report
