San Antonio Basin Groundwater Sustainability Agency

2021 Annual Groundwater Level Monitoring Report

January 28, 2022

GSI Water Solutions, Inc.

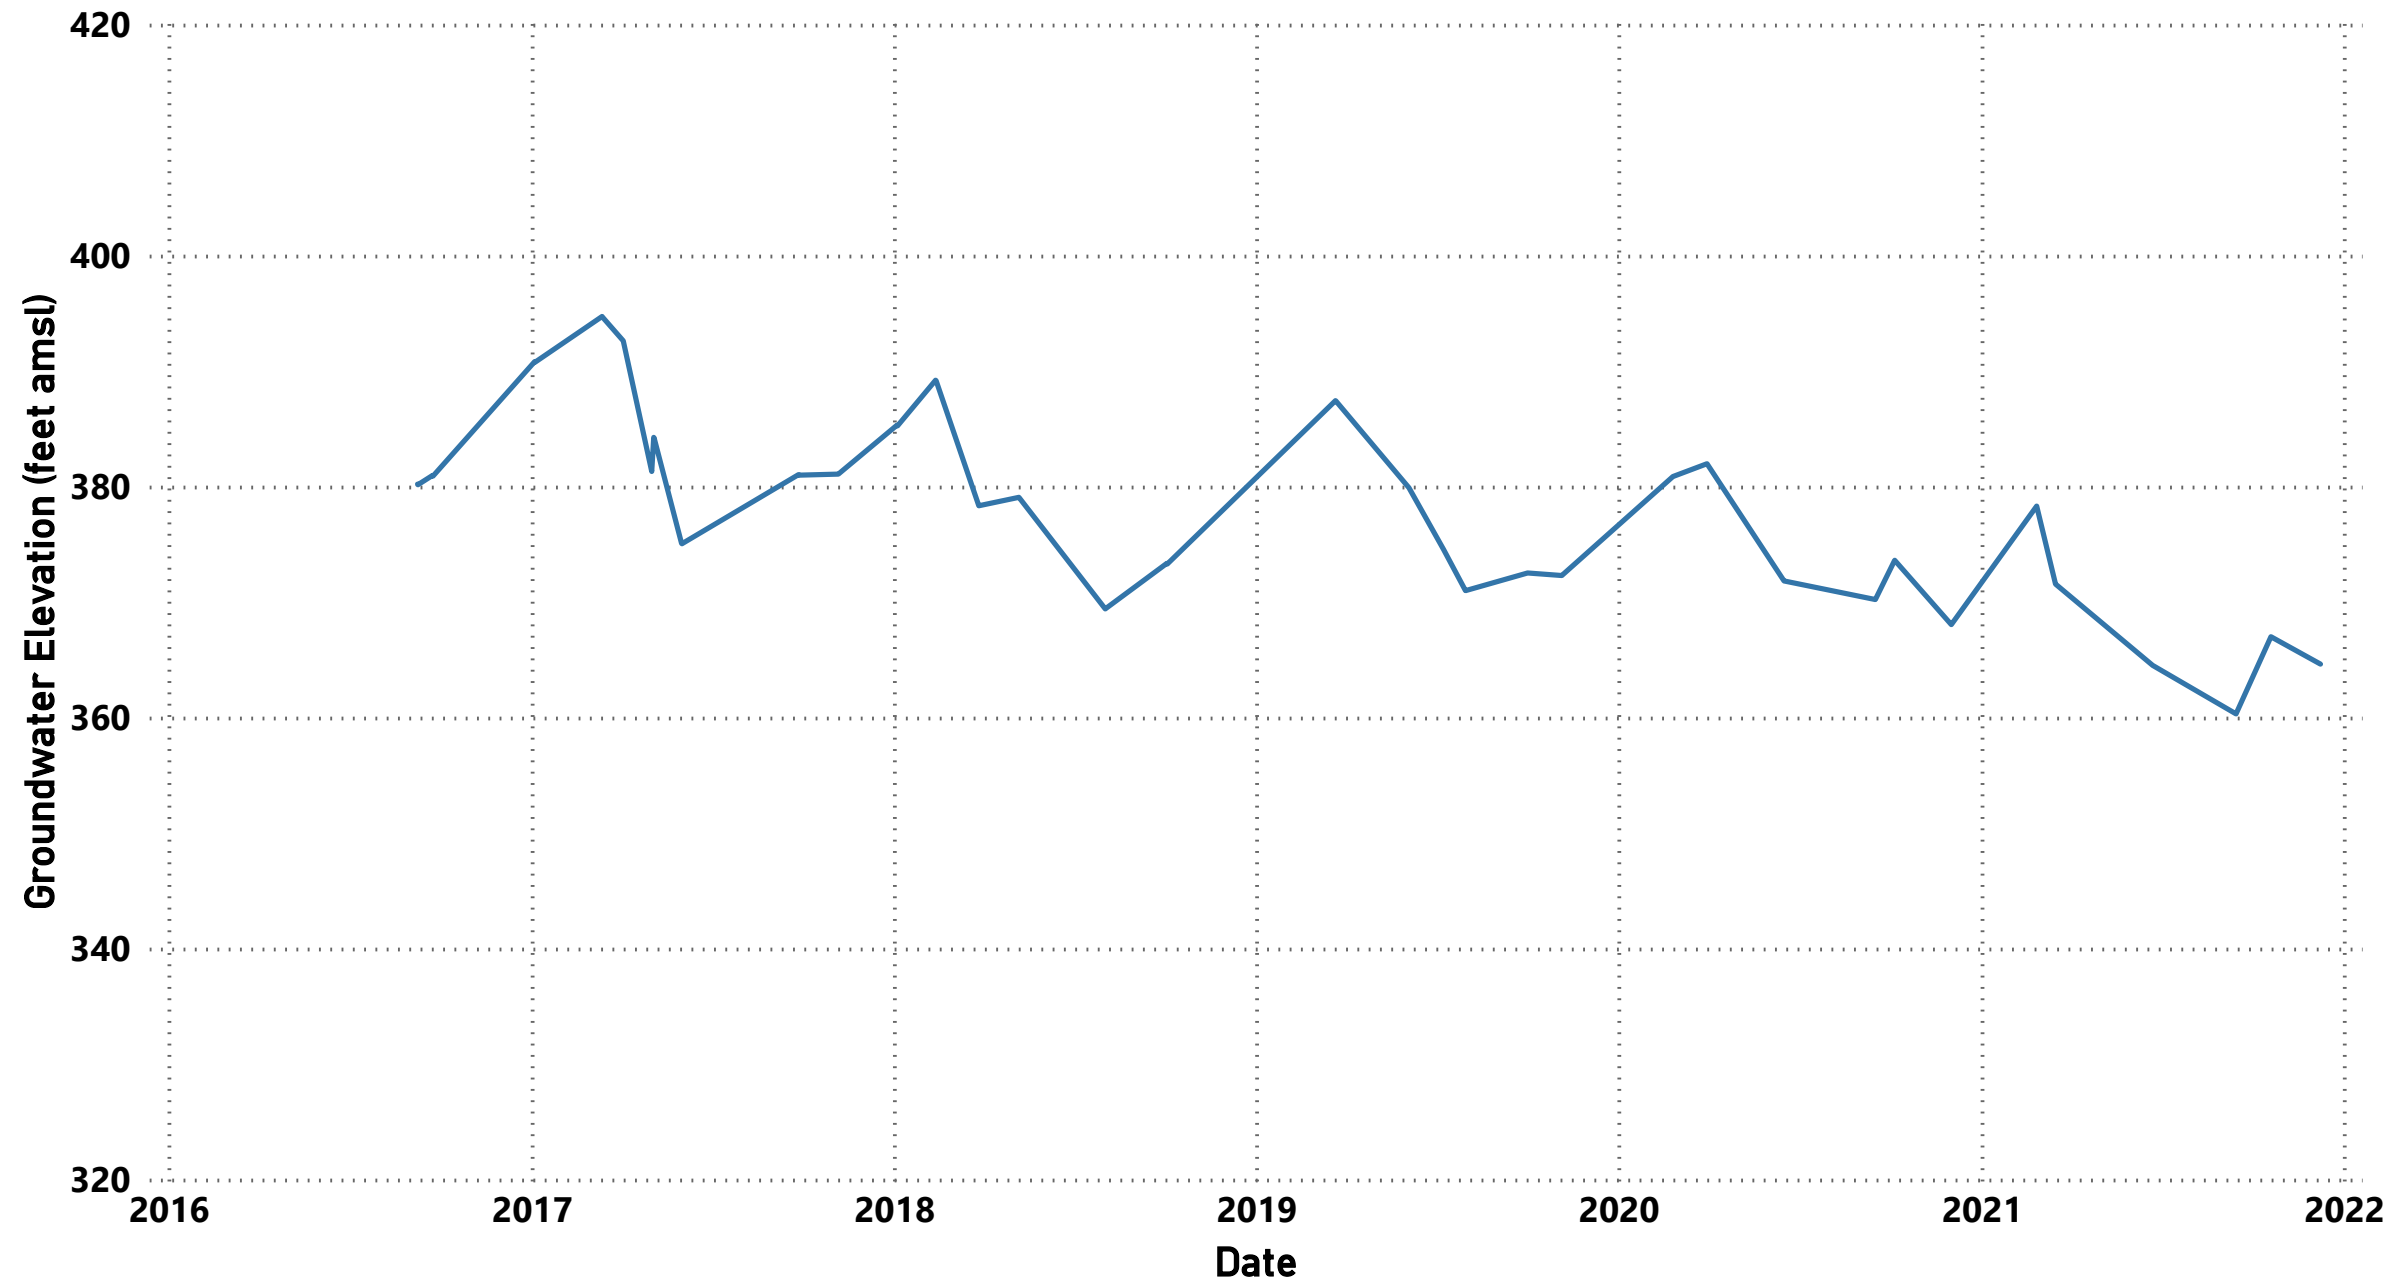
FIGURE 11
Hydrograph for Well SACC3
Paso Robles Formation Aquifer
San Antonio Basin GSA
2021 Annual Groundwater
Level Monitoring Report

Following each quarterly monitoring event, groundwater level data are provided to the SABGSA in an email monitoring report. Groundwater level measurements are housed within the SABGSA Data Management System and available upon request. Groundwater level trends observed since November 5, 2019, are consistent with historical trends; exhibiting a general decrease of groundwater elevations across the Basin. Water level measurements are presented in Table 1. Hydrographs from the wells in the monitoring network are included as Figures 6 through 43. The following noteworthy trends are observed in the hydrographs:

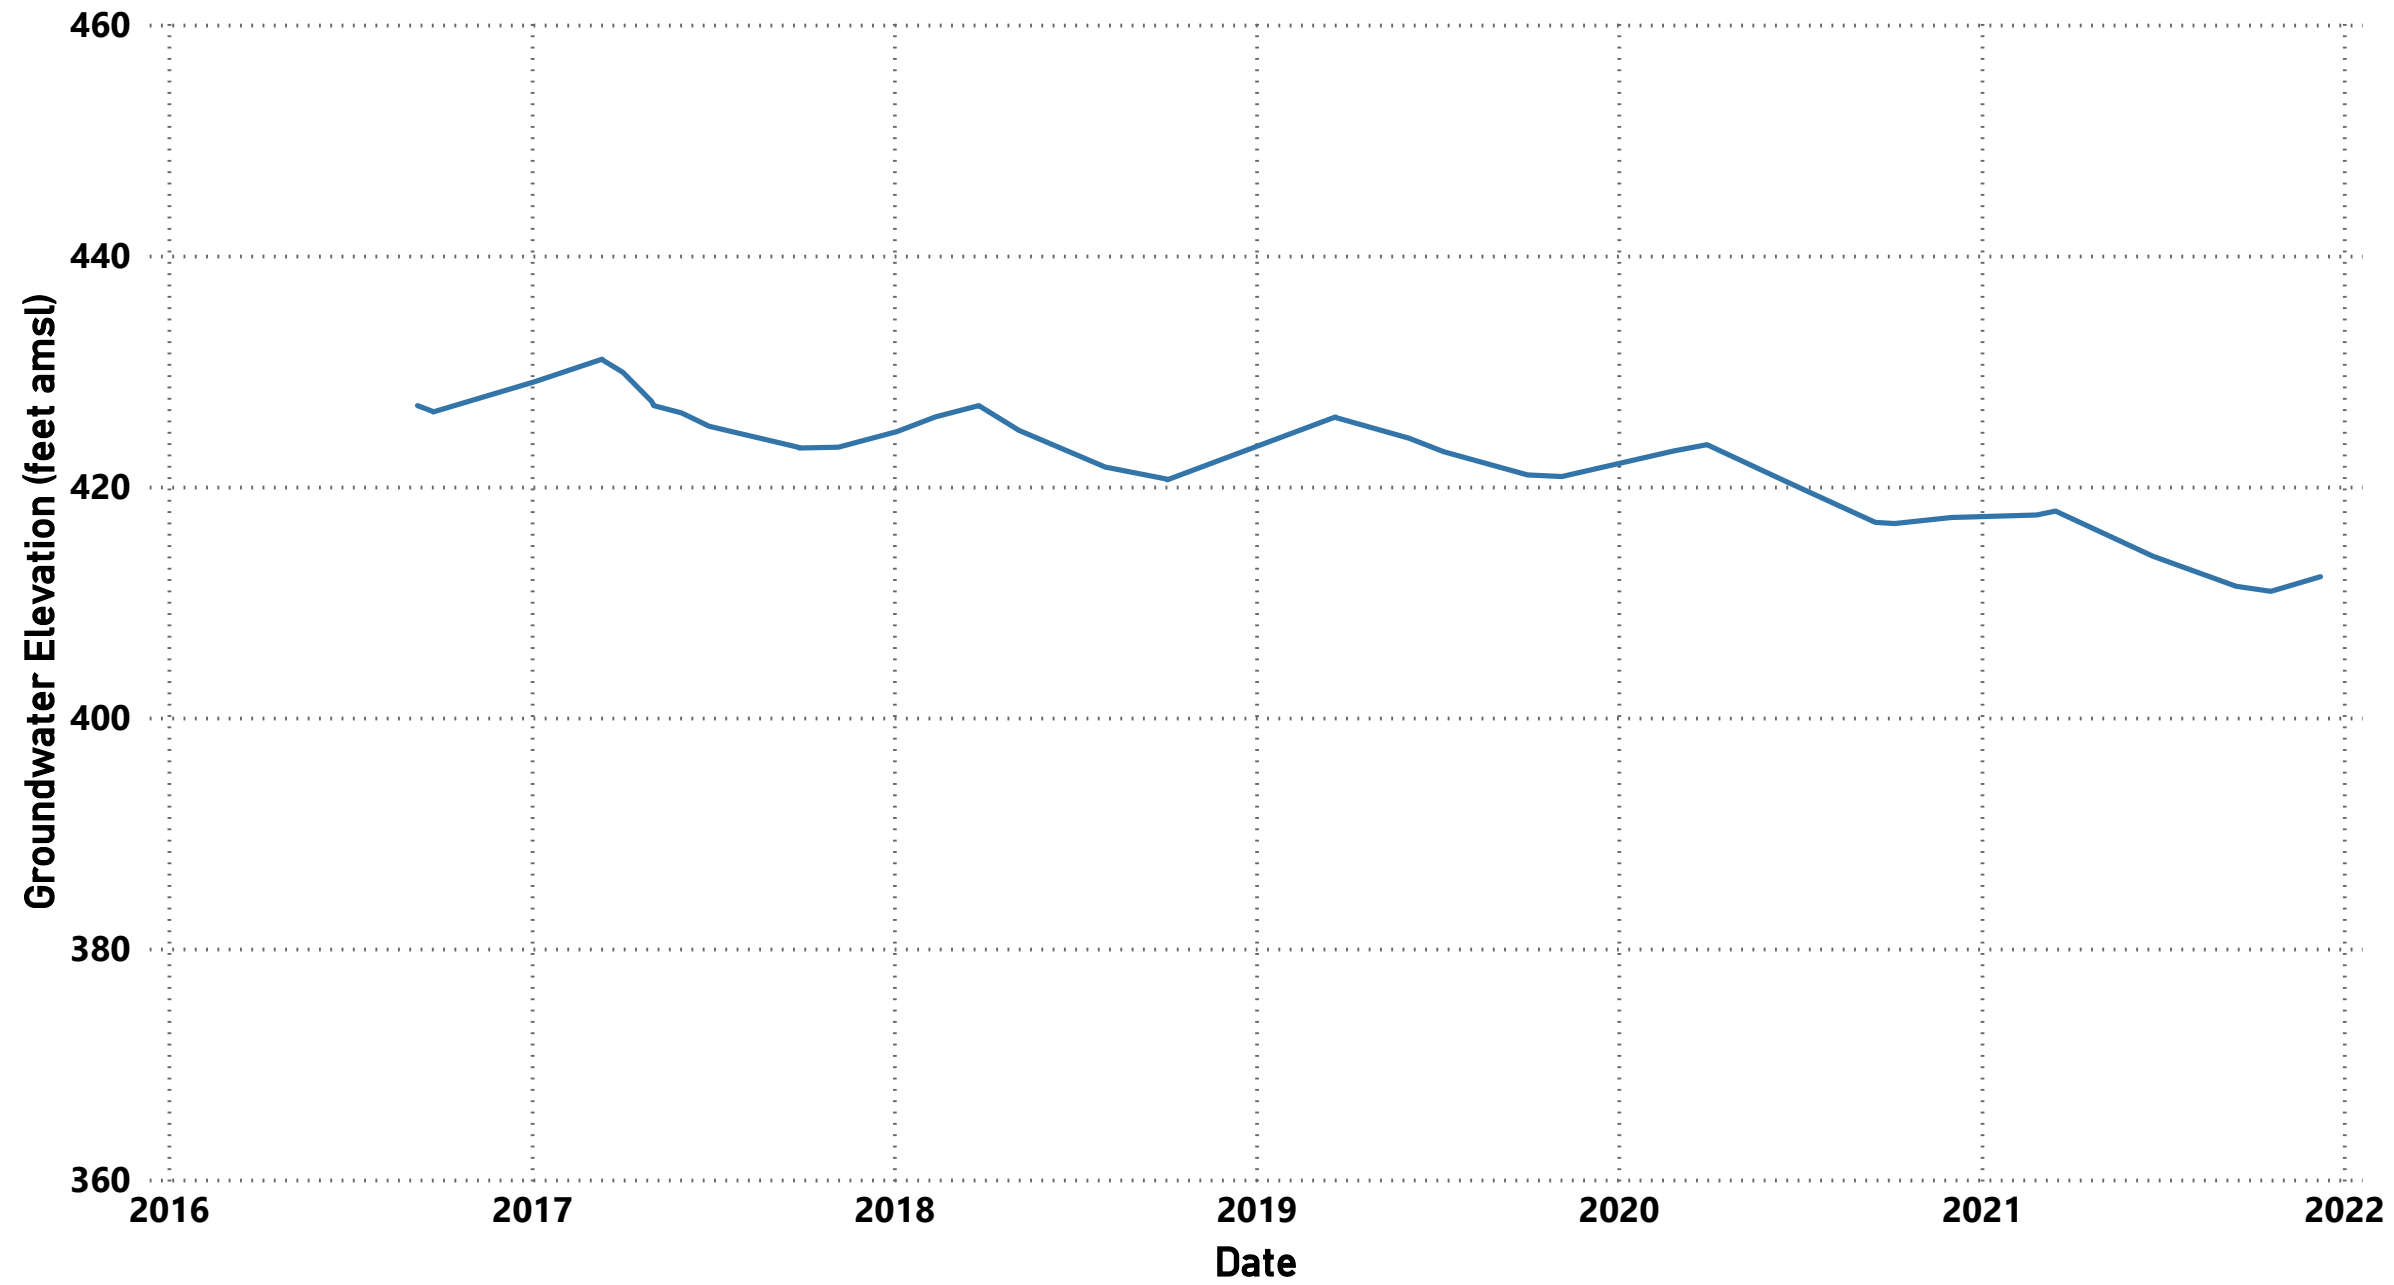
FIGURE 12
Hydrograph for Well SACC4
Paso Robles Formation Aquifer
San Antonio Basin GSA
2021 Annual Groundwater
Level Monitoring Report

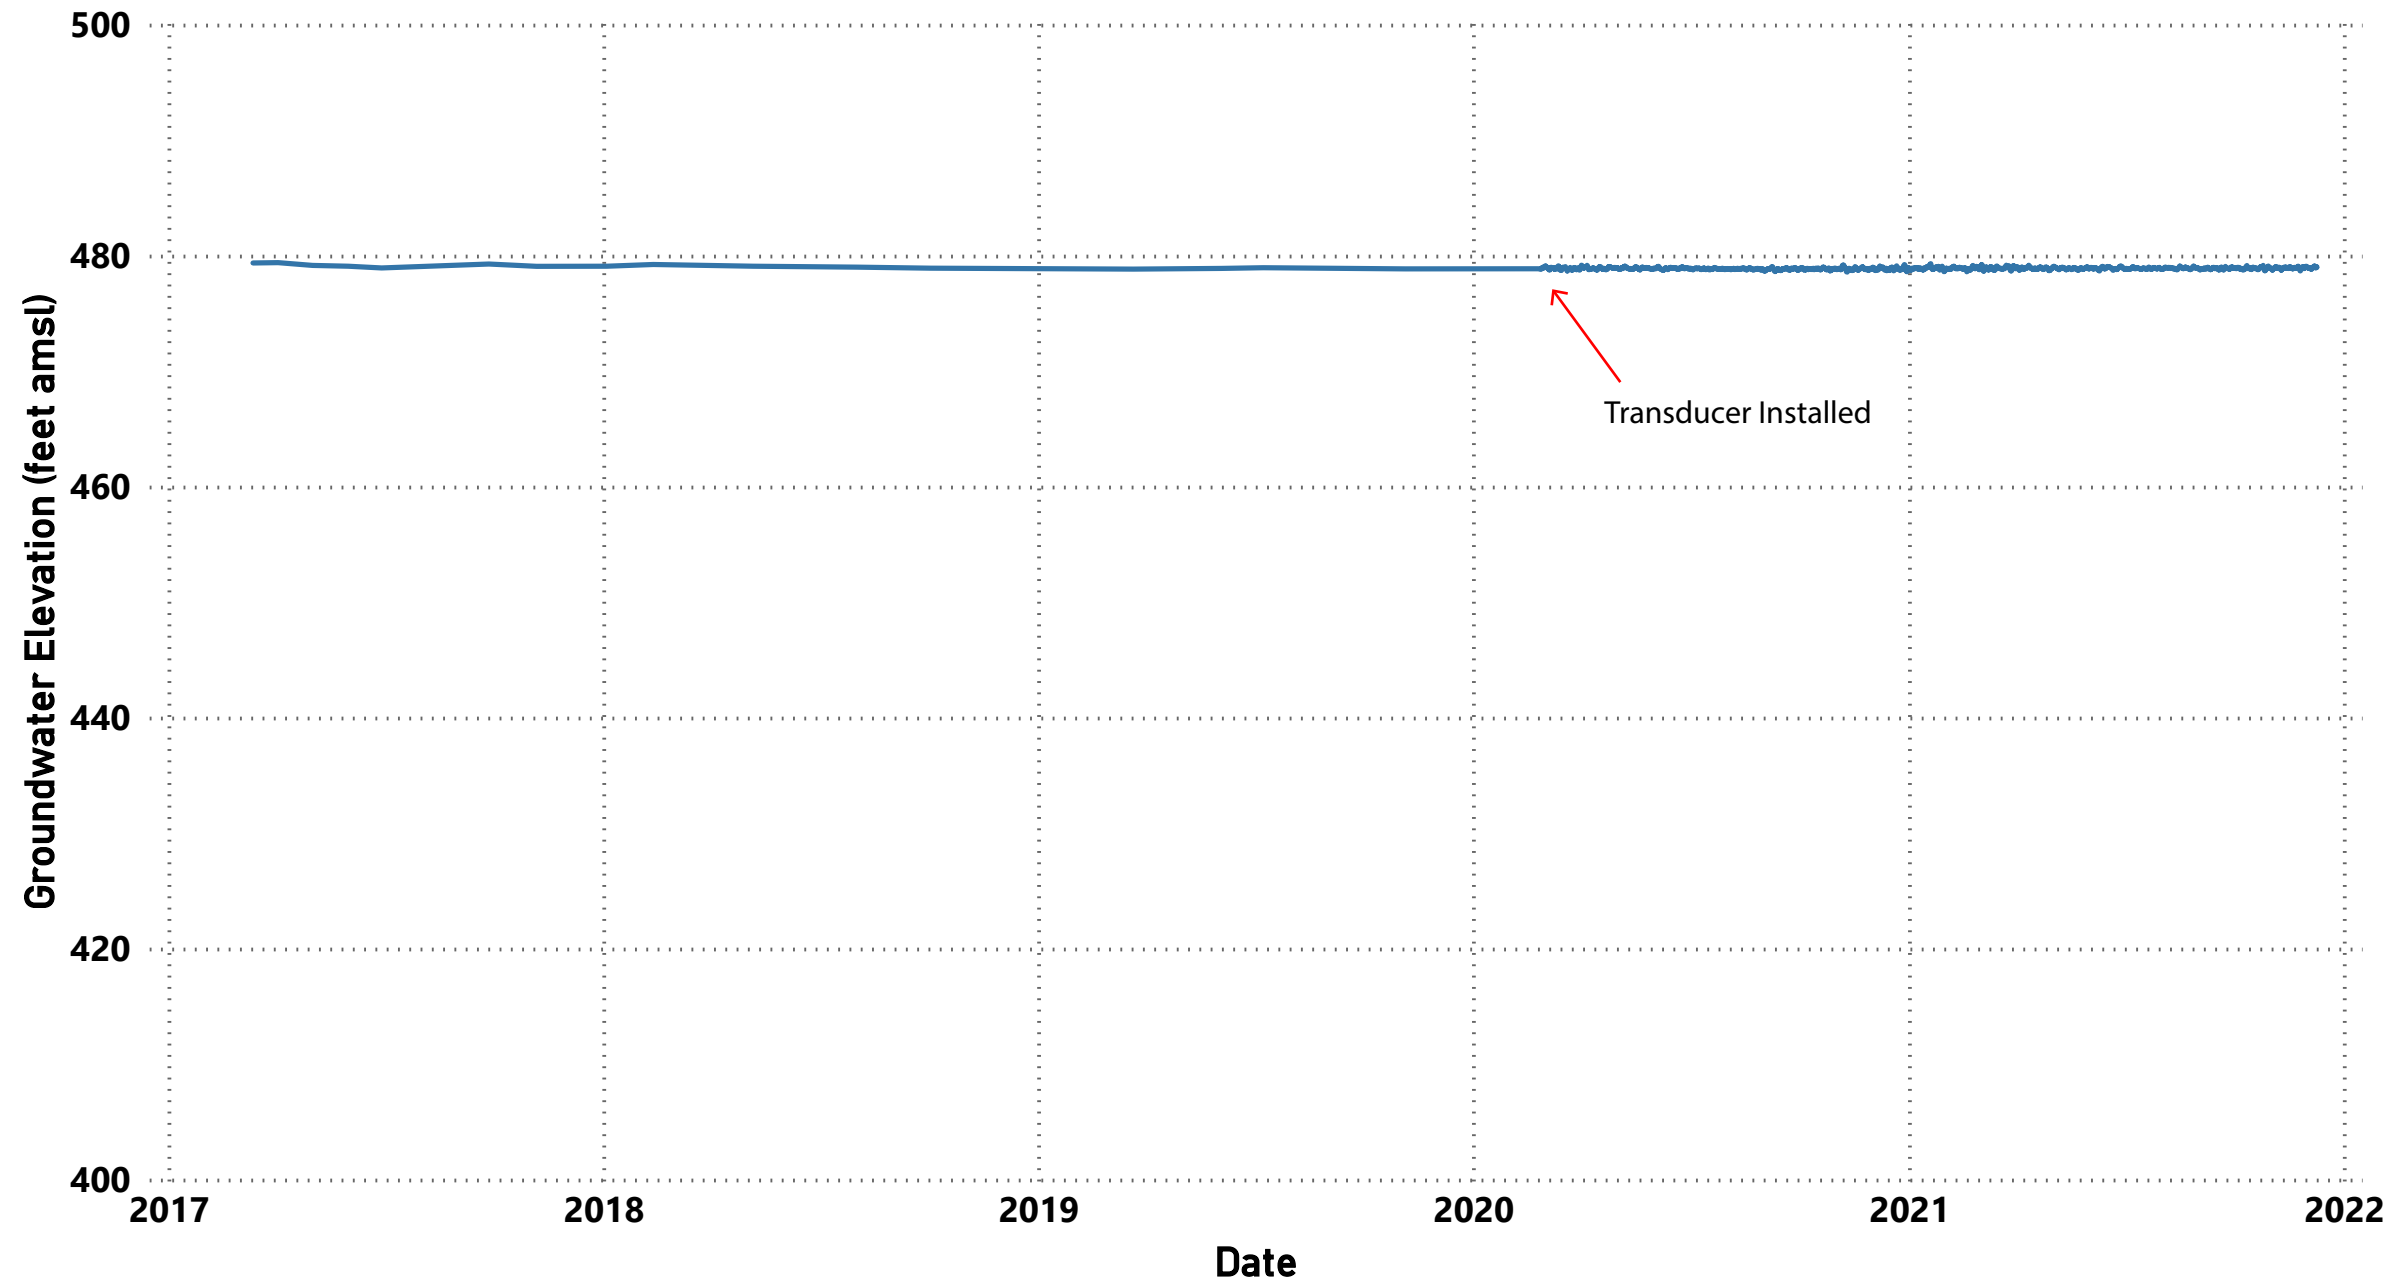
FIGURE 13
Hydrograph for Well SACC5
Paso Robles Formation Aquifer
San Antonio Basin GSA
2021 Annual Groundwater
Level Monitoring Report

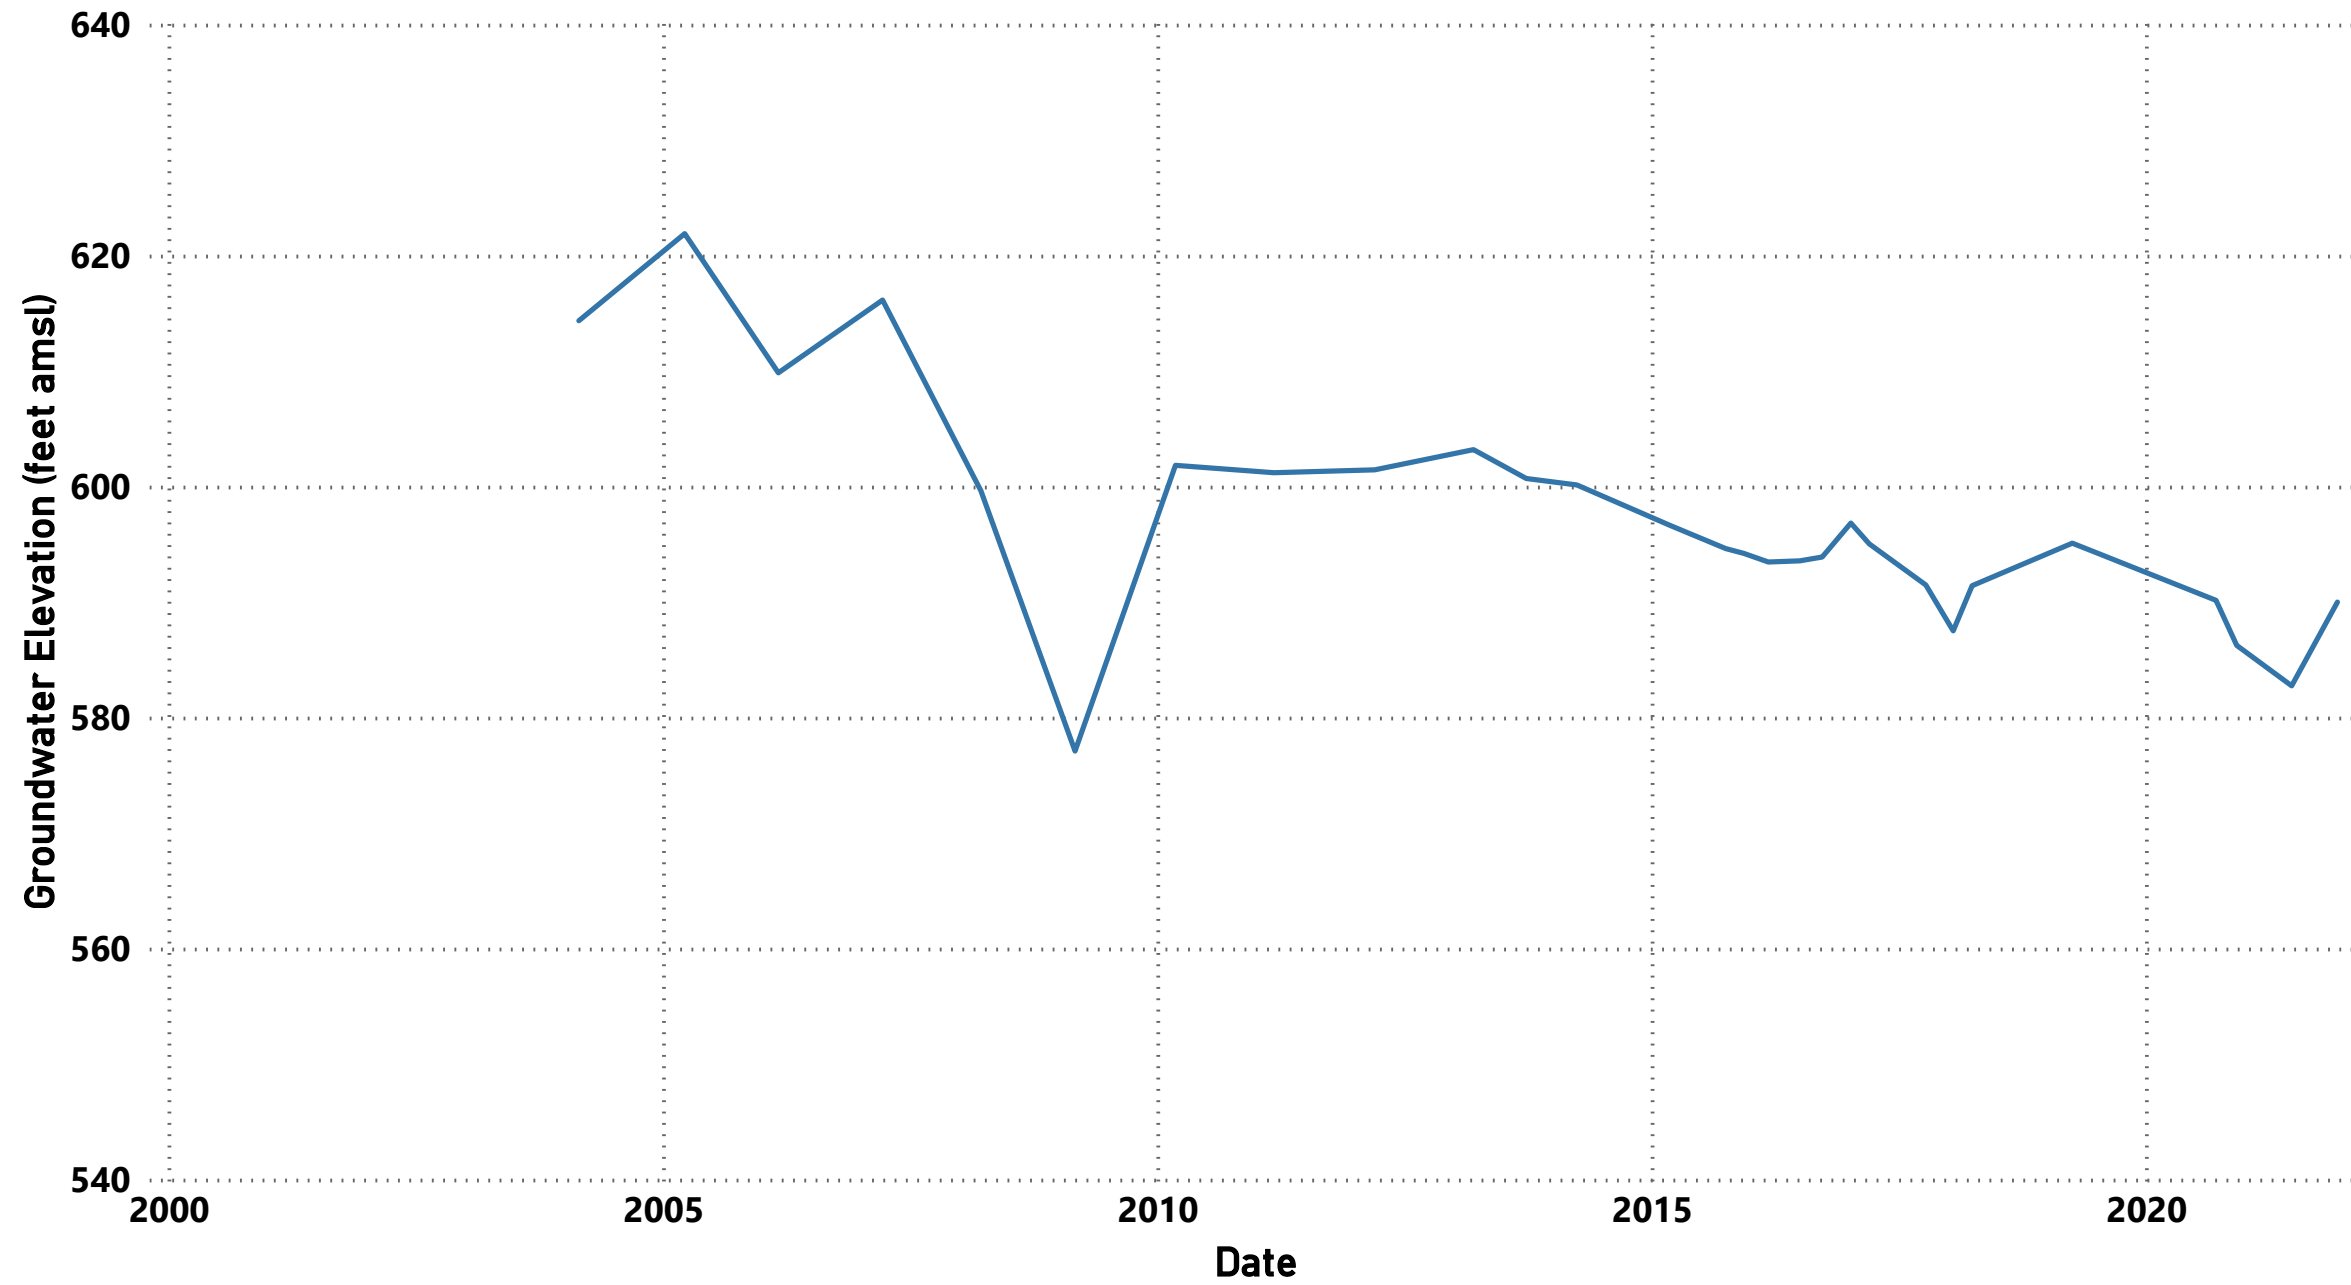
FIGURE 14
Hydrograph for Well 13C1
Careaga Formation Aquifer
San Antonio Basin GSA
2021 Annual Groundwater
Level Monitoring Report

- Well 17K2 on the south side of Barka Slough remained inaccessible due to overgrown vegetation.
- A water level measurement was not obtained from 13C1 because the pump was on.
- The transducer communication cable for well 16C4 was not working properly - the cable was sent into the supplier for repair.
- The water level in the Stephens Well (Kick On Ranch) was not measured because access had not been re-negotiated.

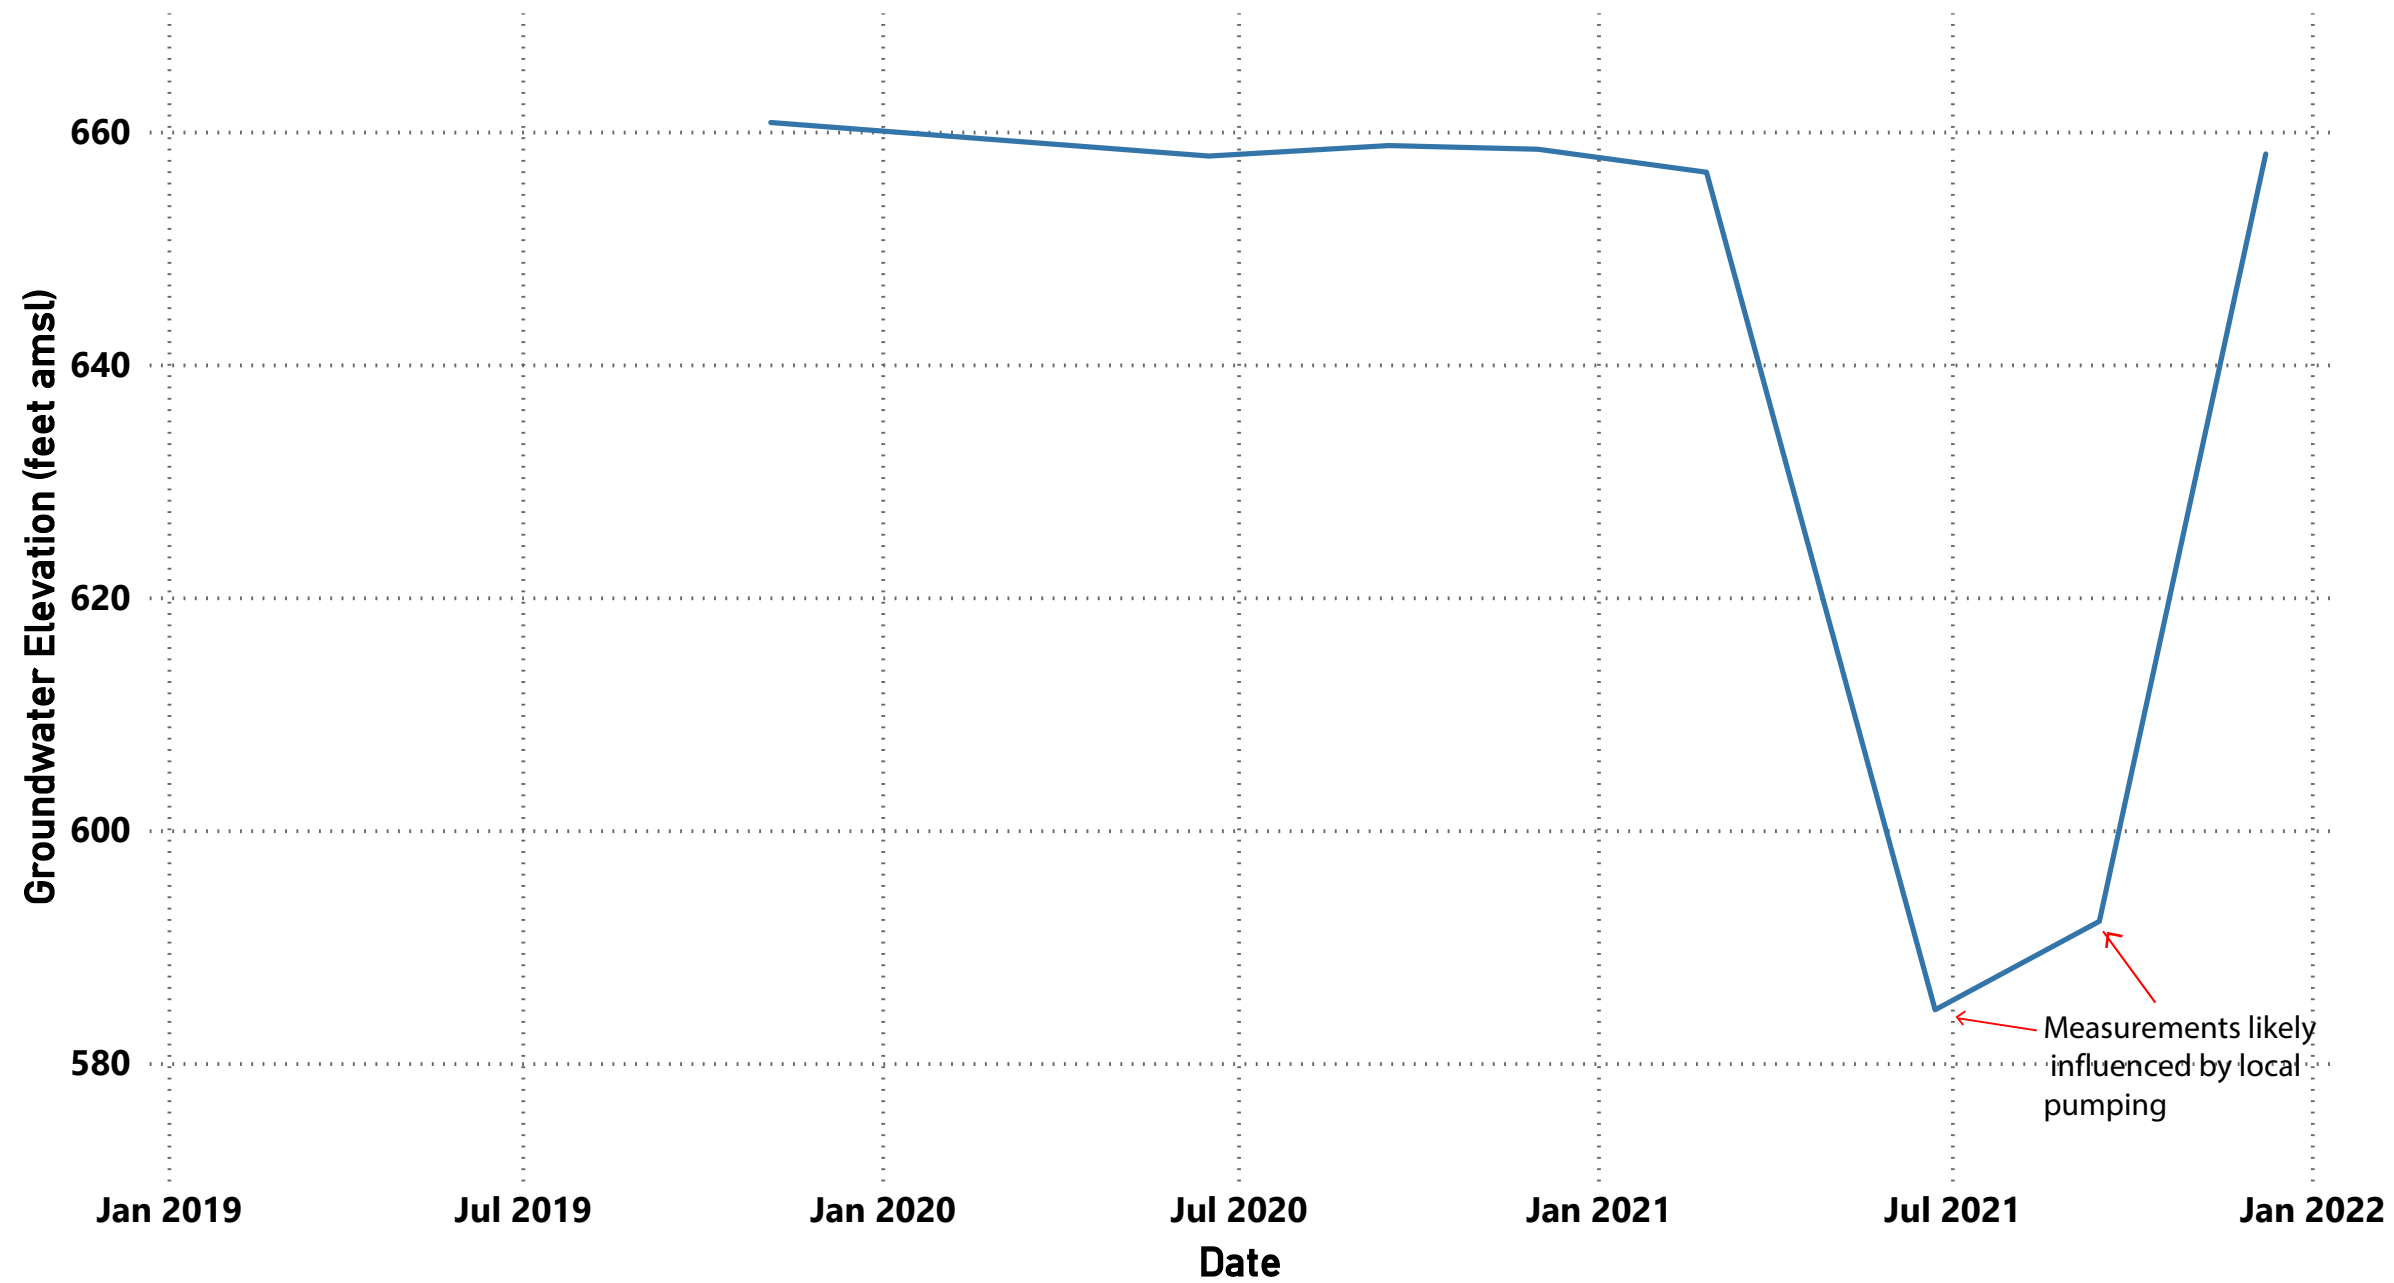
FIGURE 15
Hydrograph for Well 2R1
Careaga Formation Aquifer
San Antonio Basin GSA
2021 Annual Groundwater
Level Monitoring Report

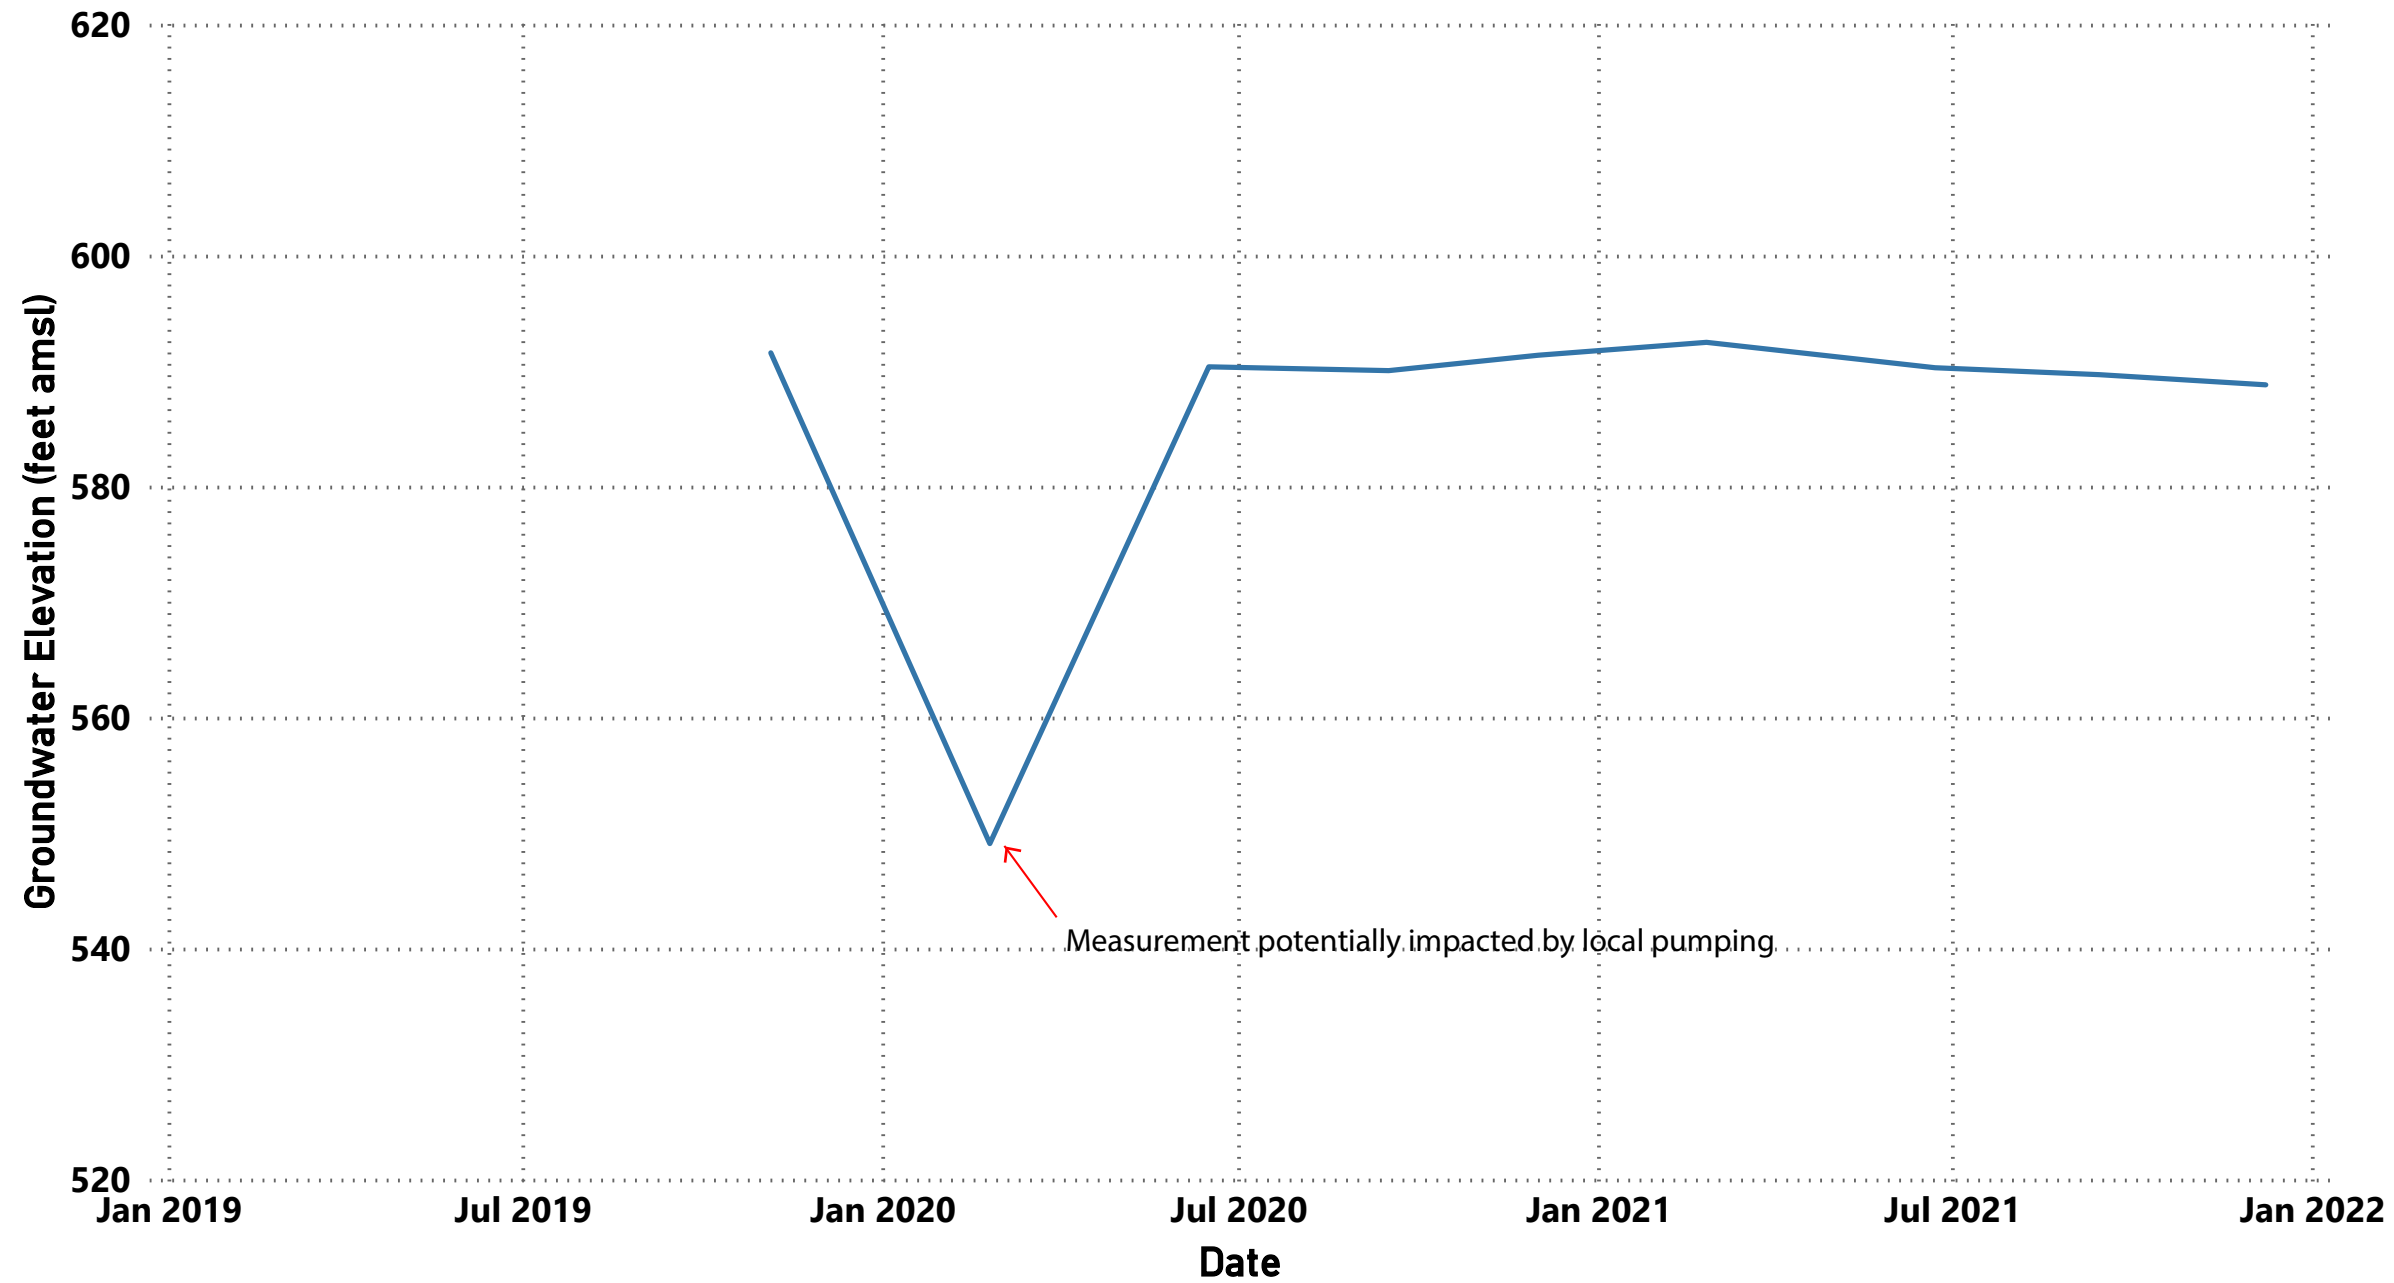
FIGURE 16
Hydrograph for Mesa Vineyard Well
Careaga Formation Aquifer
San Antonio Basin GSA
2021 Annual Groundwater
Level Monitoring Report

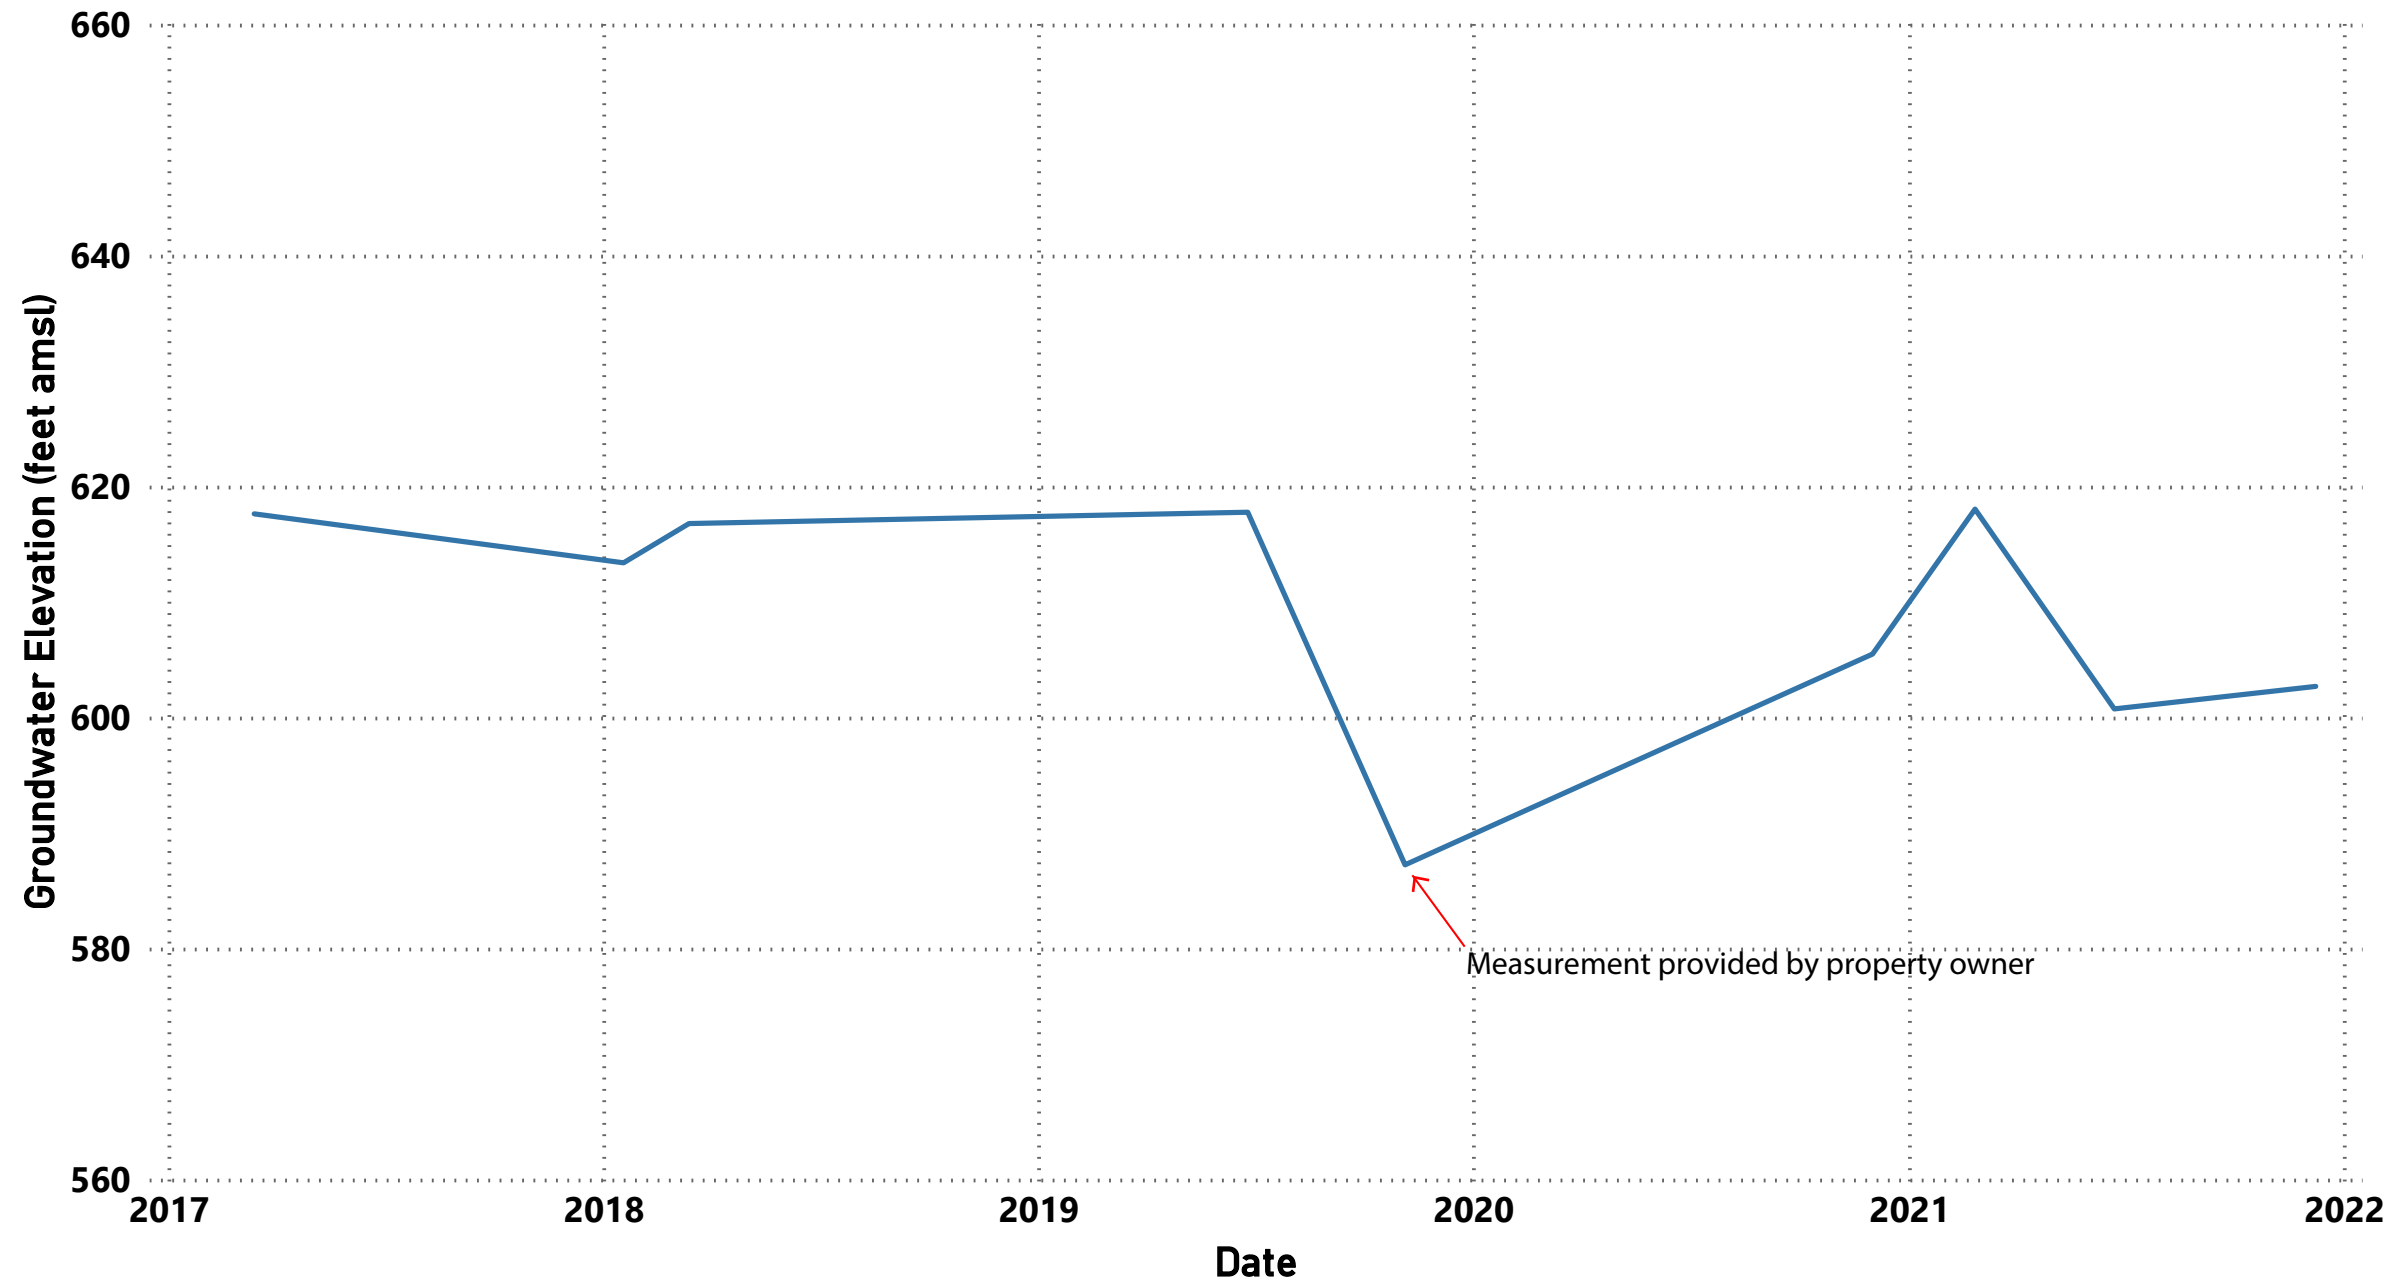
FIGURE 17
Hydrograph for Well 2N1
Careaga Formation Aquifer
San Antonio Basin GSA
2021 Annual Groundwater
Level Monitoring Report
