San Antonio Basin Groundwater Sustainability Agency

2021 Annual Groundwater Level Monitoring Report

January 28, 2022

GSI Water Solutions, Inc.

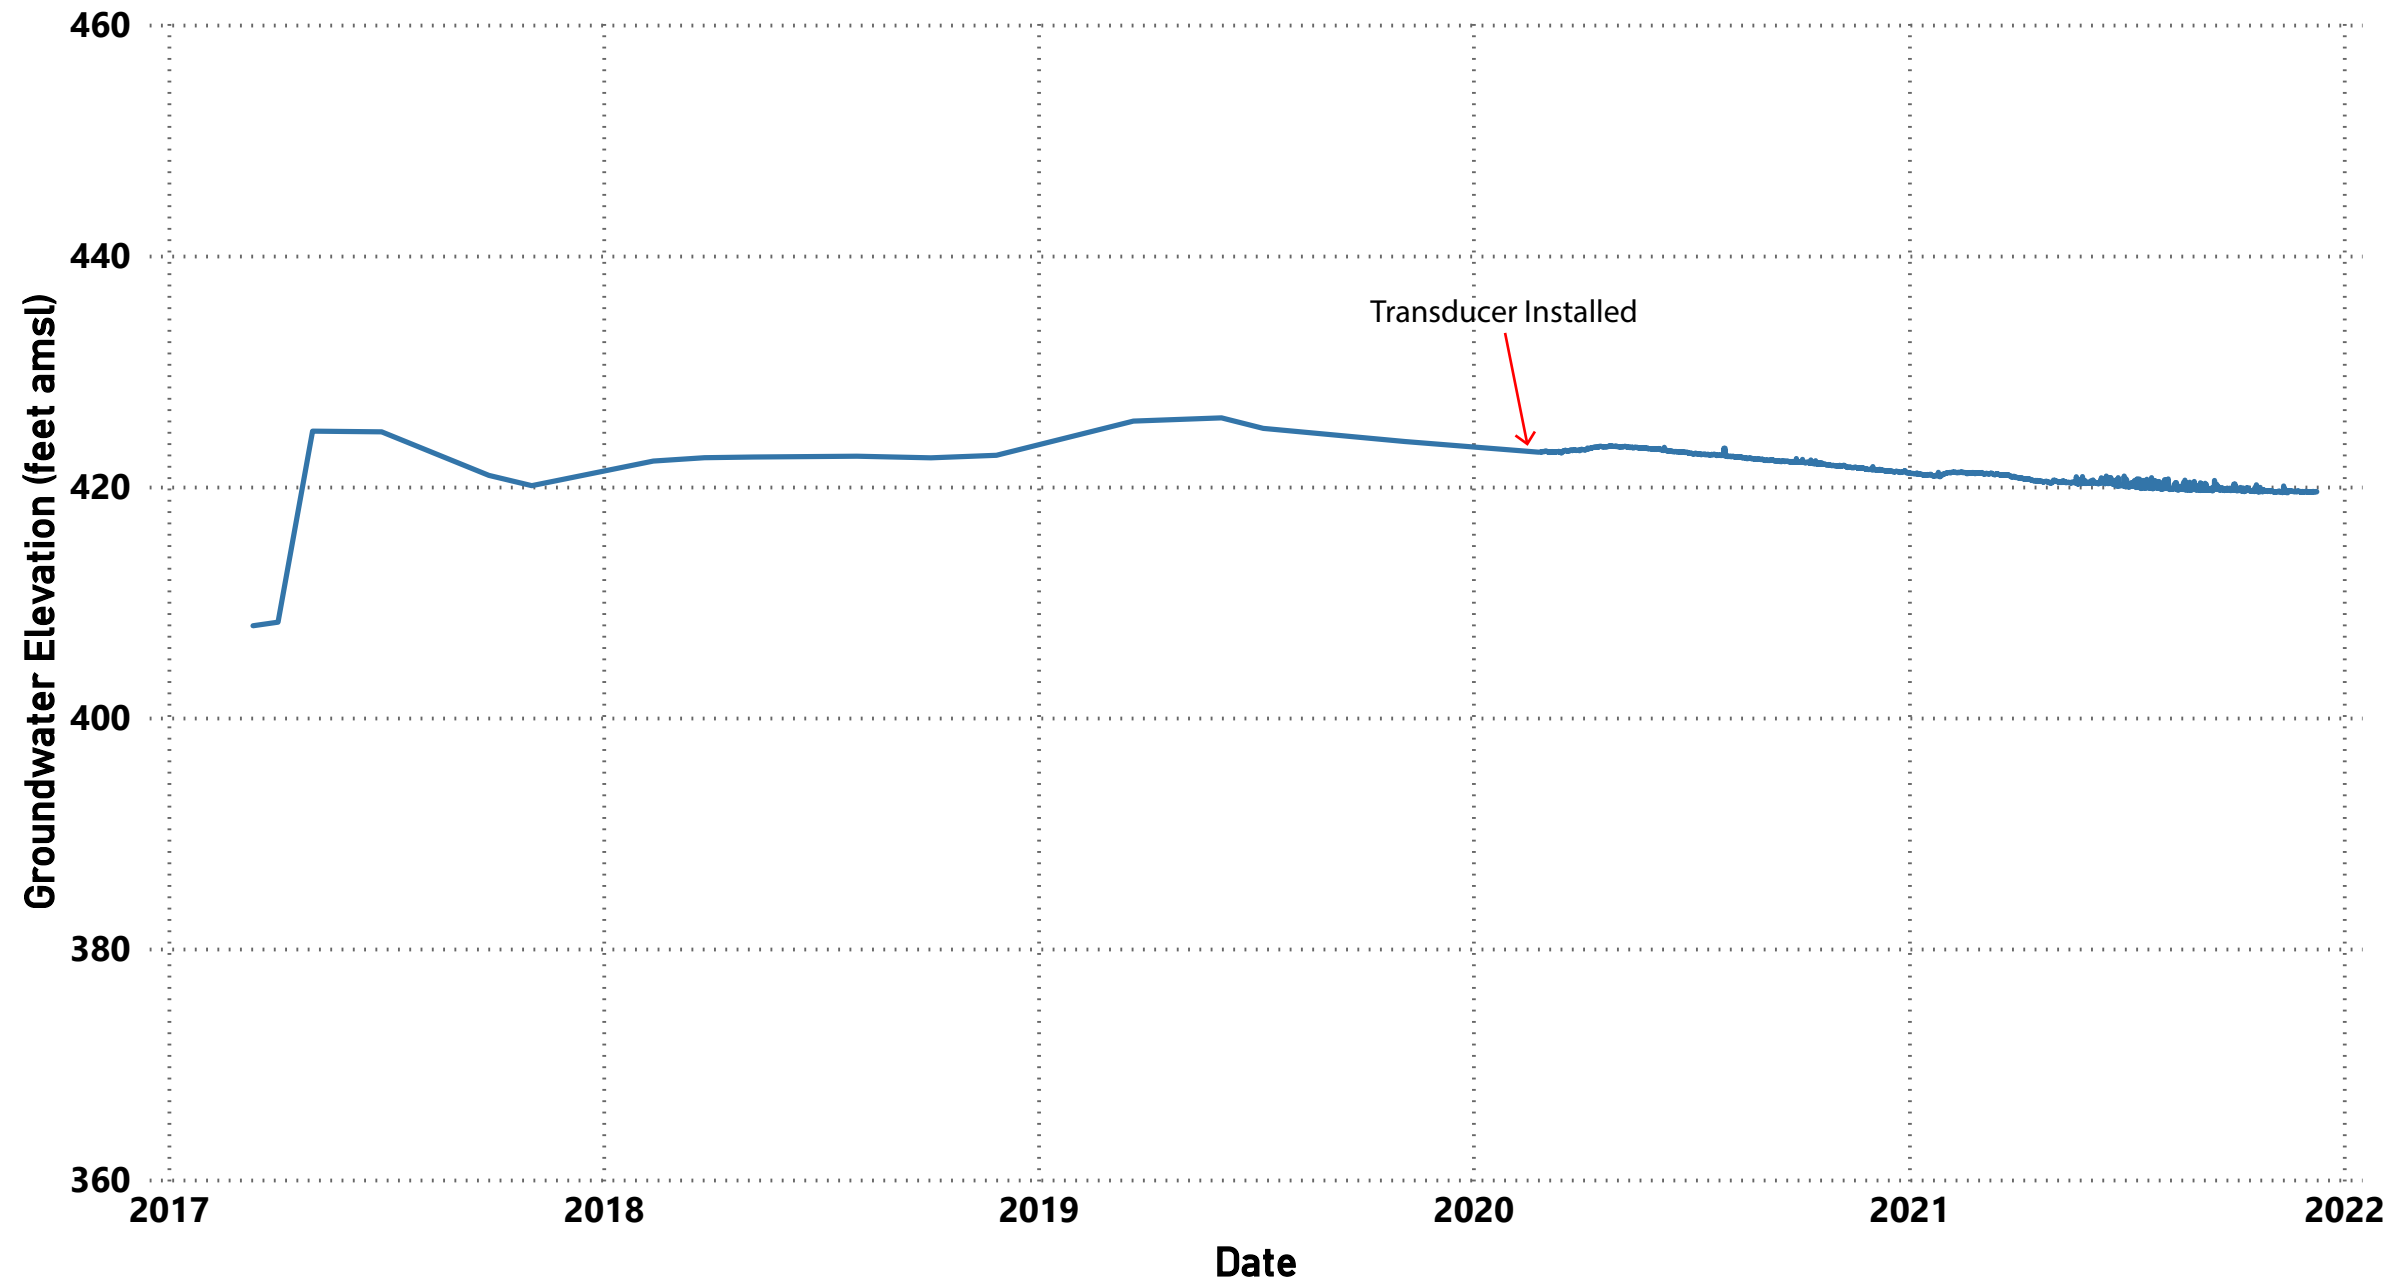
FIGURE 18
Hydrograph for Well SALS
Paso Robles Formation Aquifer
San Antonio Basin GSA
2021 Annual Groundwater
Level Monitoring Report

Following each quarterly monitoring event, groundwater level data are provided to the SABGSA in an email monitoring report. Groundwater level measurements are housed within the SABGSA Data Management System and available upon request. Groundwater level trends observed since November 5, 2019, are consistent with historical trends; exhibiting a general decrease of groundwater elevations across the Basin. Water level measurements are presented in Table 1. Hydrographs from the wells in the monitoring network are included as Figures 6 through 43. The following noteworthy trends are observed in the hydrographs:

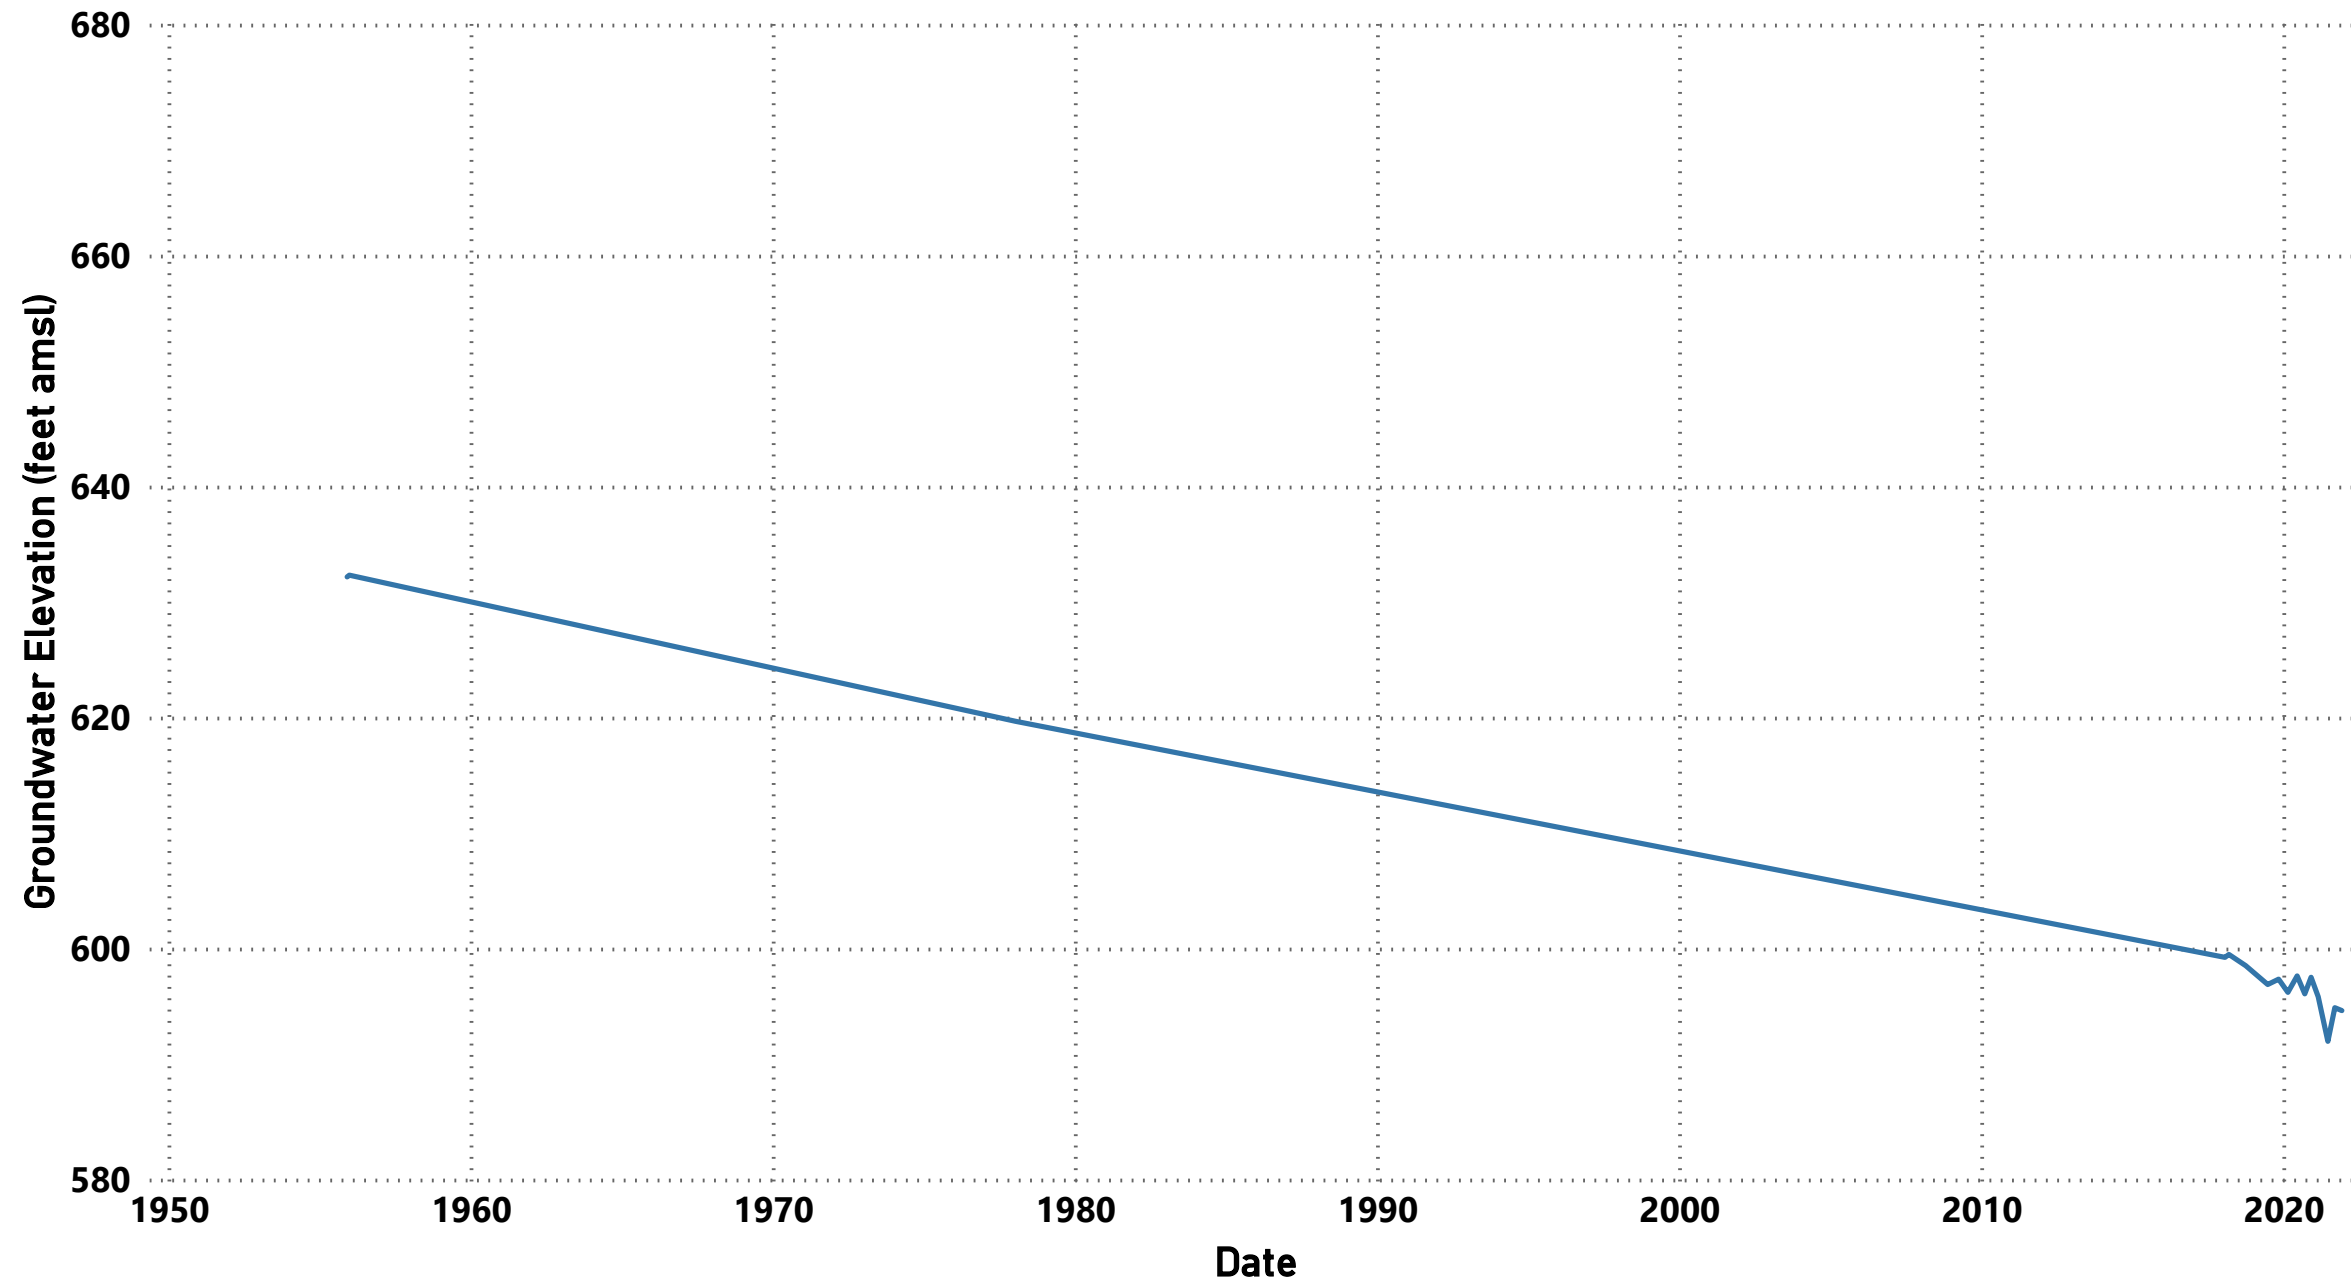
FIGURE 19
Hydrograph for
4-Deer Highway Well
Careaga Formation Aquifer

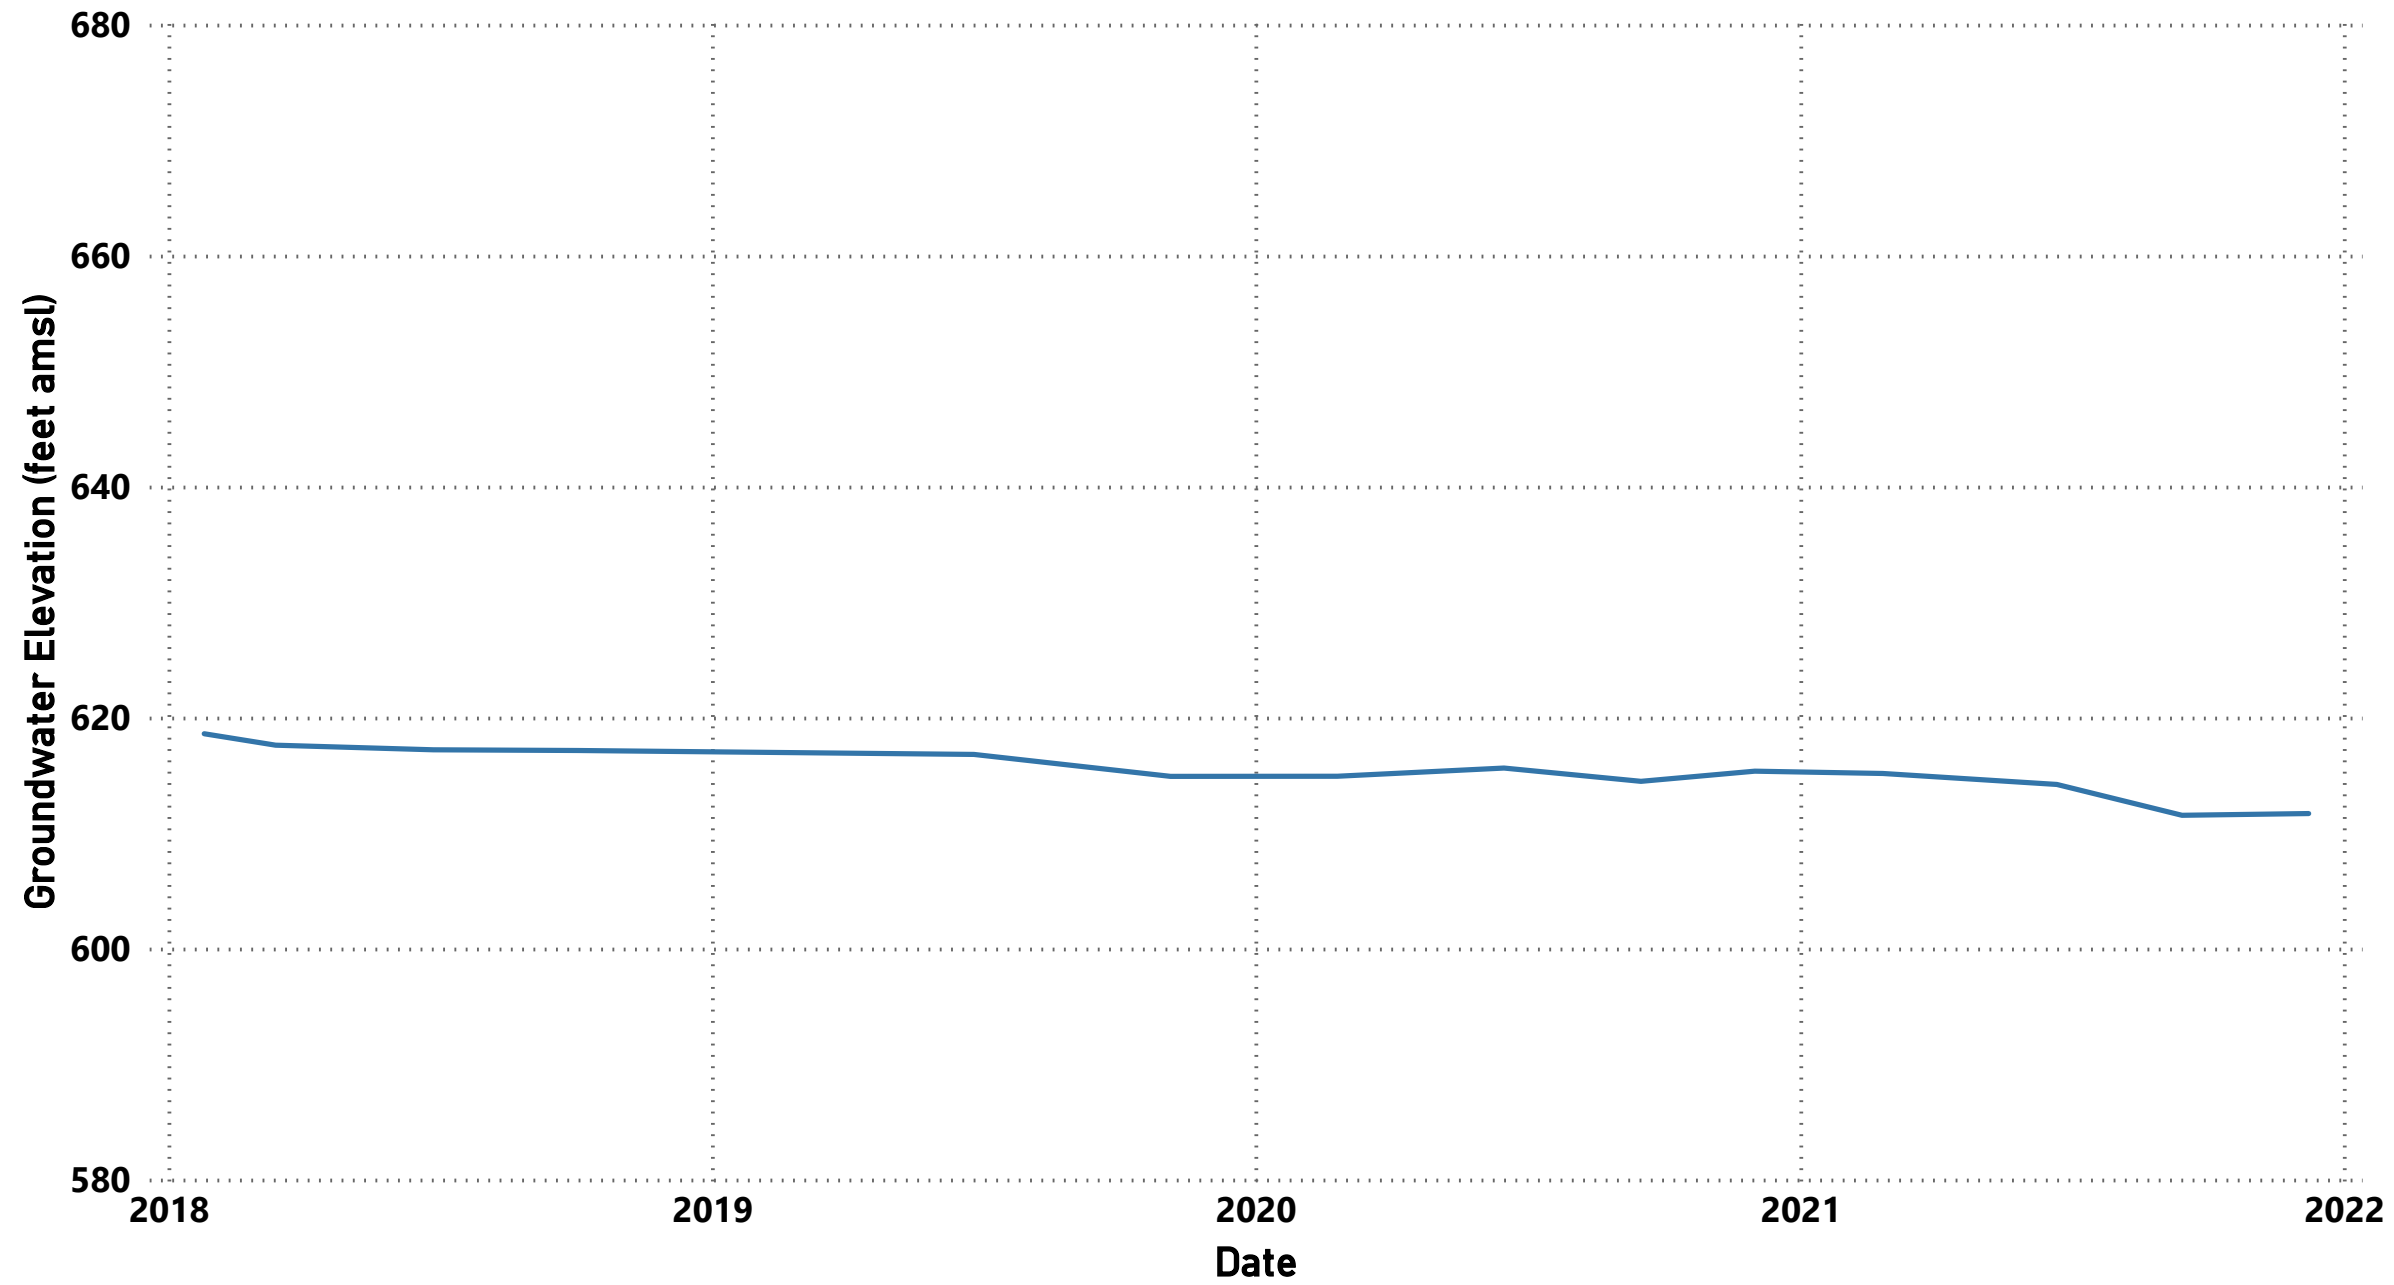
FIGURE 20
Hydrograph for 4-Deer Field Well
Careaga Formation Aquifer
San Antonio Basin GSA
2021 Annual Groundwater
Level Monitoring Report

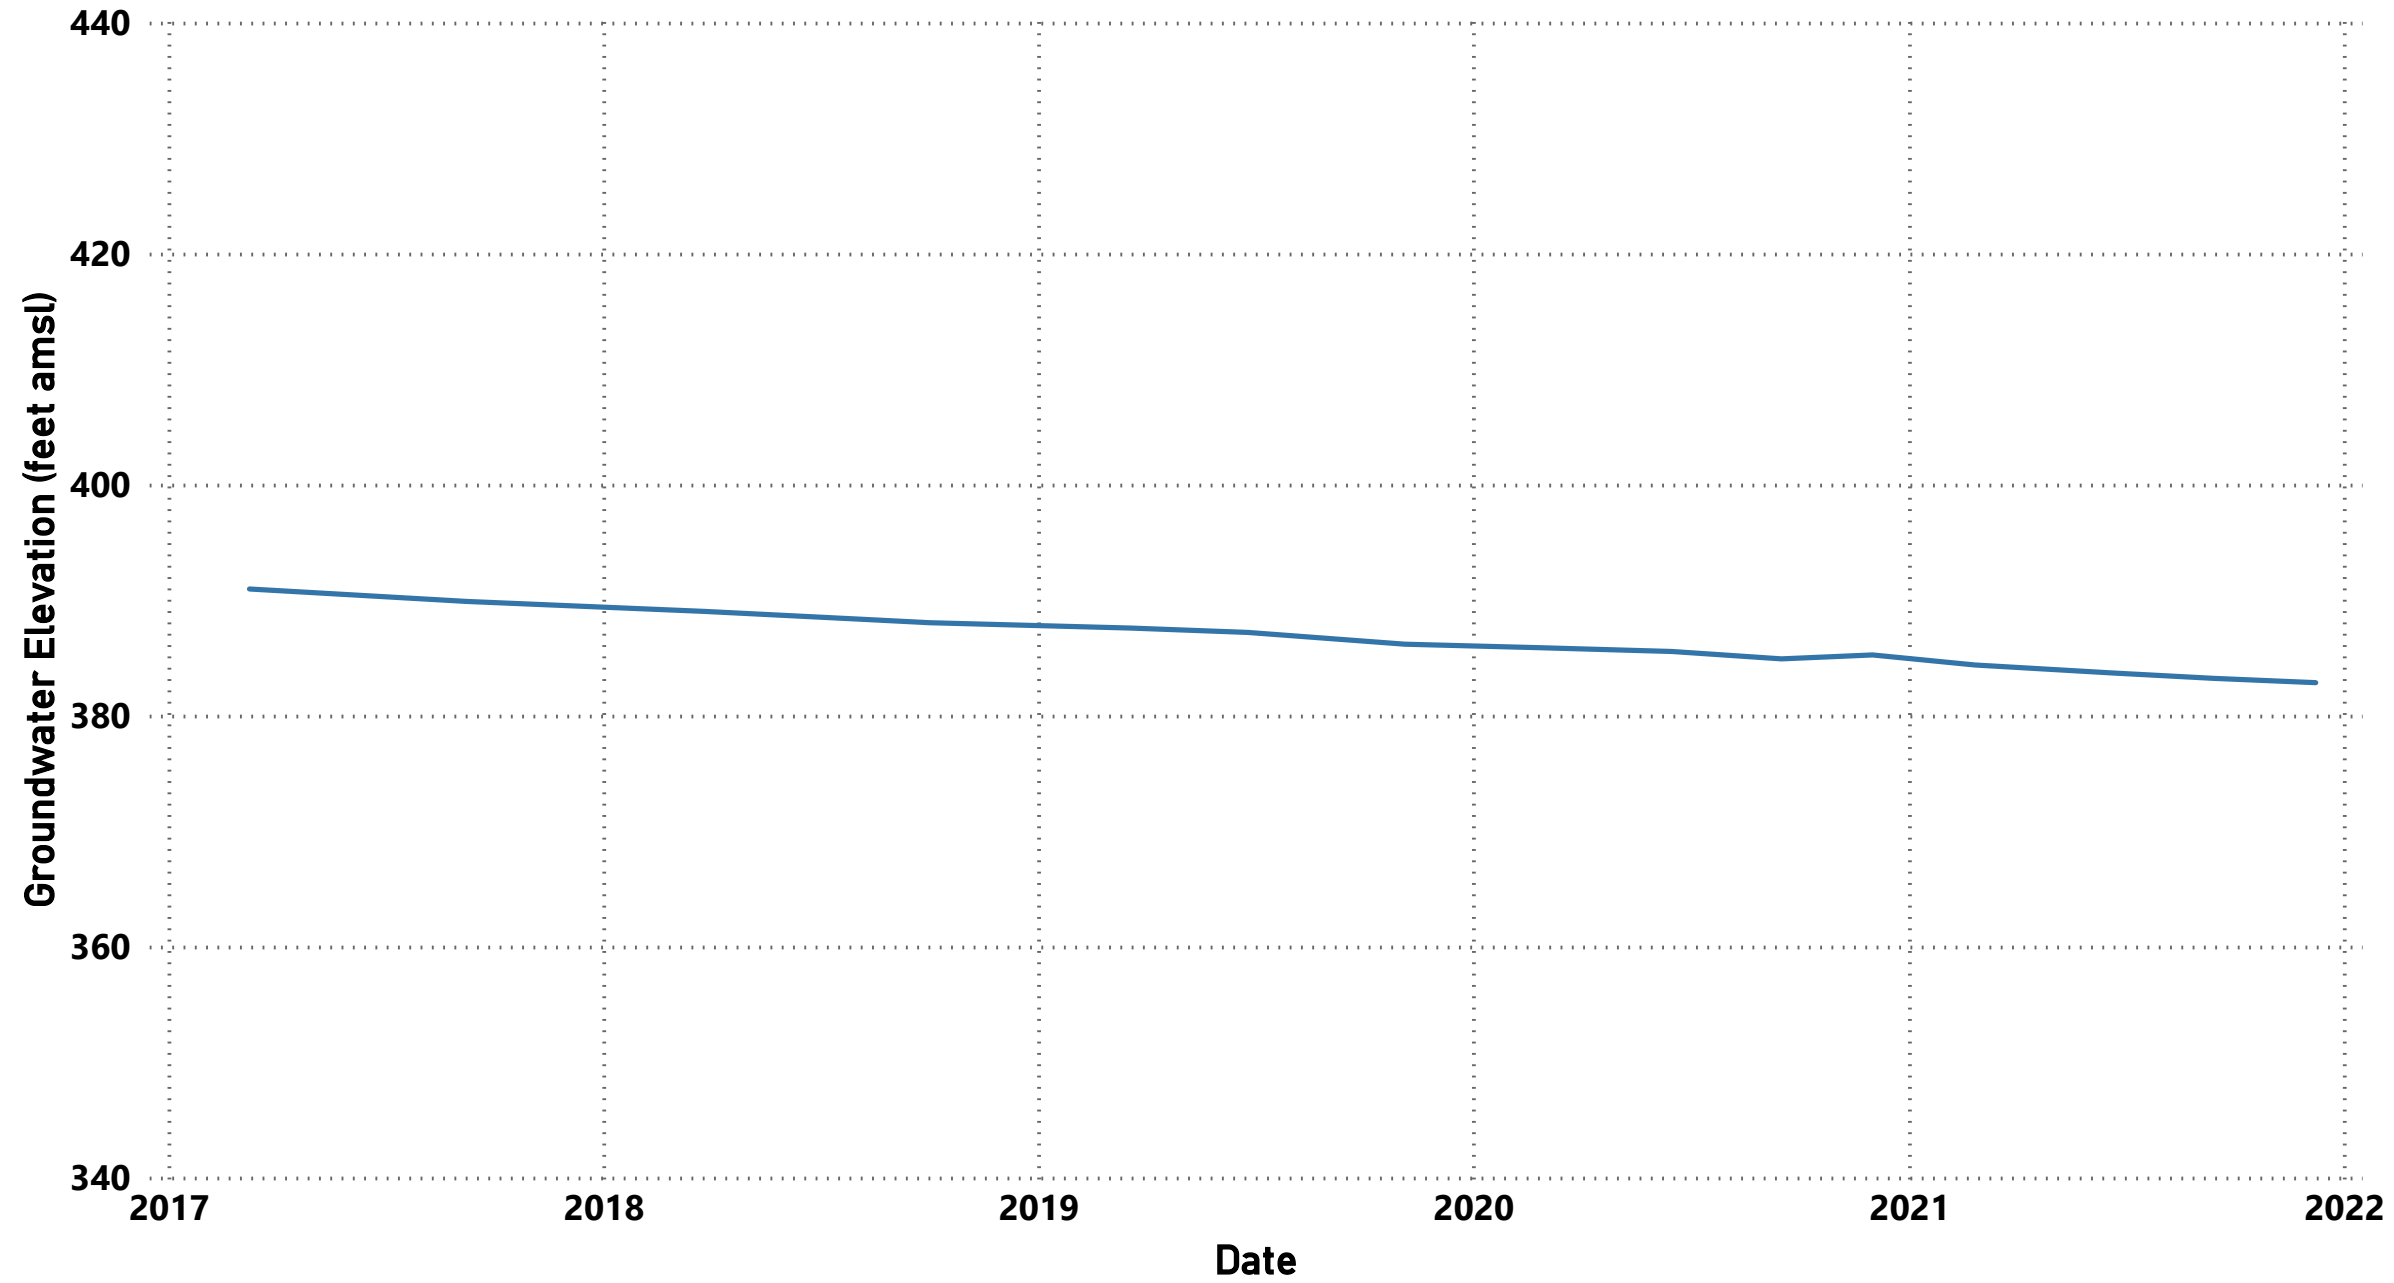
FIGURE 21
Hydrograph for Schaff Well
Careaga Formation Aquifer
San Antonio Basin GSA
2021 Annual Groundwater
Level Monitoring Report

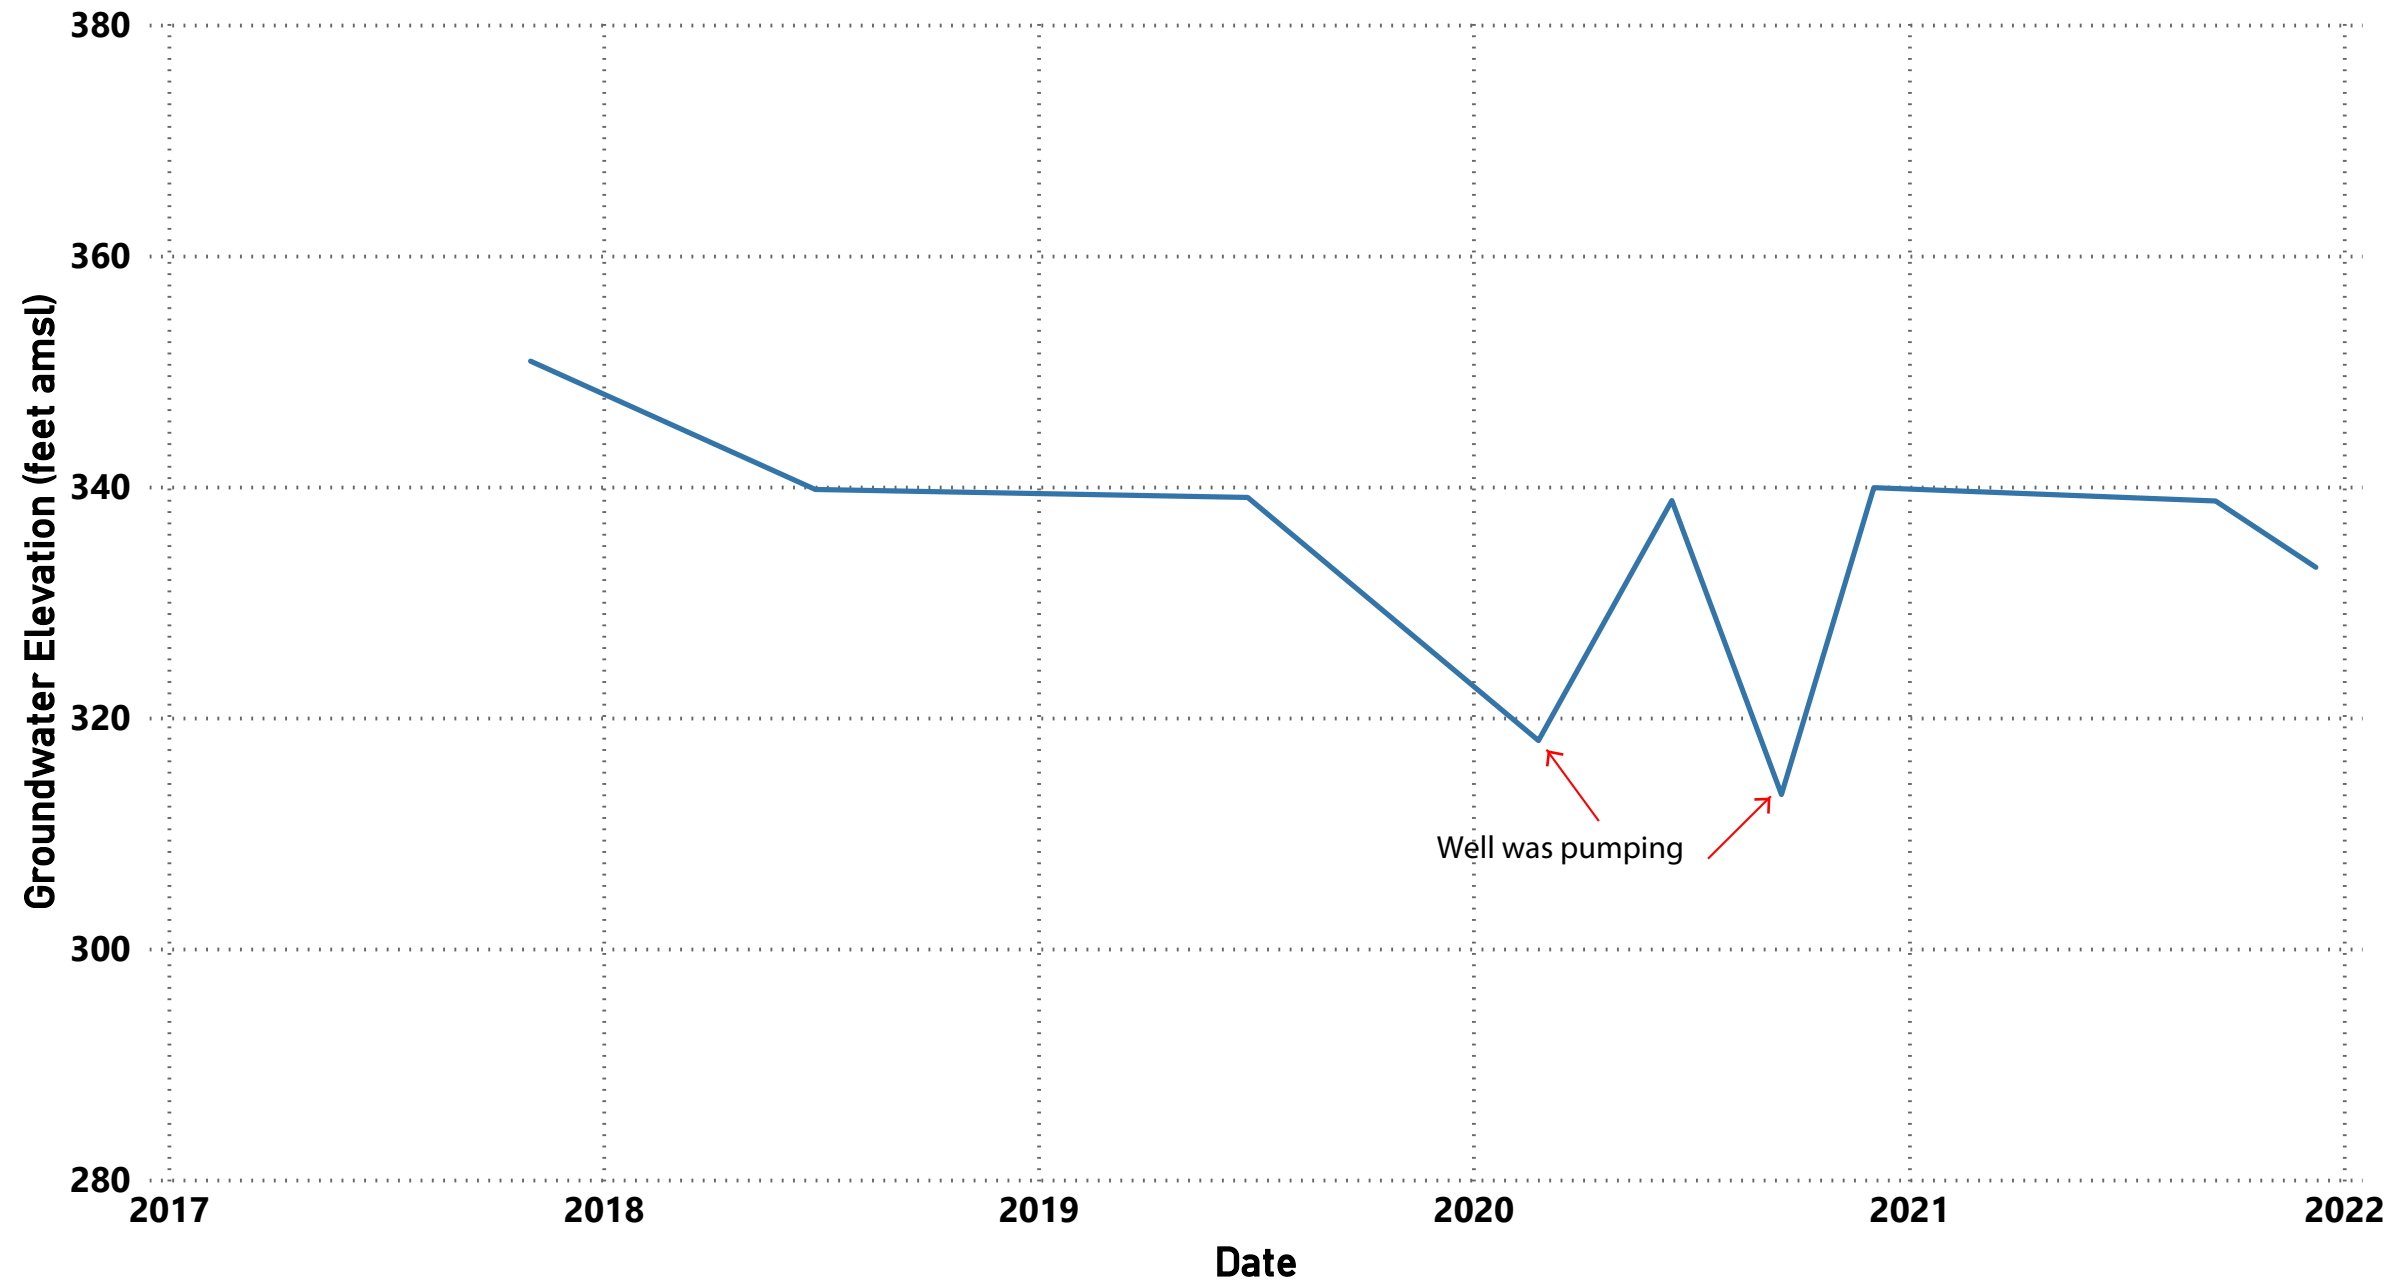
FIGURE 22
Hydrograph for Stephen's Well
Careaga Formation Aquifer
San Antonio Basin GSA
2021 Annual Groundwater
Level Monitoring Report

- Access to the Stephen's well was re-negotiated. Depth to water was measured using an airline and an air compressor.
- The transducer communication cable for well 16C2 was repaired by the vendor and re-installed on September 15th.
- Well 2N1 was not monitored because the access port could not be opened.
- The depth to water measurement for well 2R1 was flagged because it is believed to have been influenced by nearby pumping.
- A depth to water measurement was not collected from well 13C1, northeast of Los Alamos, because the well was undergoing repair.
- A depth to water measurement was not collected from well 17Q1, on the south side of Barka Slough, because of overgrown vegetation.
- A depth to water measurement was not collected from well 17K2, on the south side of Barka Slough, because of overgrown vegetation.

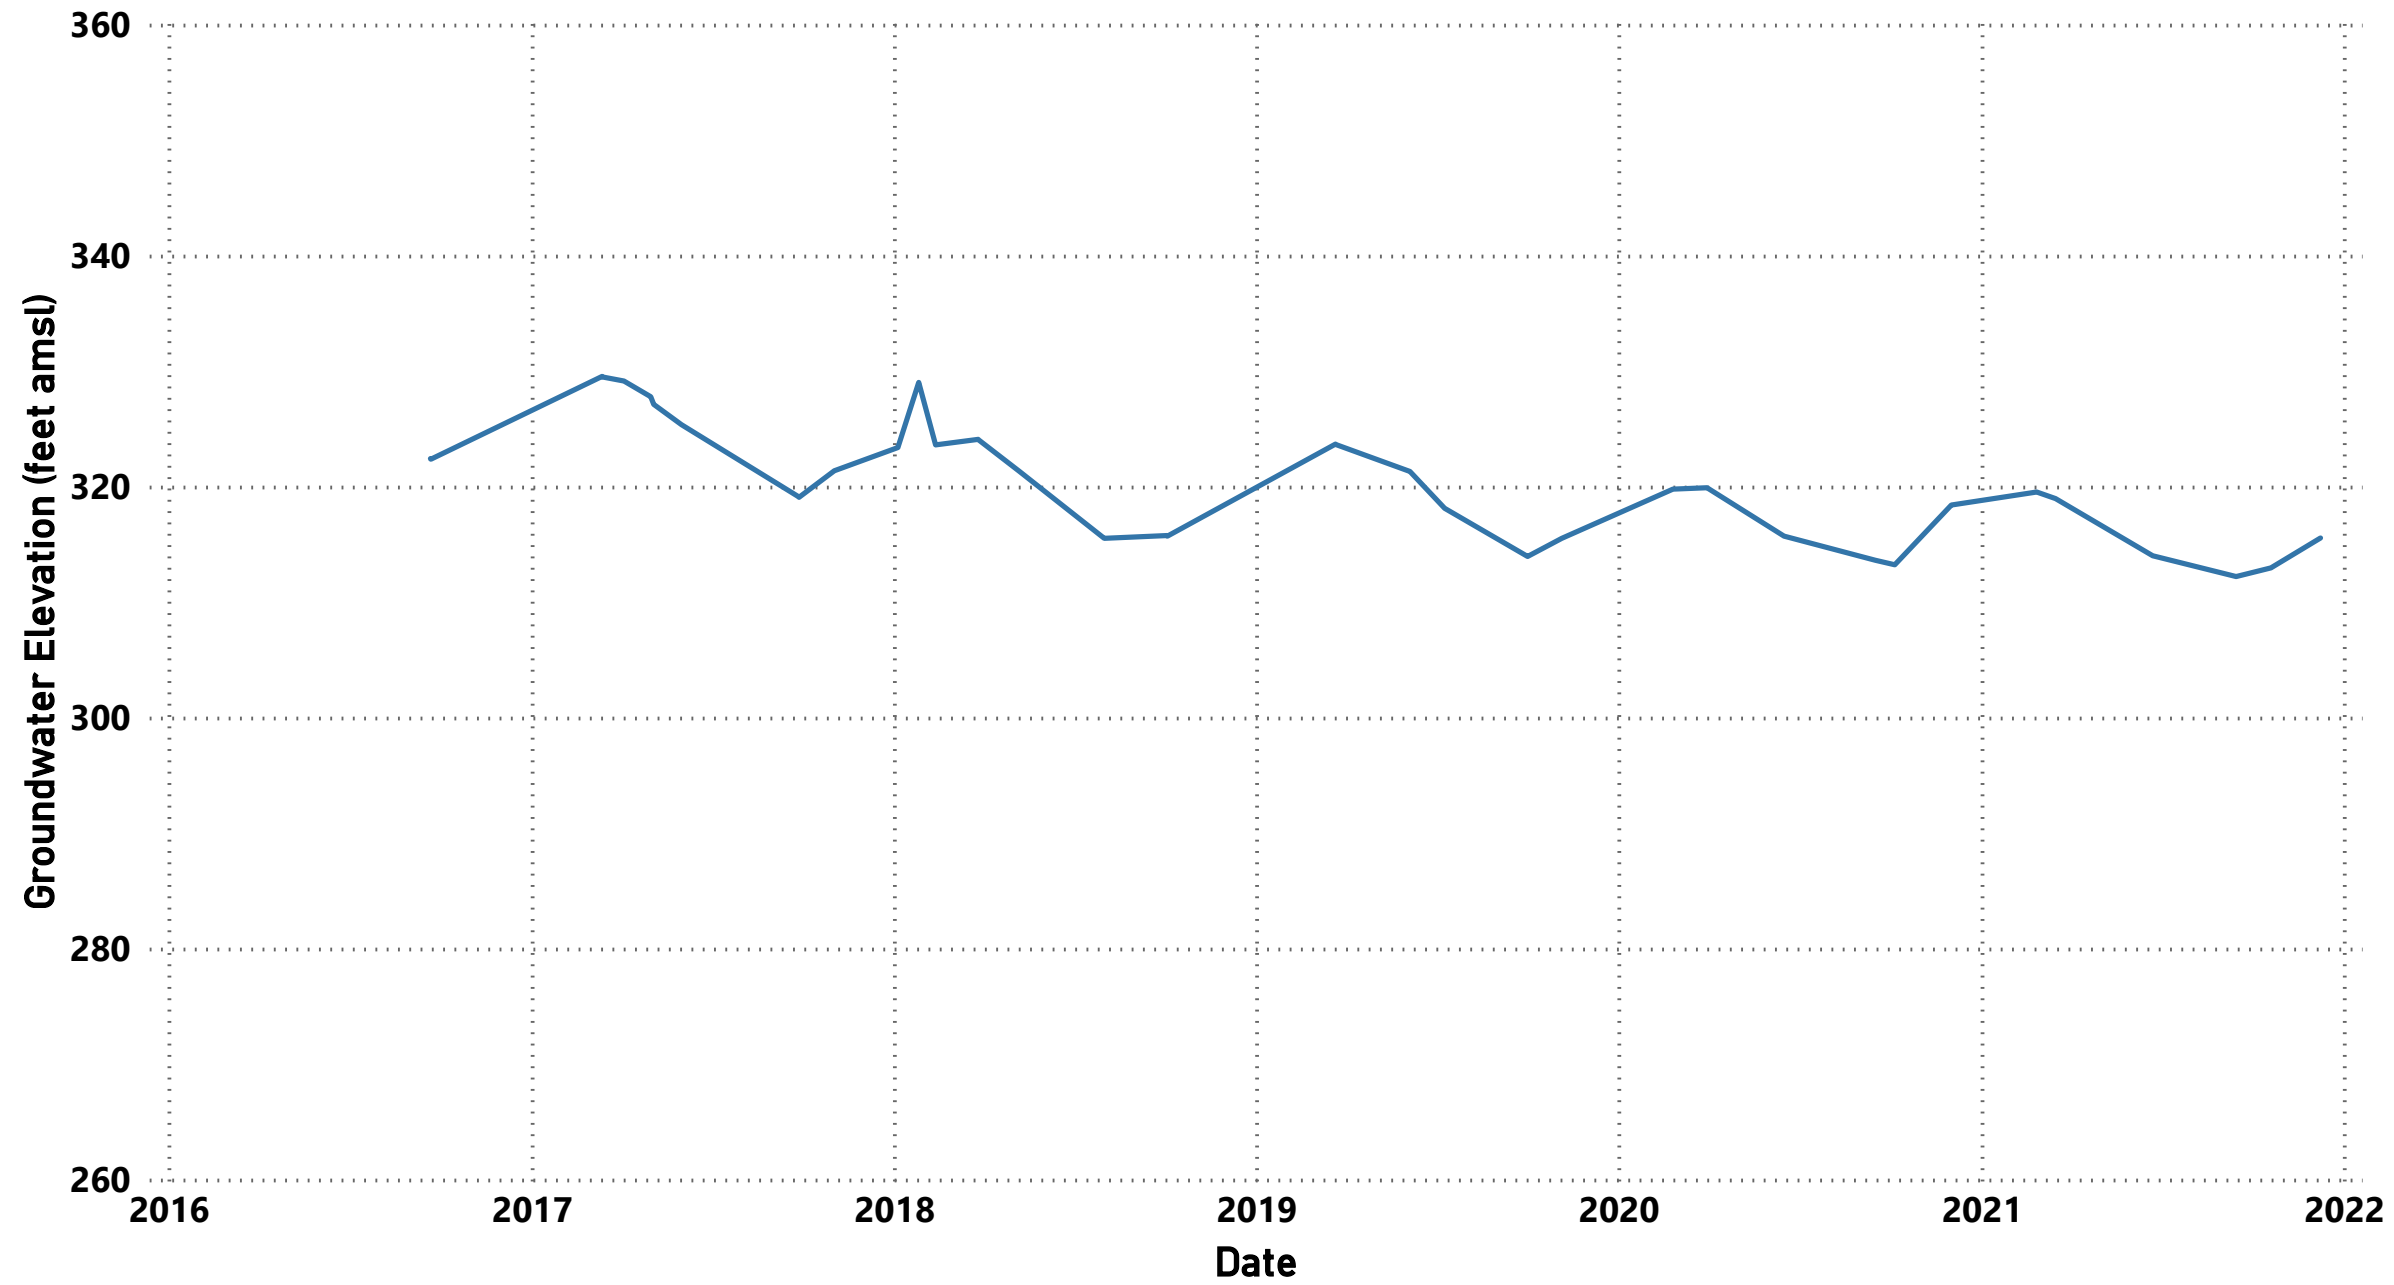
FIGURE 23
Hydrograph for Well SACR1
Careaga Formation Aquifer
San Antonio Basin GSA
2021 Annual Groundwater
Level Monitoring Report

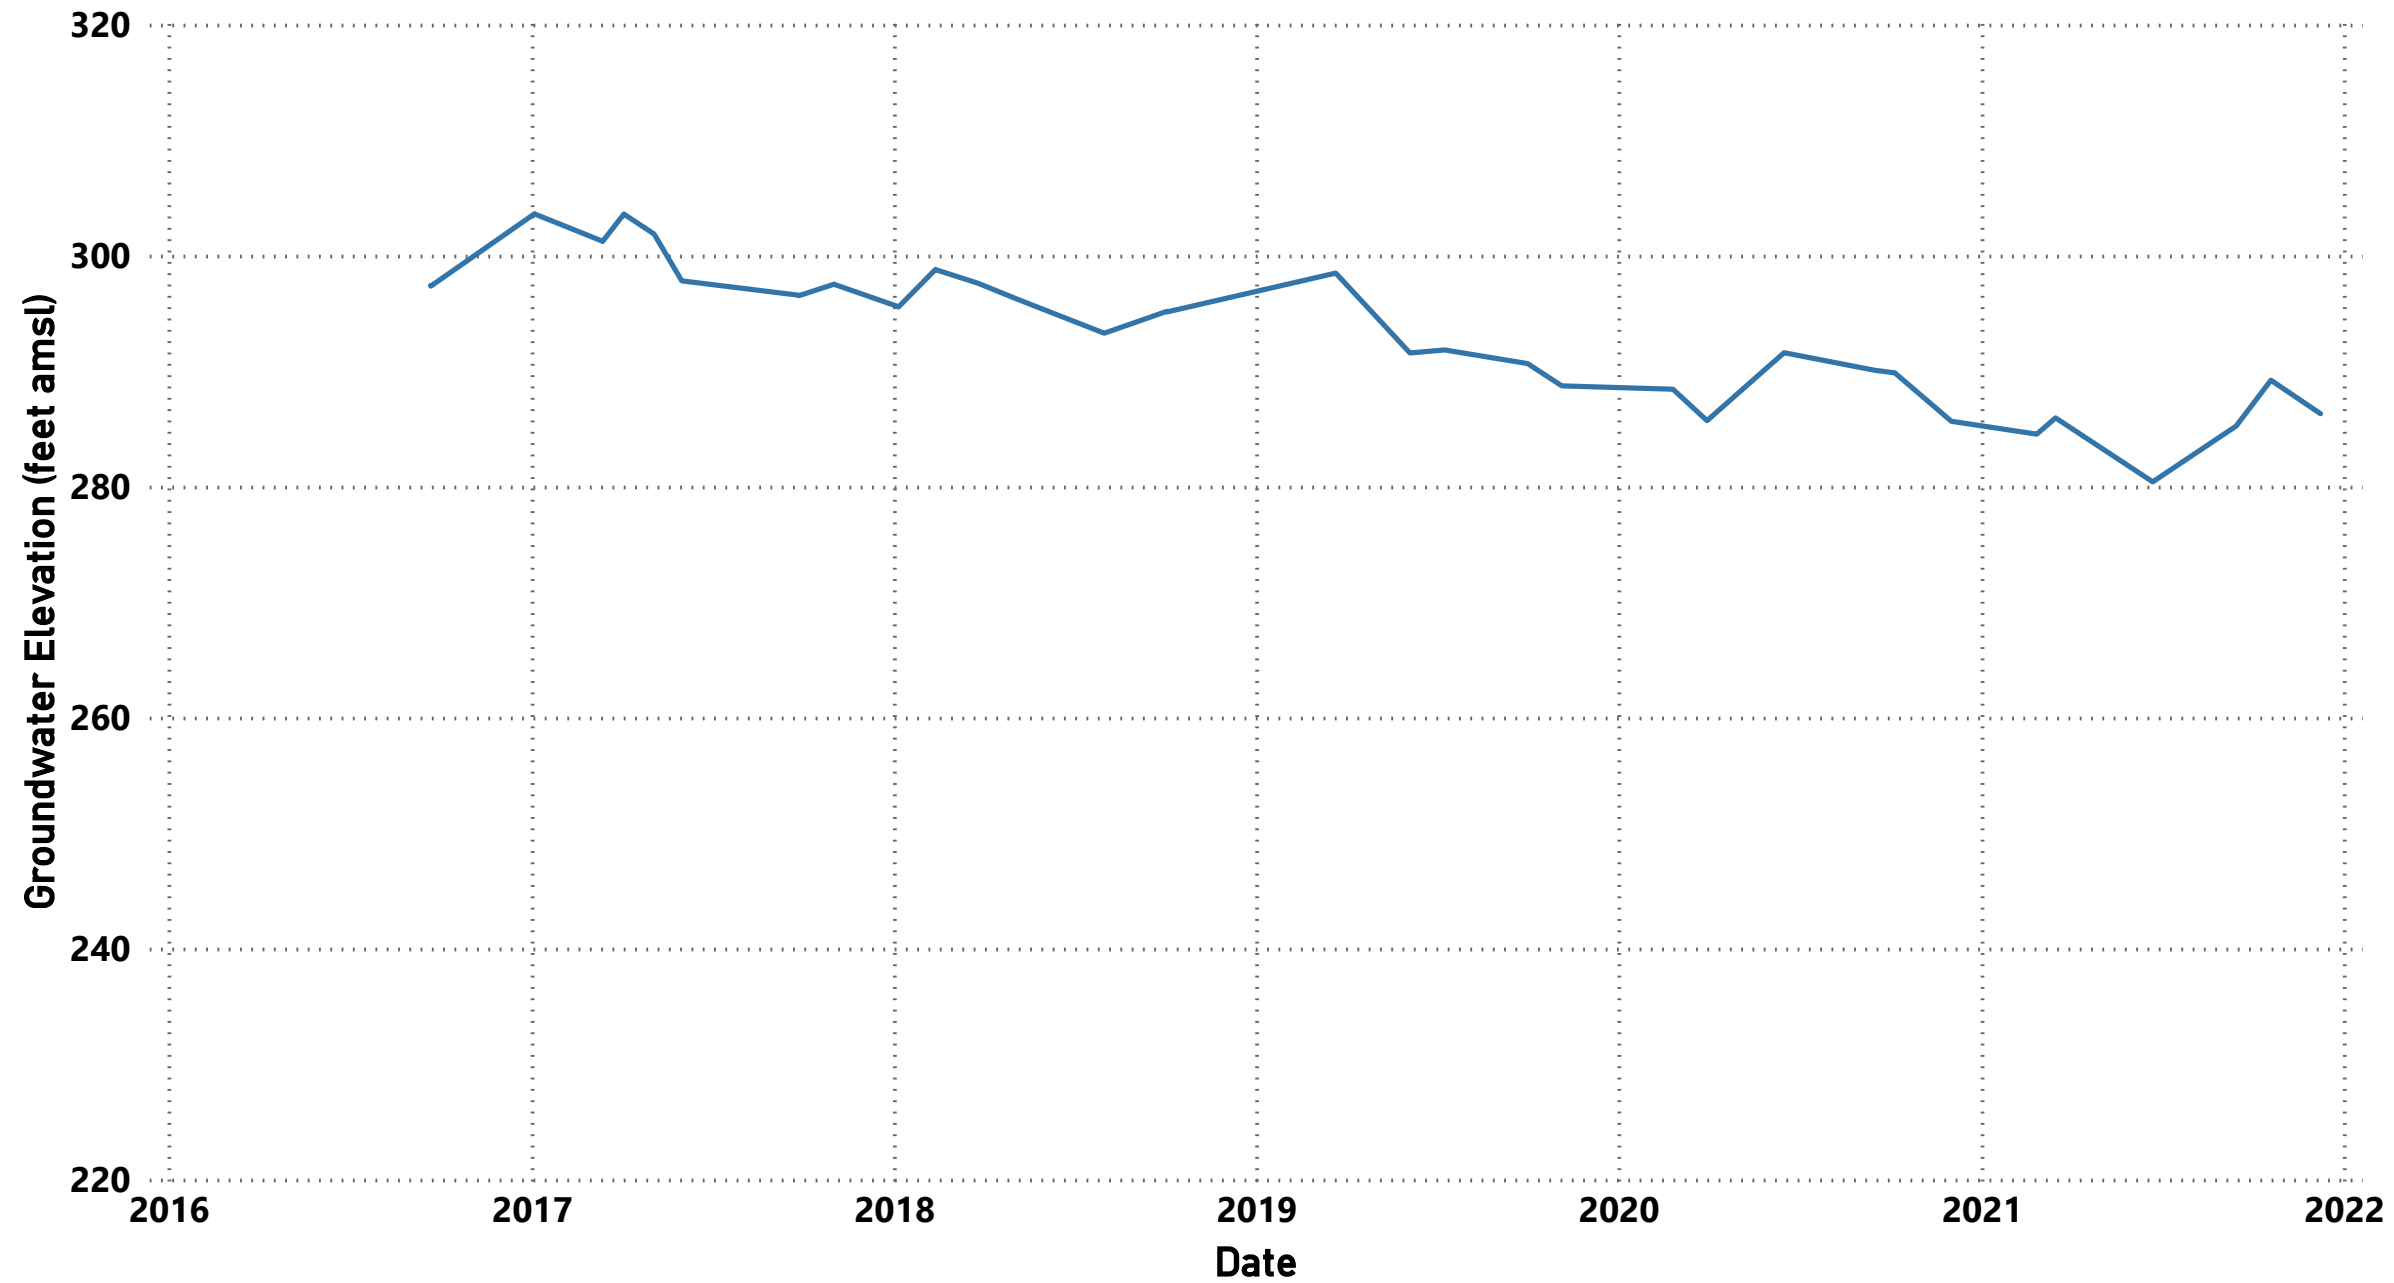
FIGURE 24
Hydrograph for Well SACR2
Paso Robles Formation Aquifer
San Antonio Basin GSA
2021 Annual Groundwater
Level Monitoring Report
