San Antonio Basin Groundwater Sustainability Agency

2021 Annual Groundwater Level Monitoring Report

January 28, 2022

GSI Water Solutions, Inc.

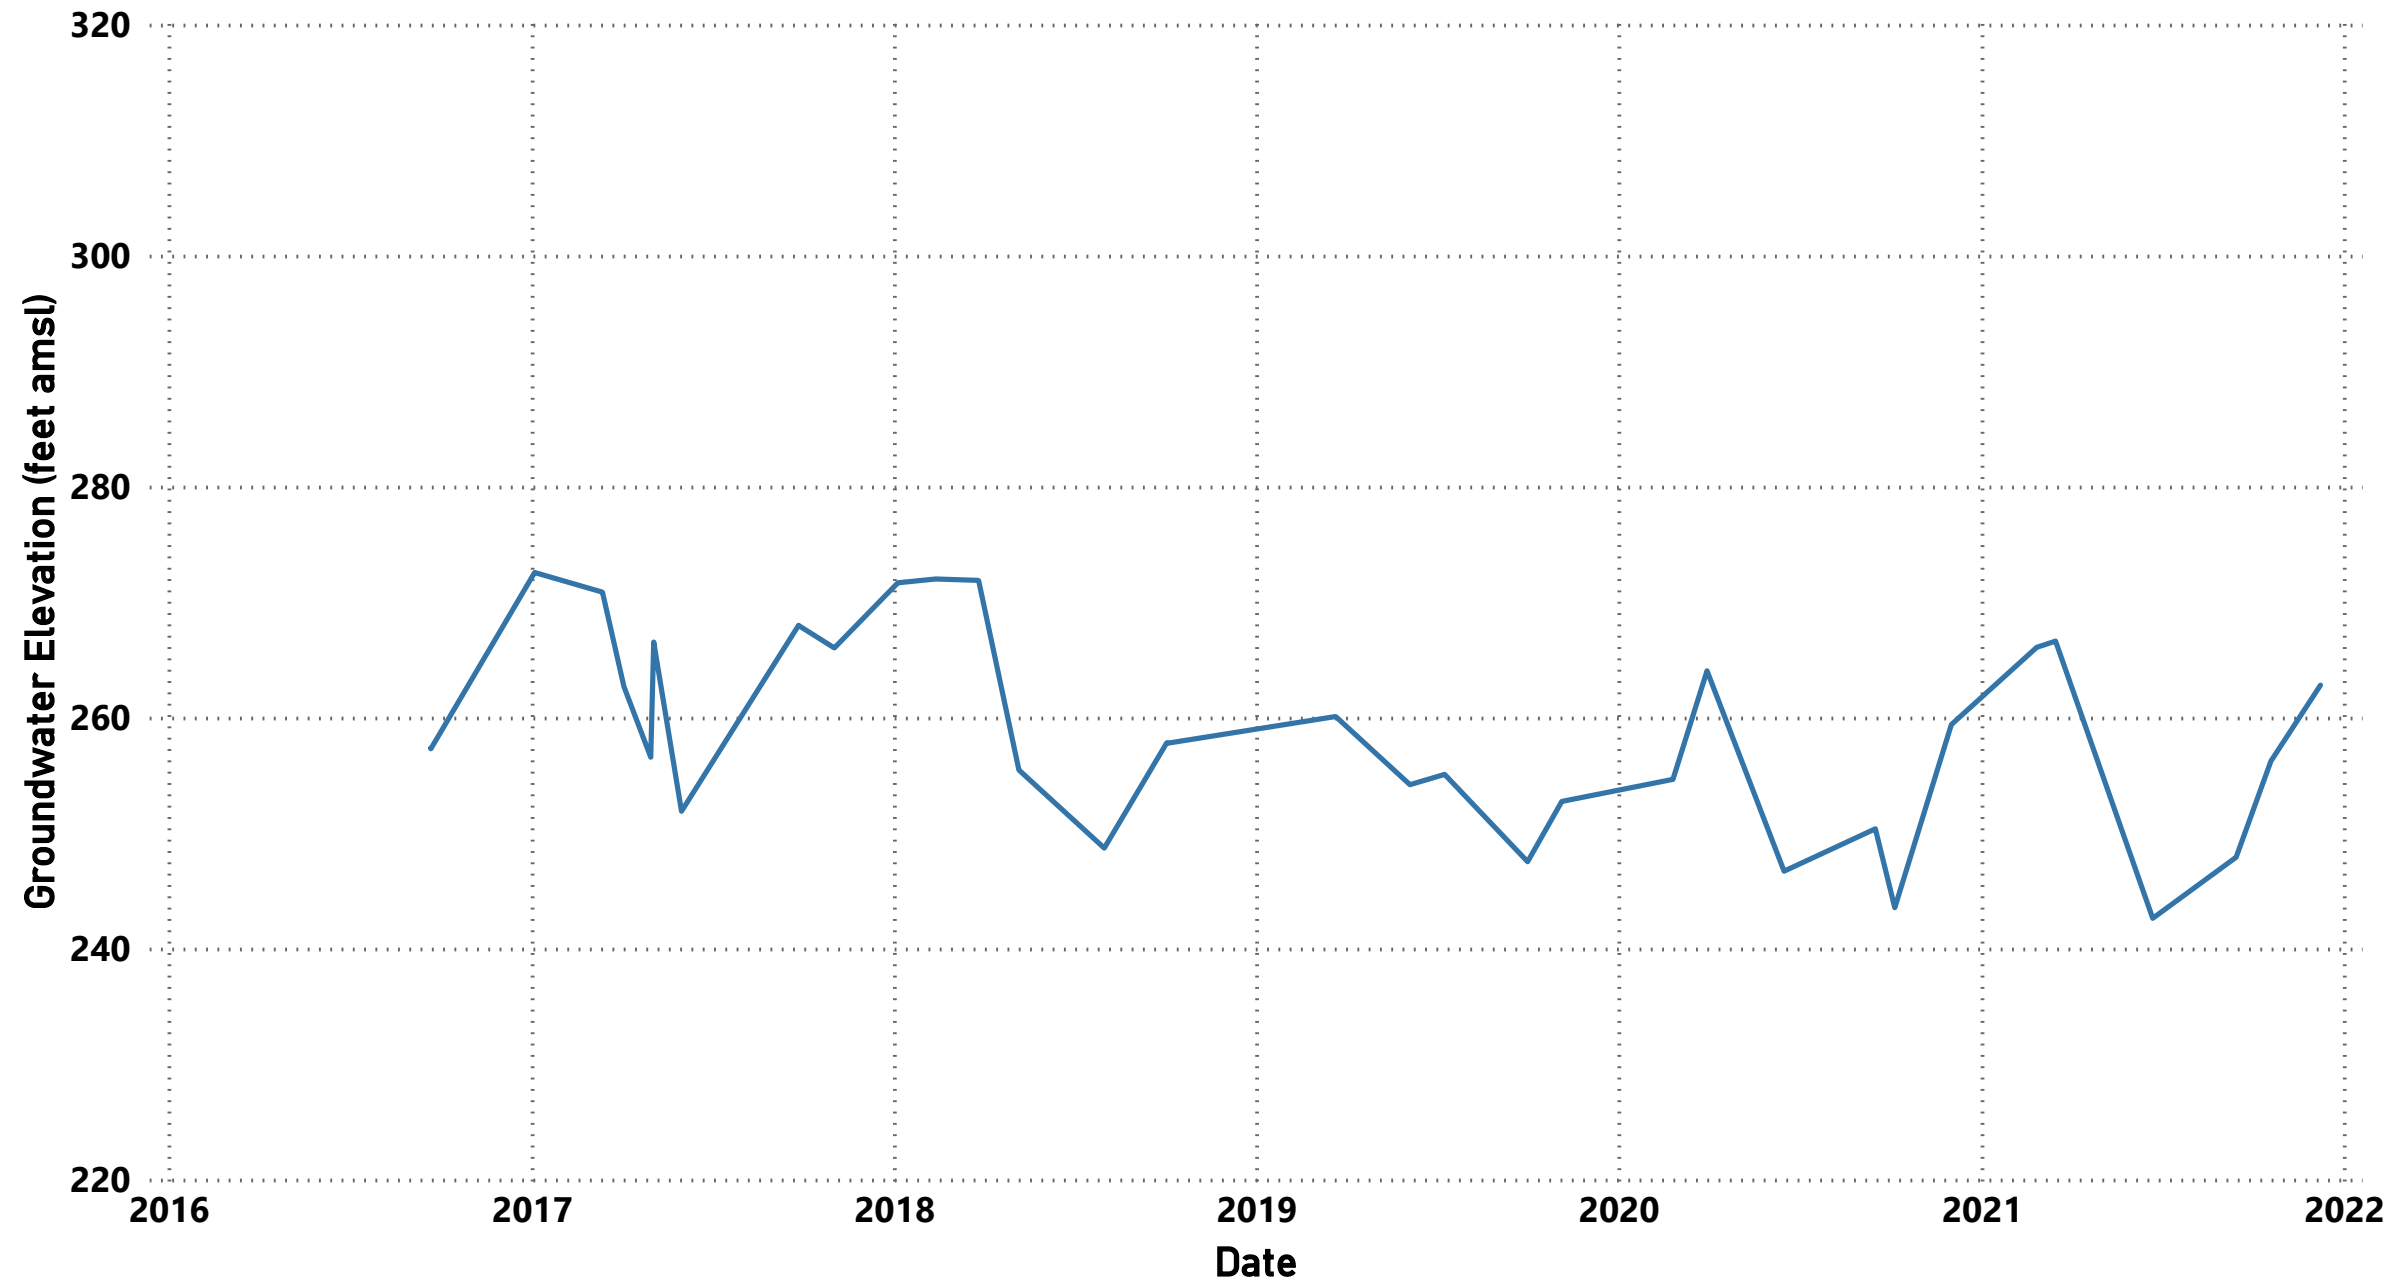
FIGURE 25
Hydrograph for Well SACR3
Paso Robles Formation Aquifer
 San Antonio Basin GSA
 2021 Annual Groundwater
 Level Monitoring Report

Following each quarterly monitoring event, groundwater level data are provided to the SABGSA in an email monitoring report. Groundwater level measurements are housed within the SABGSA Data Management System and available upon request. Groundwater level trends observed since November 5, 2019, are consistent with historical trends; exhibiting a general decrease of groundwater elevations across the Basin. Water level measurements are presented in Table 1. Hydrographs from the wells in the monitoring network are included as Figures 6 through 43. The following noteworthy trends are observed in the hydrographs:

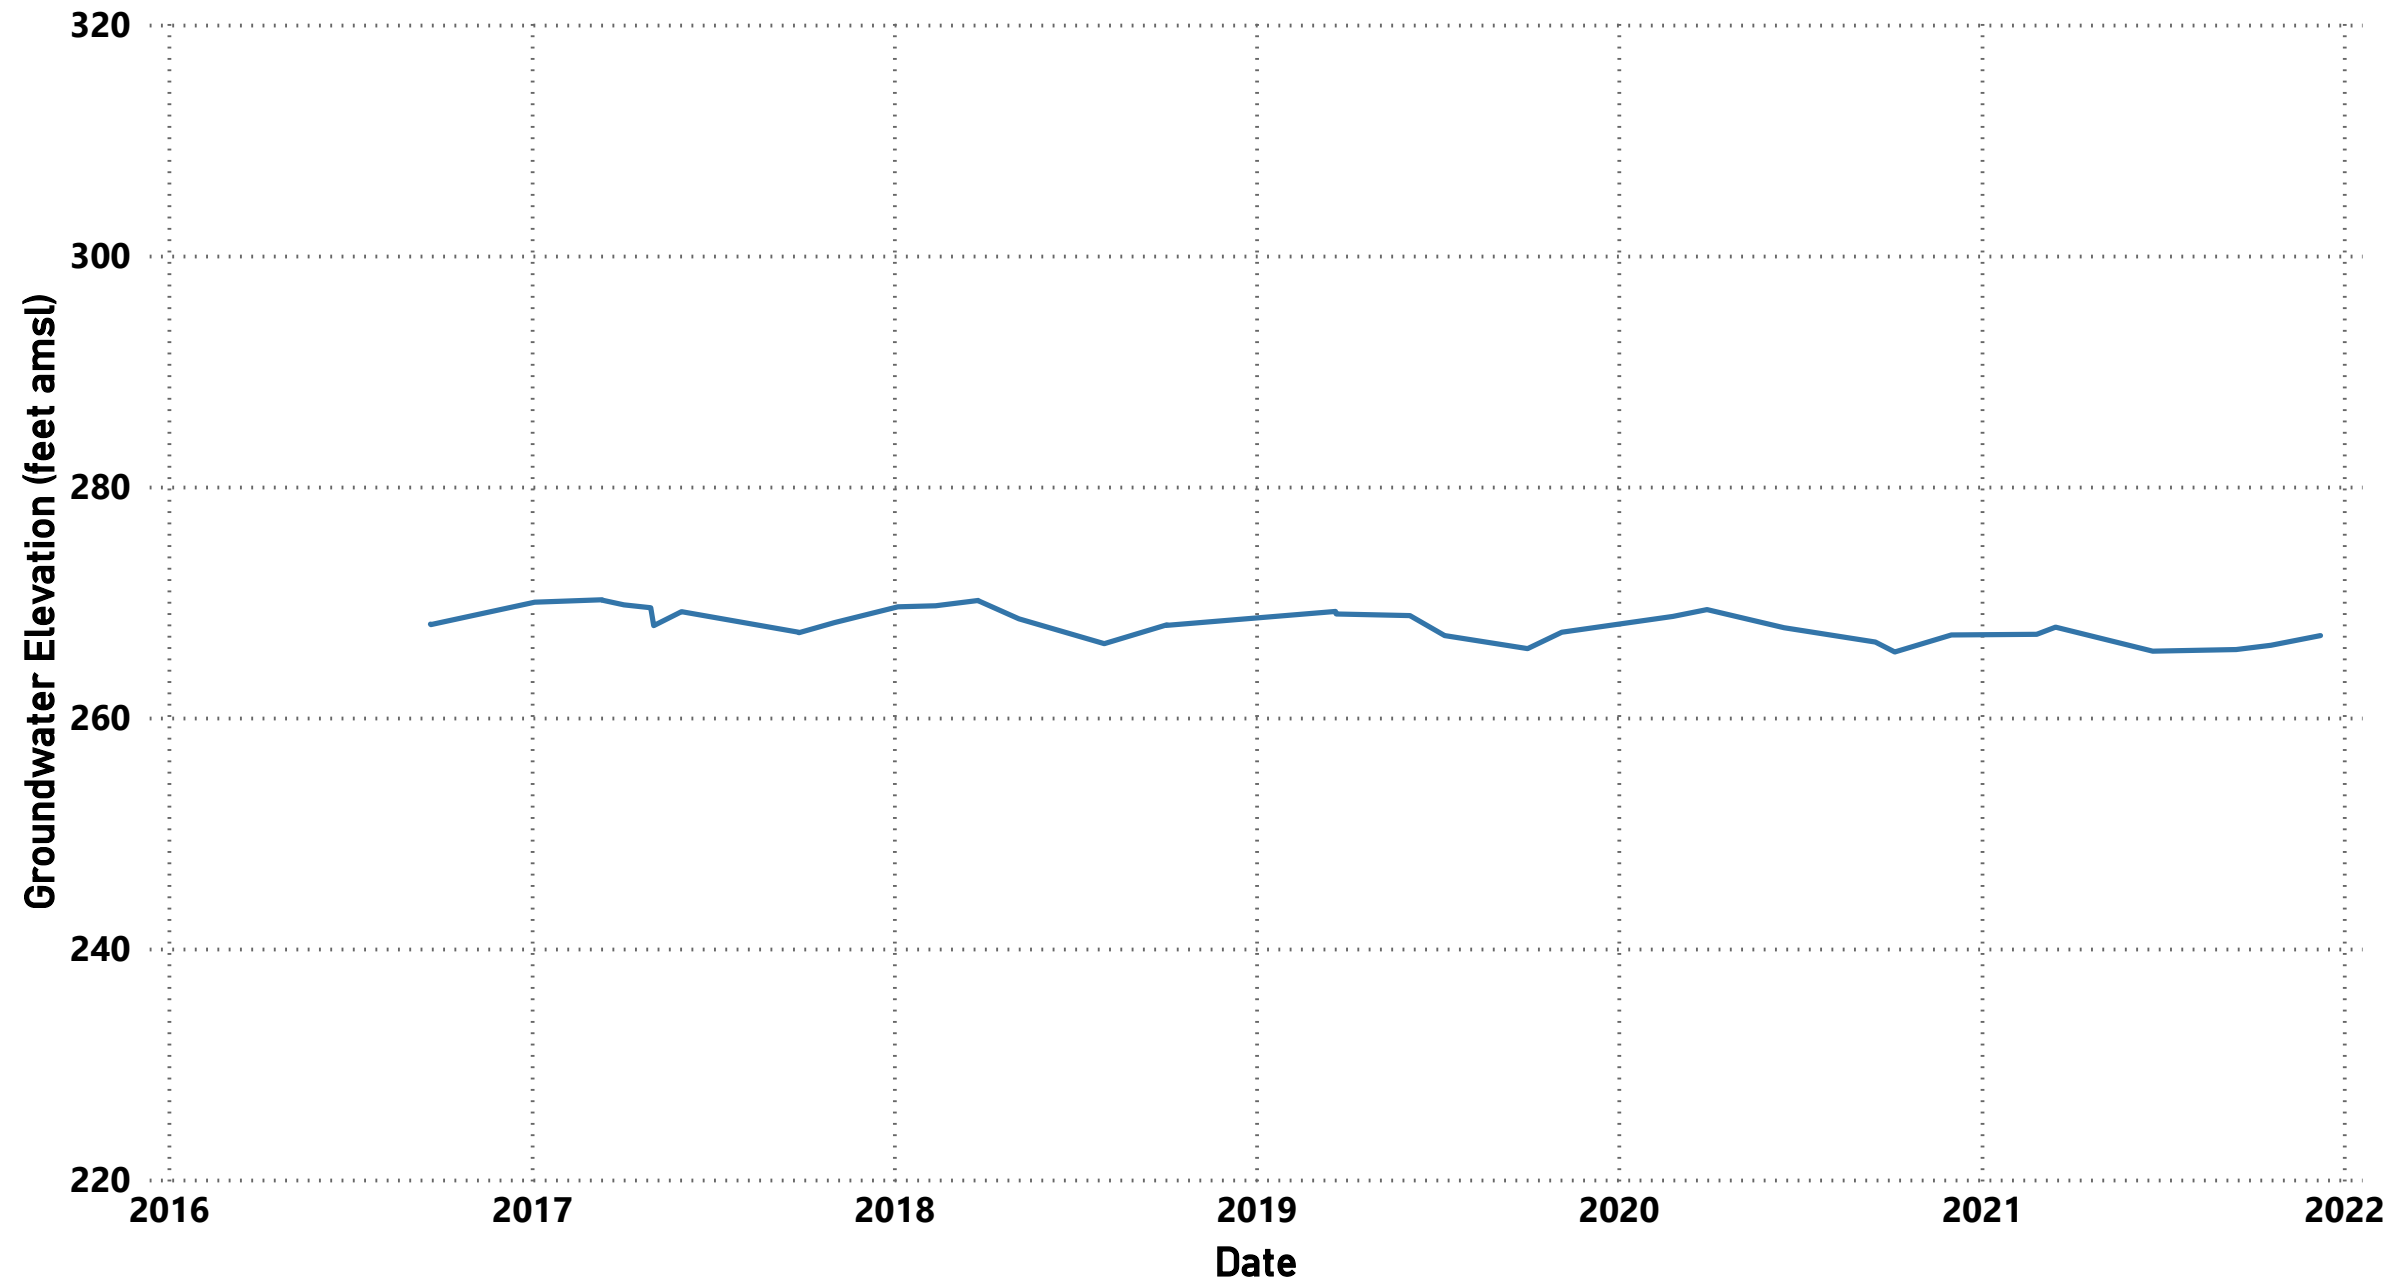
FIGURE 26
Hydrograph for Well SACR4
Paso Robles Formation Aquifer
San Antonio Basin GSA
2021 Annual Groundwater
Level Monitoring Report

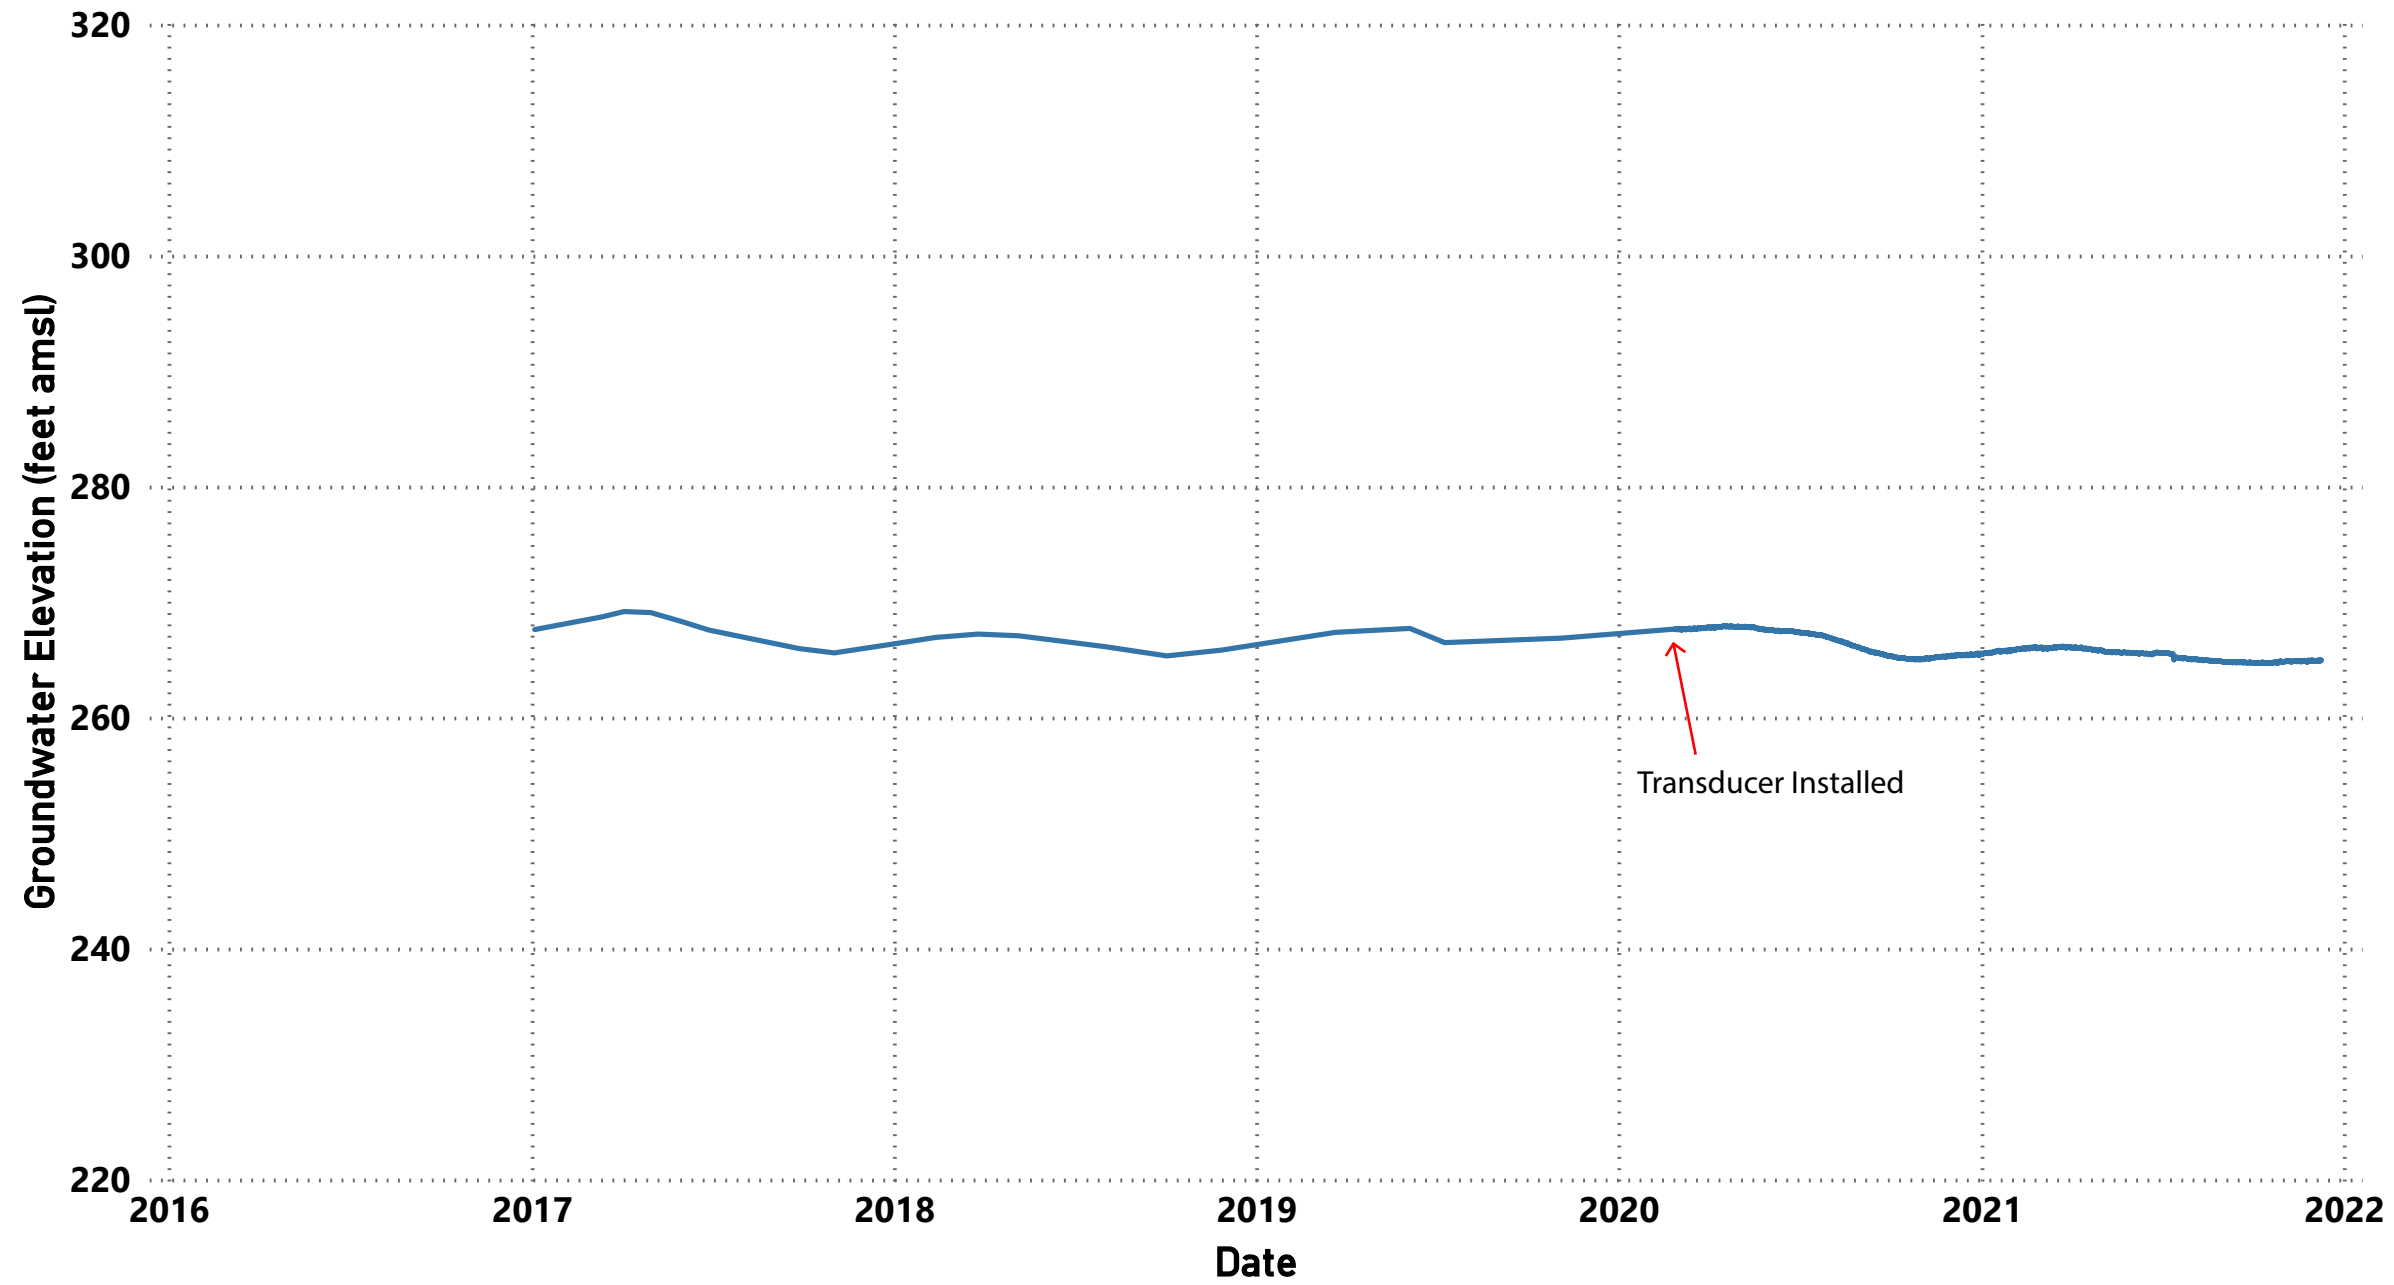
FIGURE 27
Hydrograph for Well SACR5
Paso Robles Formation Aquifer
San Antonio Basin GSA
2021 Annual Groundwater
Level Monitoring Report

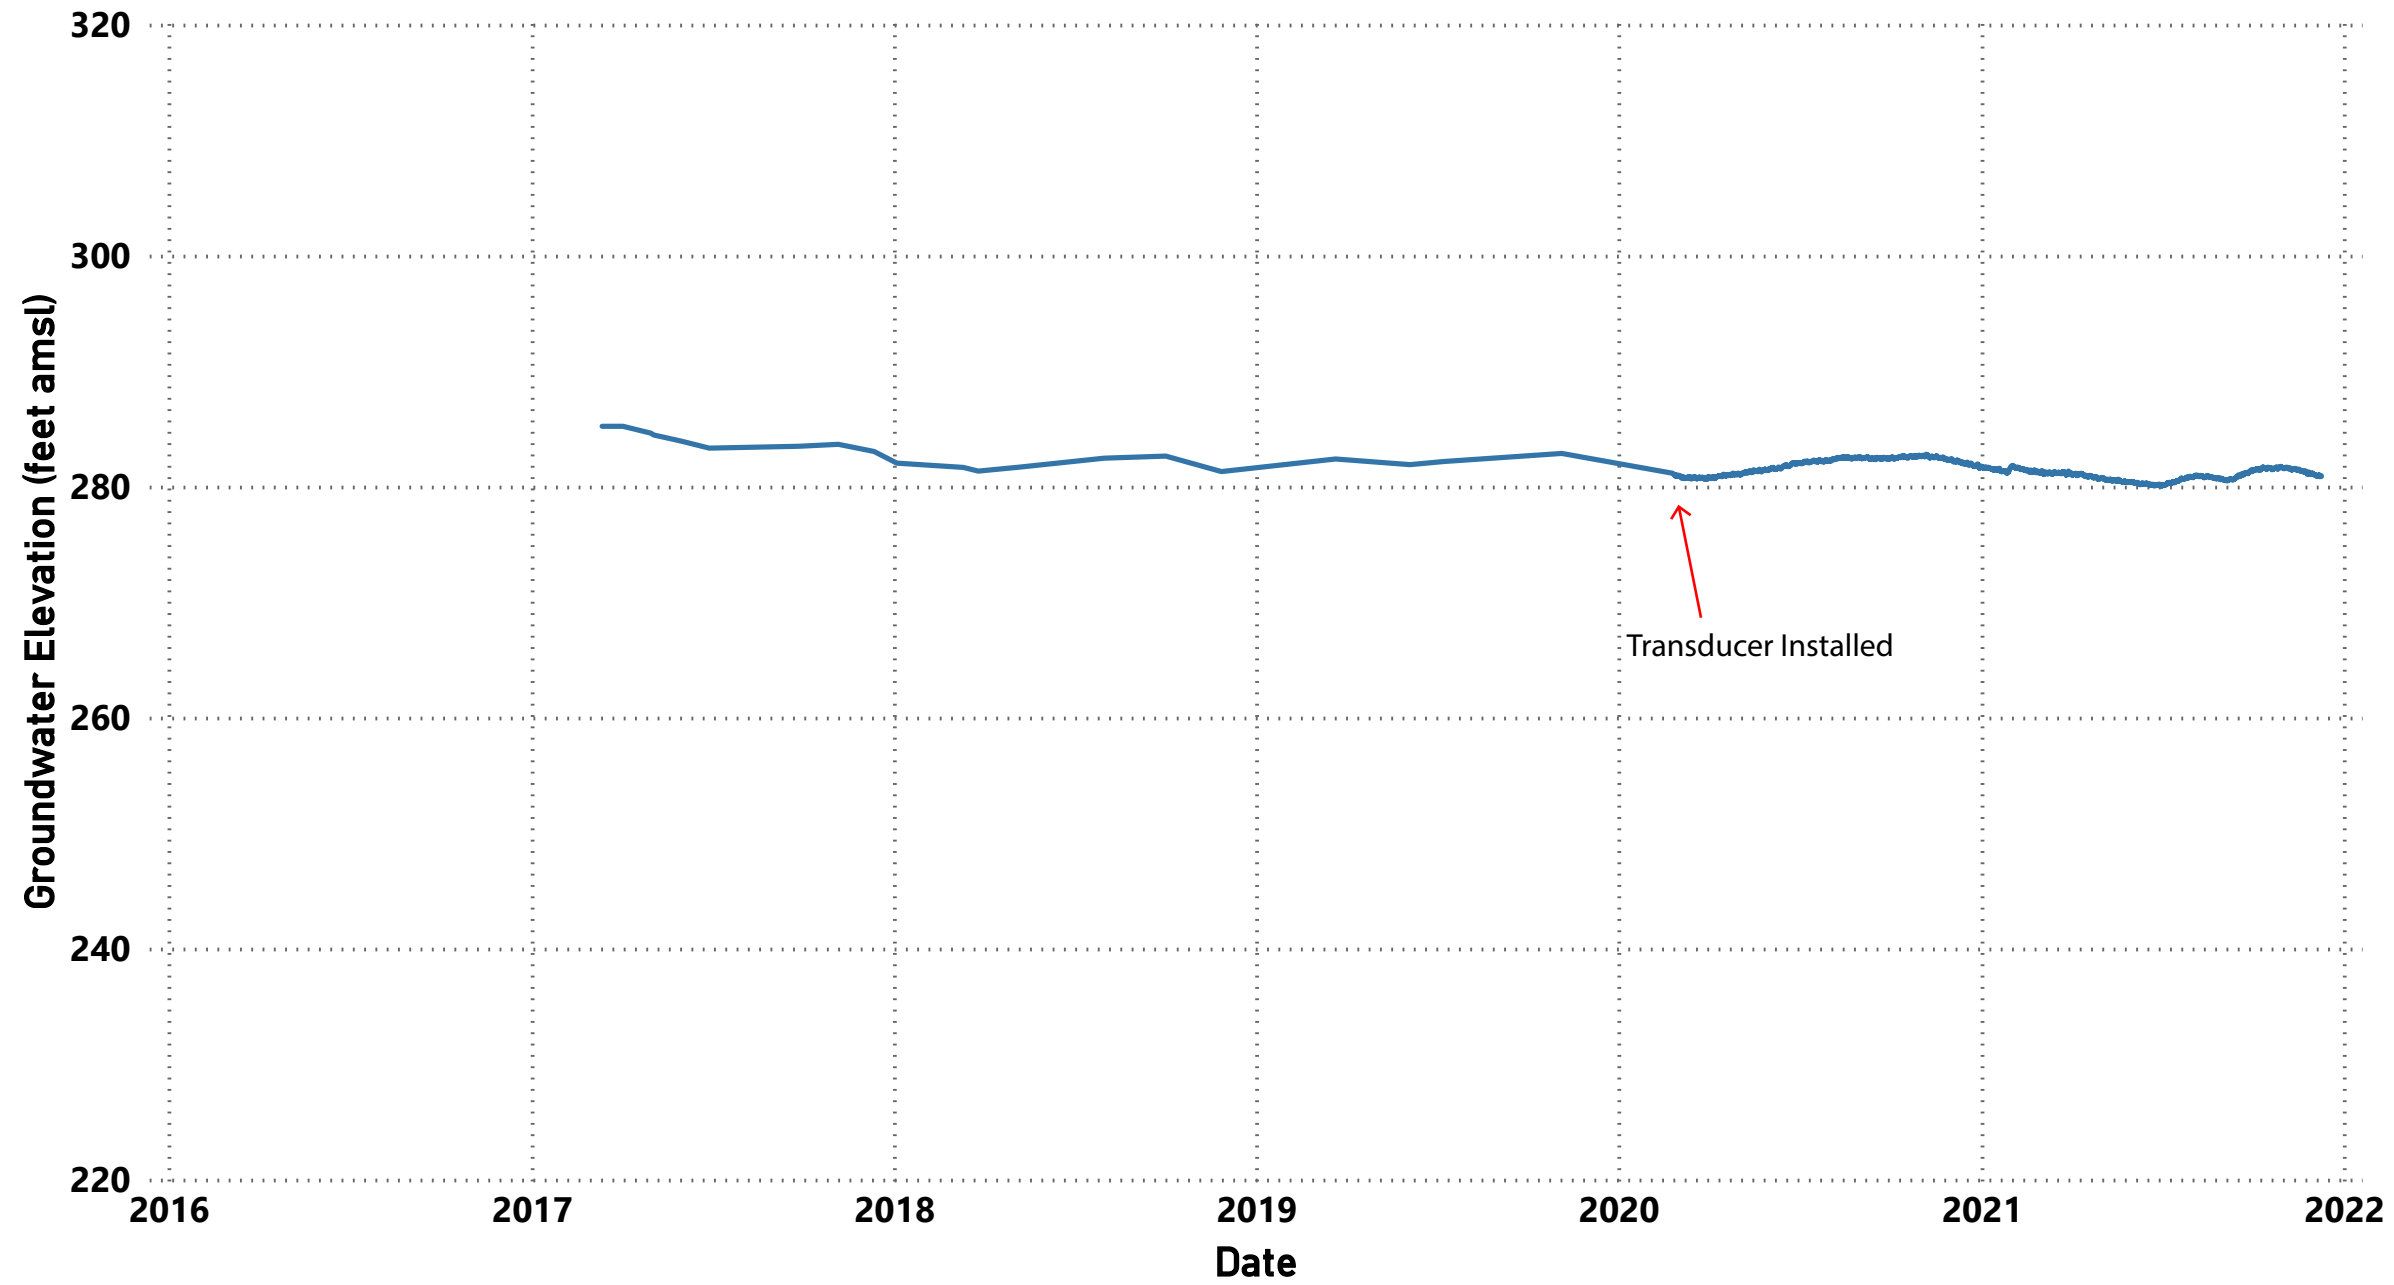
FIGURE 28
Hydrograph for Well SAHG
Paso Robles Formation Aquifer
 San Antonio Basin GSA
 2021 Annual Groundwater
 Level Monitoring Report

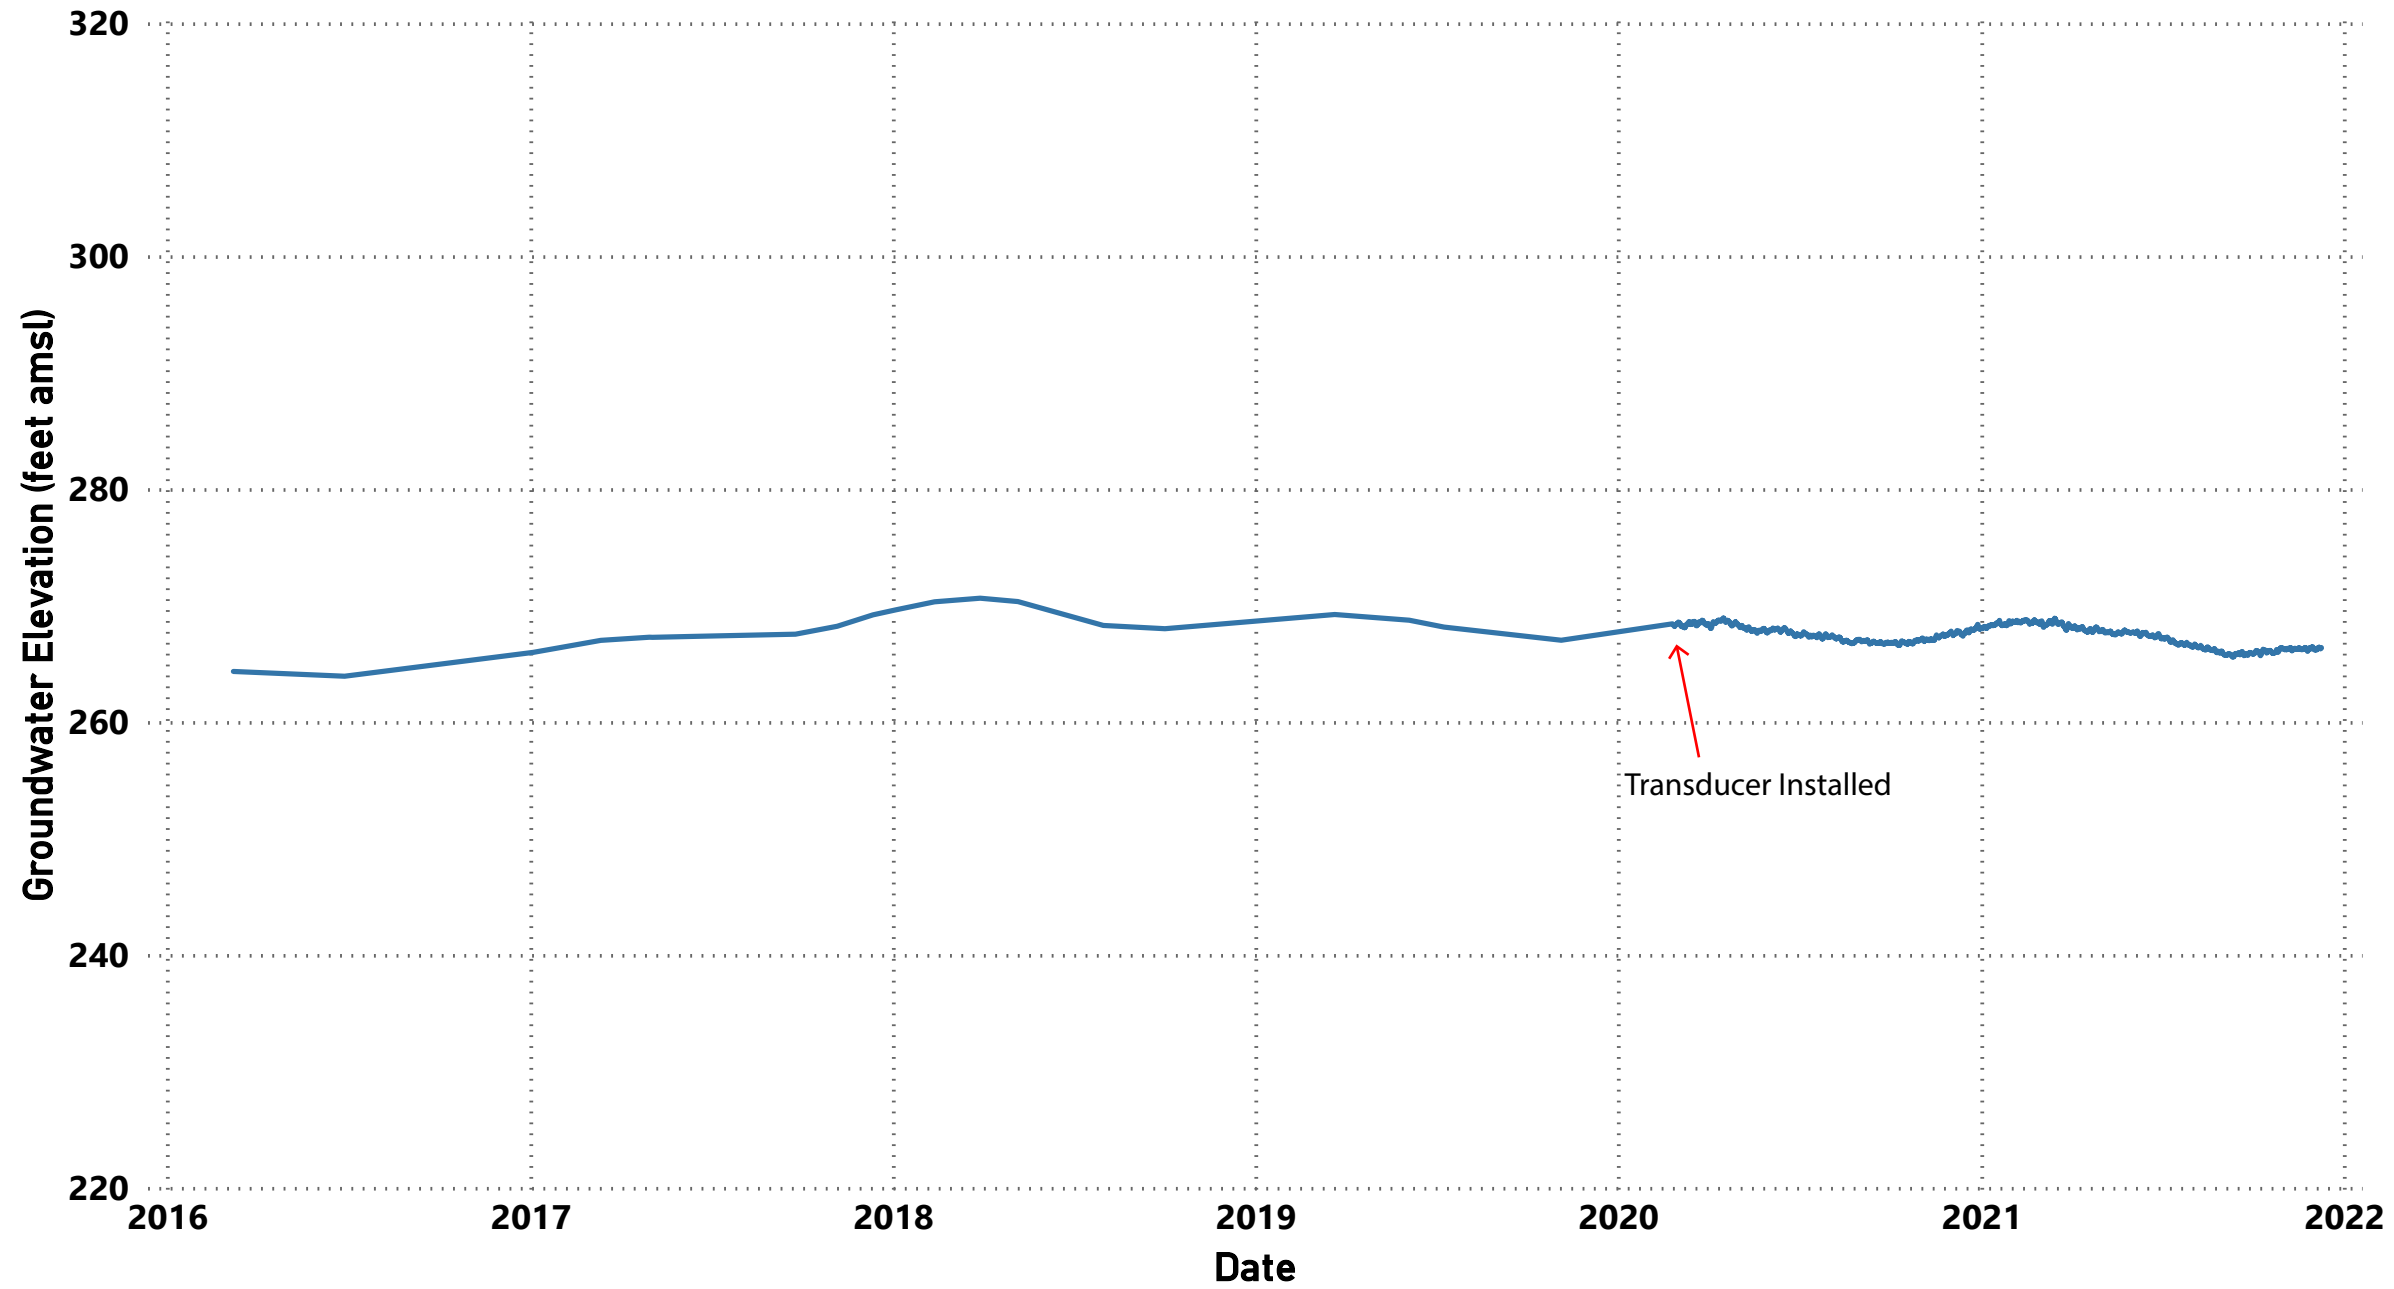
FIGURE 29
Hydrograph for Well SAGR
Paso Robles Formation Aquifer
San Antonio Basin GSA
2021 Annual Groundwater
Level Monitoring Report

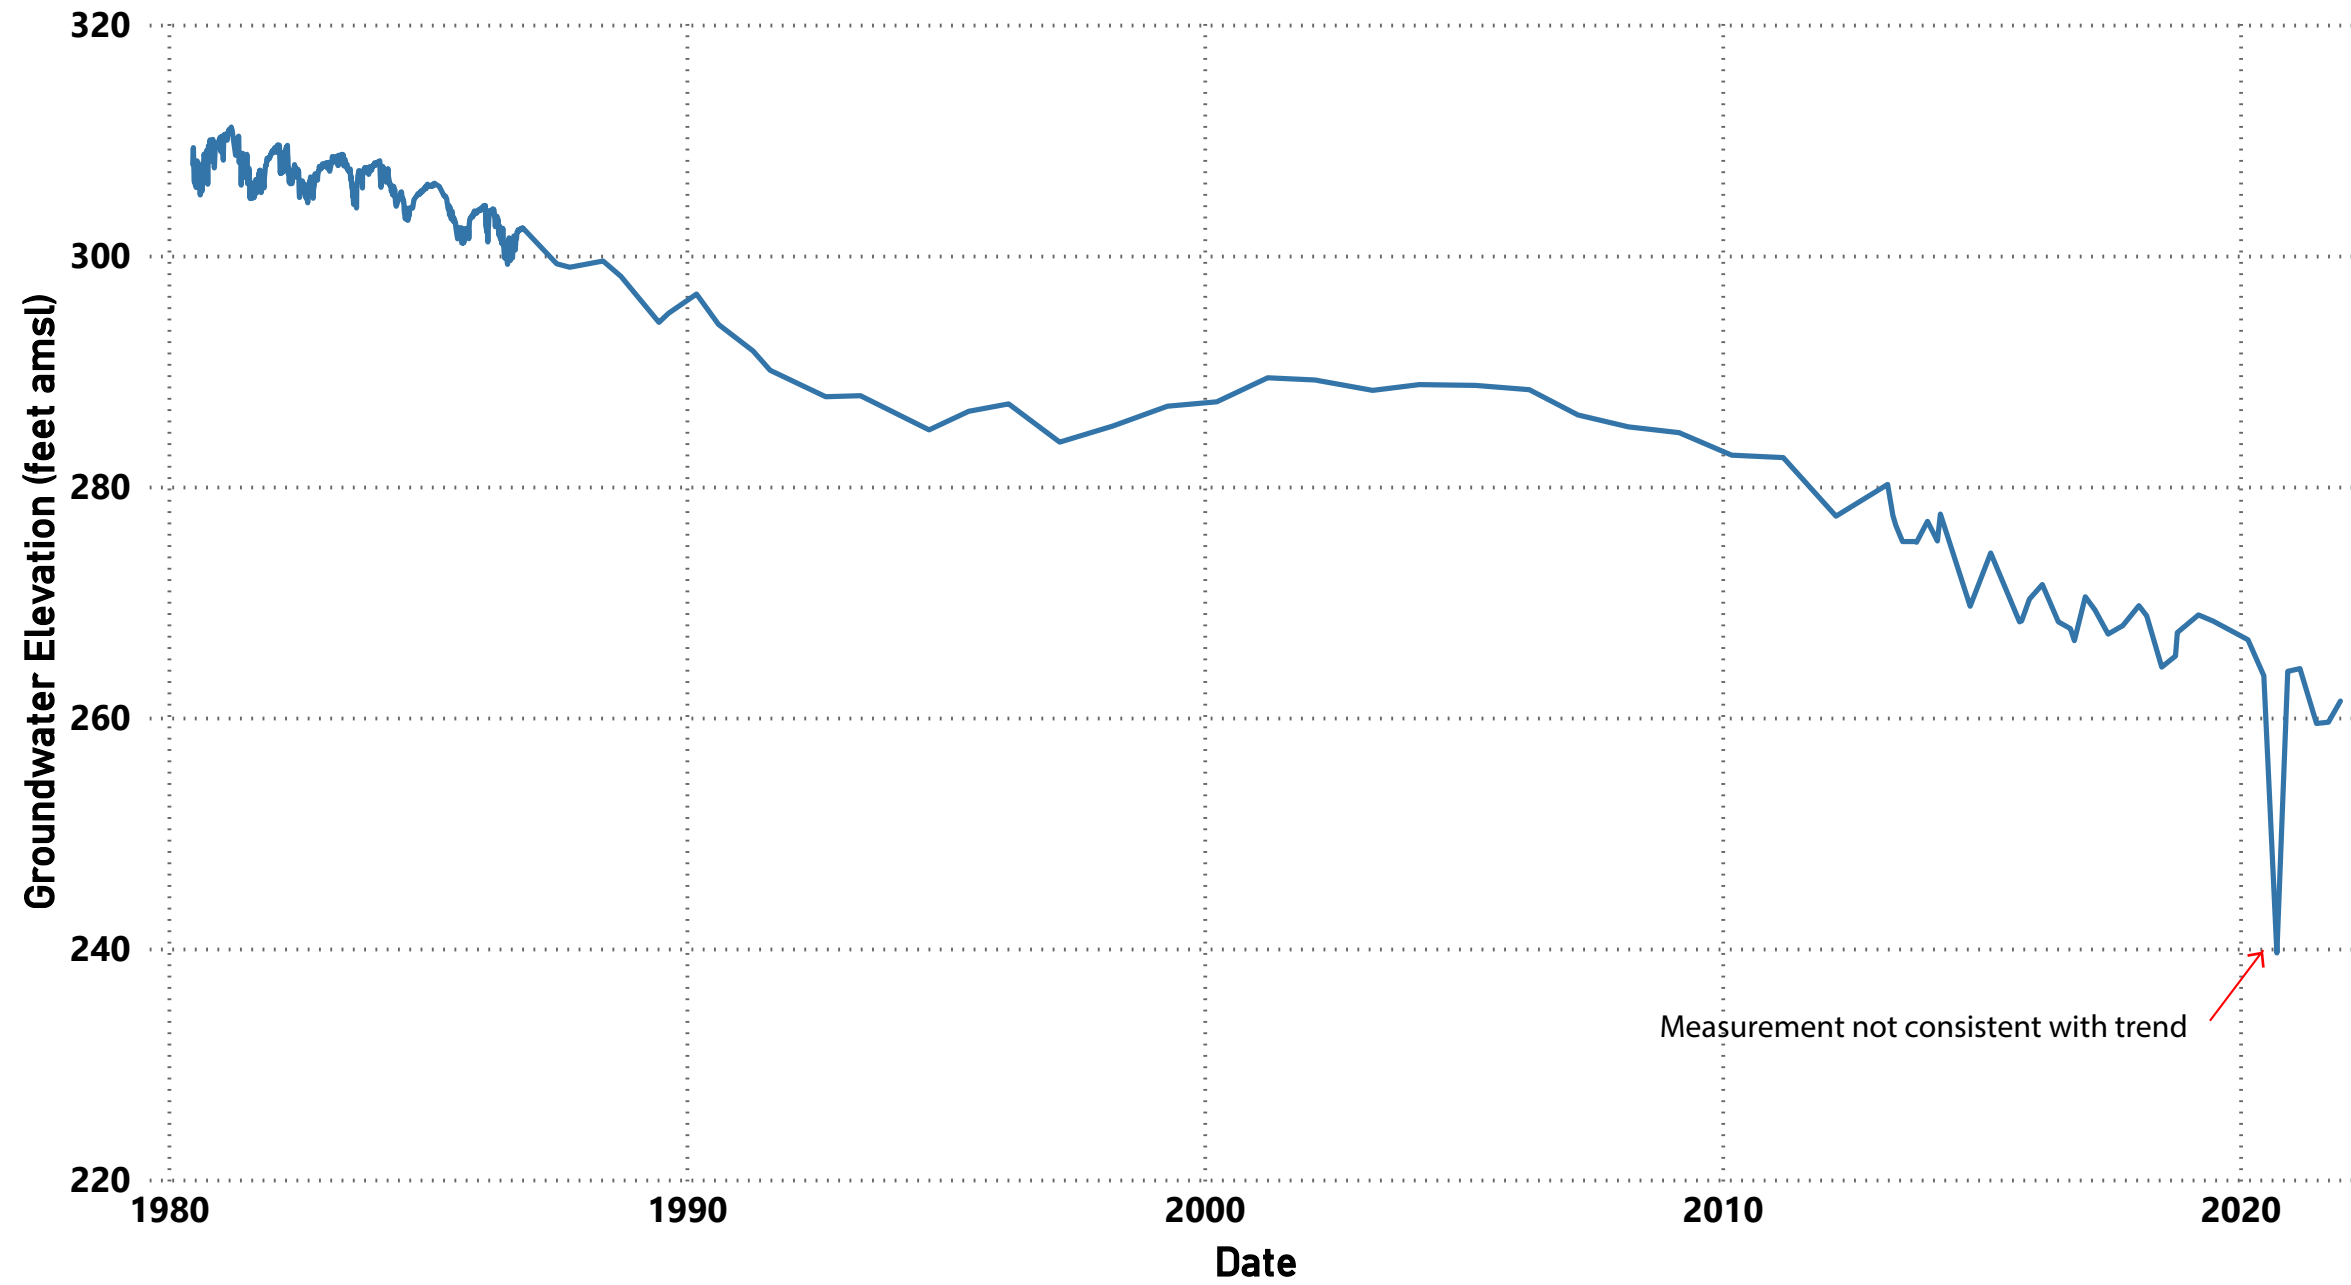
FIGURE 30
Hydrograph for Well 14L1
Careaga Formation Aquifer
San Antonio Basin GSA
2021 Annual Groundwater
Level Monitoring Report

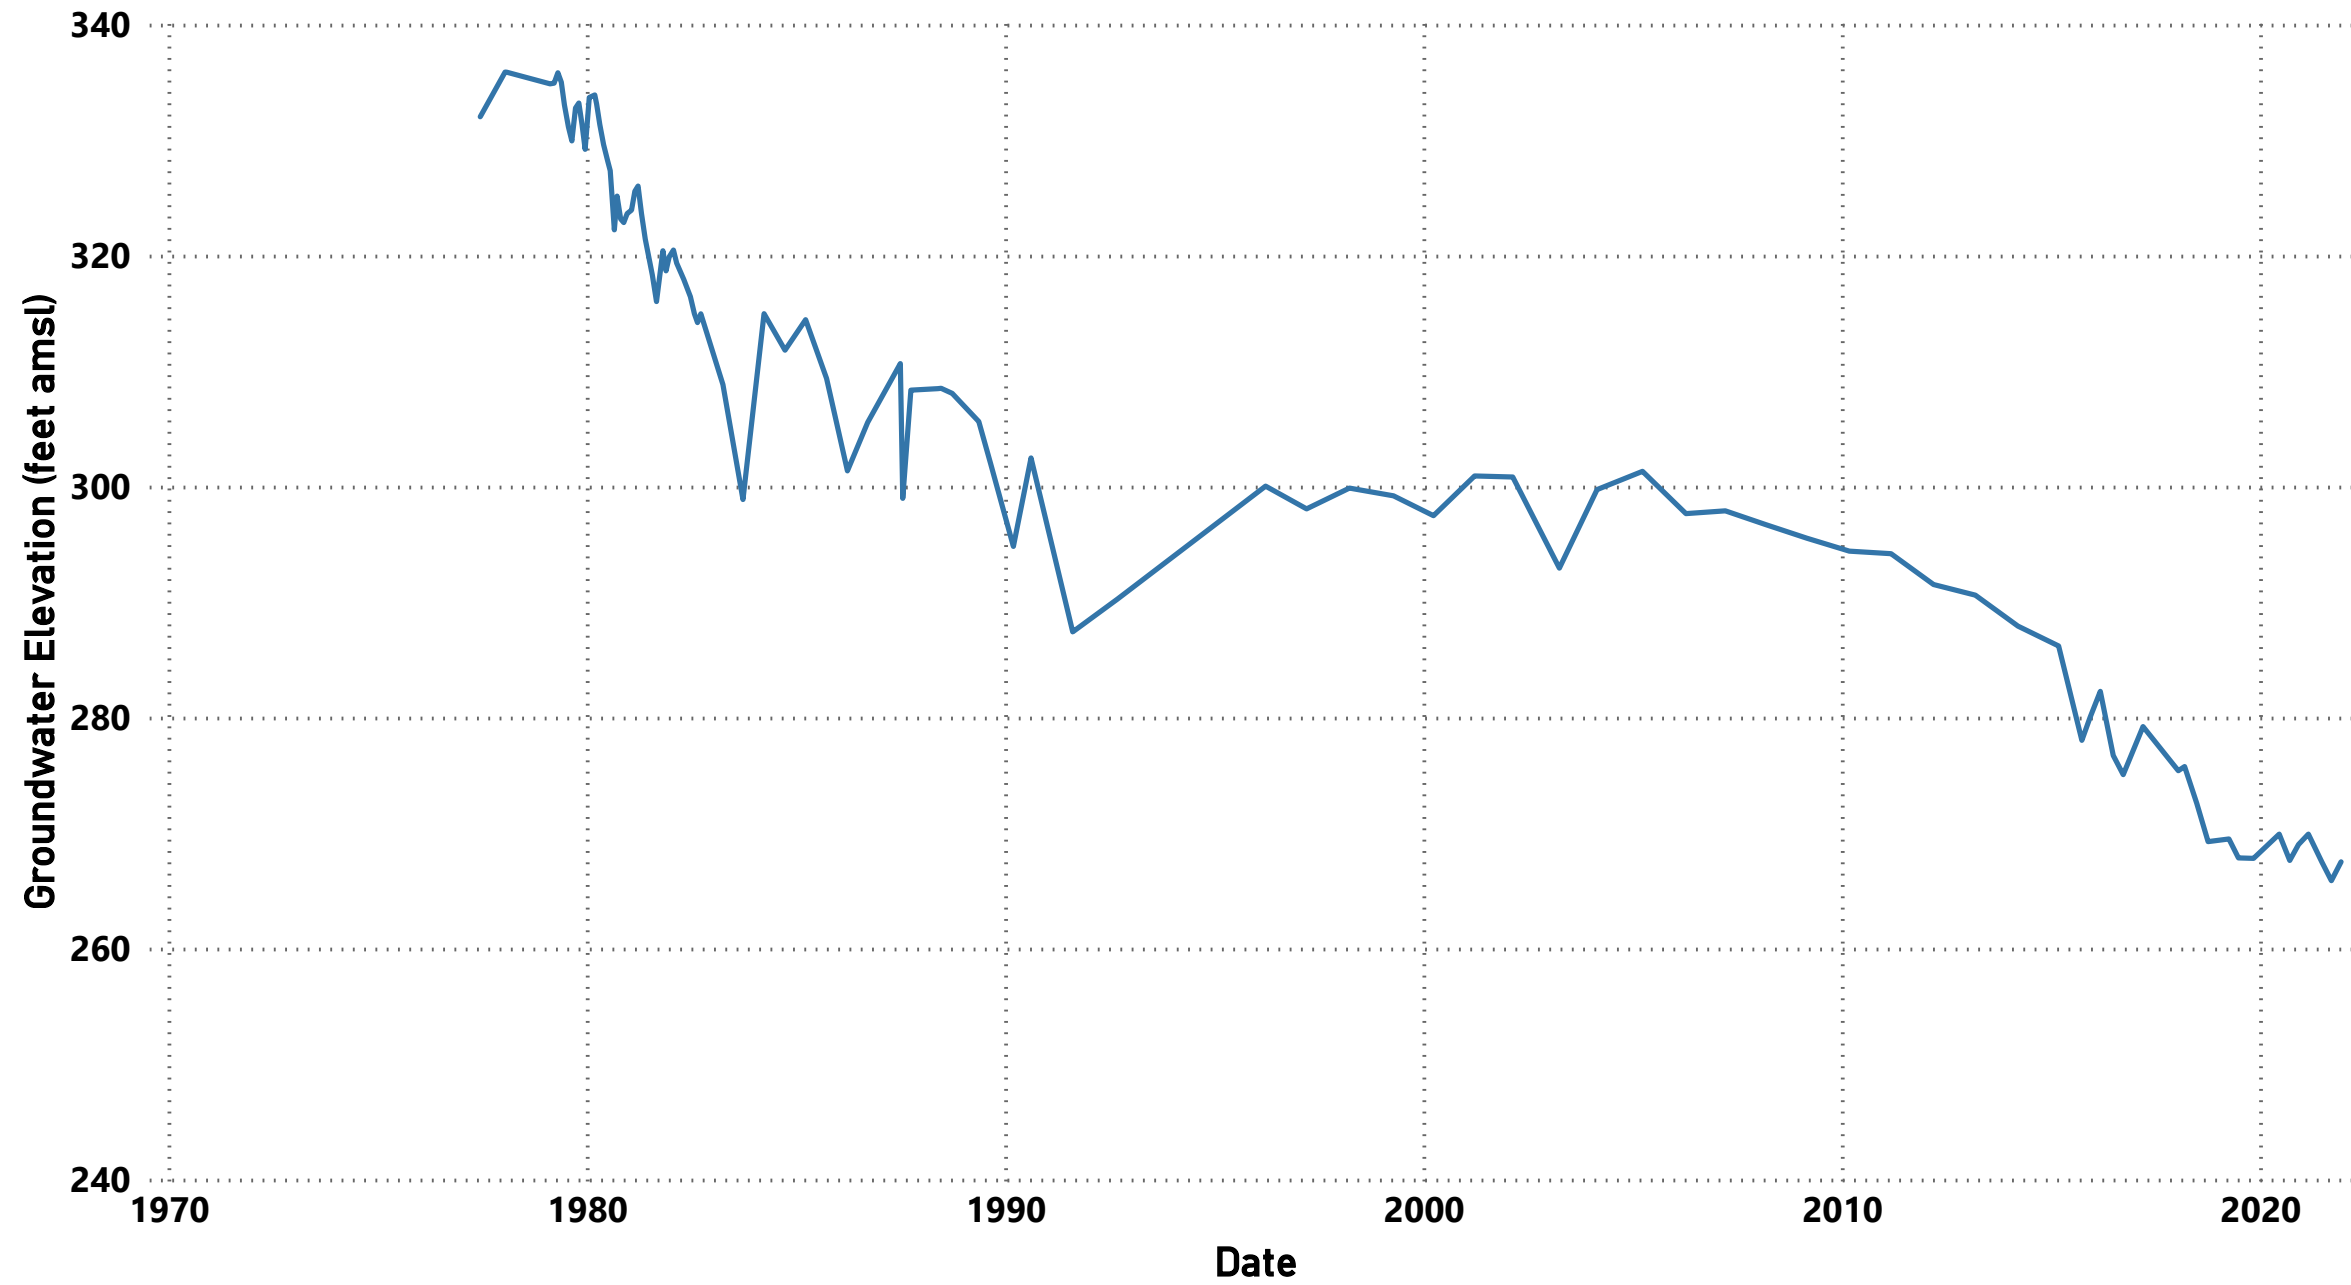
FIGURE 31
Hydrograph for Well 2M1
Paso Robles Formation Aquifer
 San Antonio Basin GSA
 2021 Annual Groundwater
 Level Monitoring Report
