San Antonio Basin Groundwater Sustainability Agency

2021 Annual Groundwater Level Monitoring Report

January 28, 2022

GSI Water Solutions, Inc.

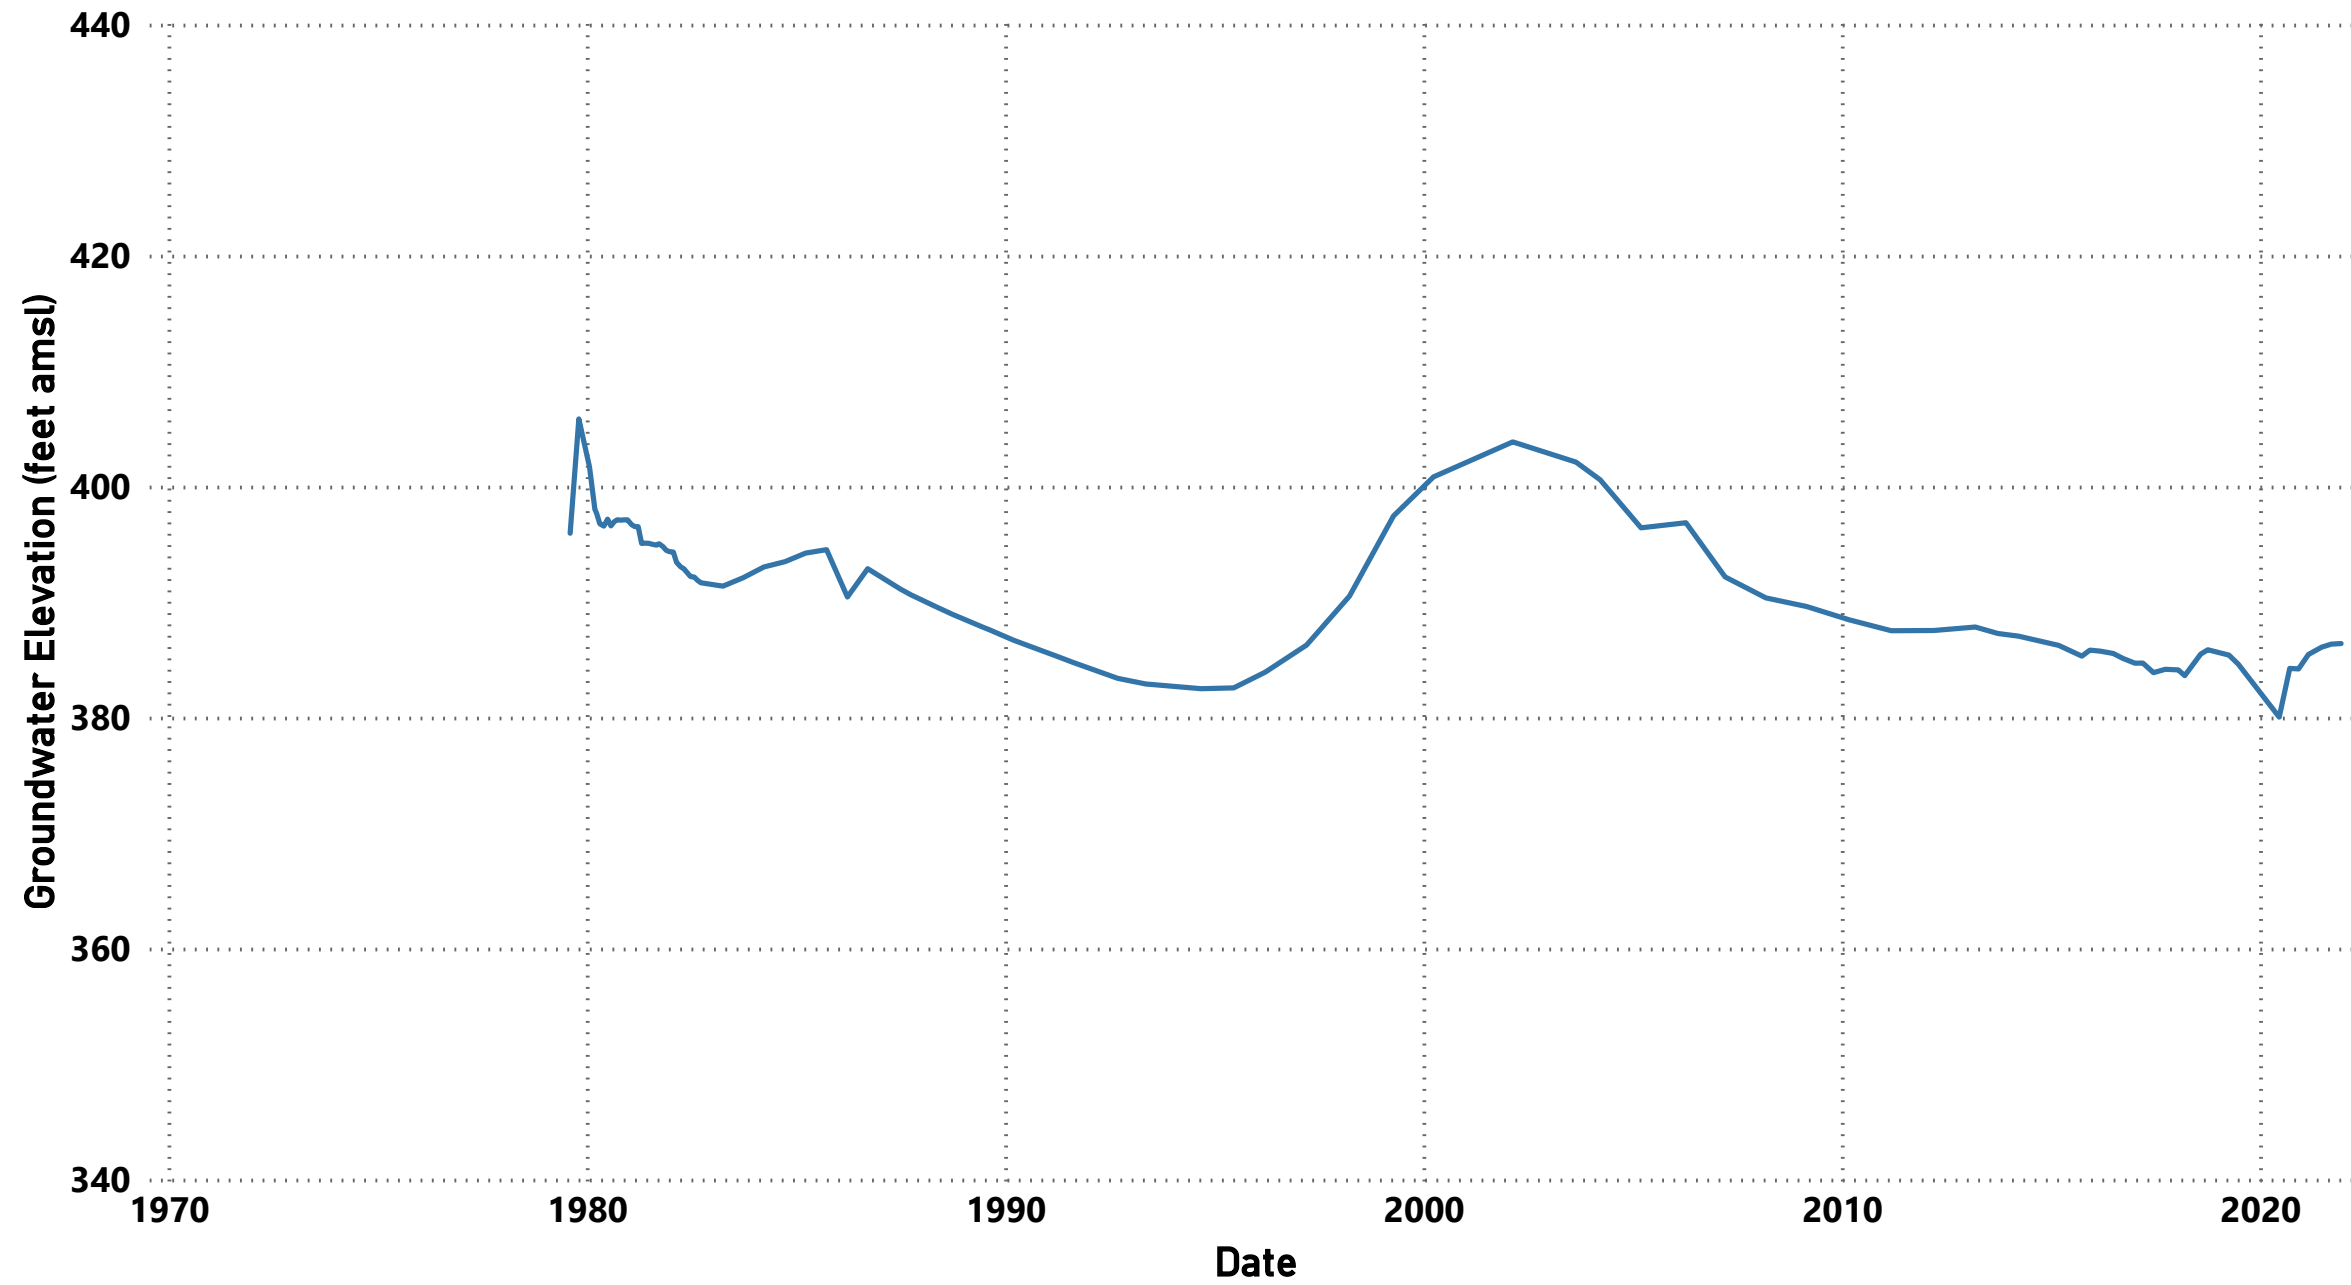
FIGURE 32
Hydrograph for Well 34P1
Careaga Formation Aquifer
San Antonio Basin GSA
2021 Annual Groundwater
Level Monitoring Report

Following each quarterly monitoring event, groundwater level data are provided to the SABGSA in an email monitoring report. Groundwater level measurements are housed within the SABGSA Data Management System and available upon request. Groundwater level trends observed since November 5, 2019, are consistent with historical trends; exhibiting a general decrease of groundwater elevations across the Basin. Water level measurements are presented in Table 1. Hydrographs from the wells in the monitoring network are included as Figures 6 through 43. The following noteworthy trends are observed in the hydrographs:

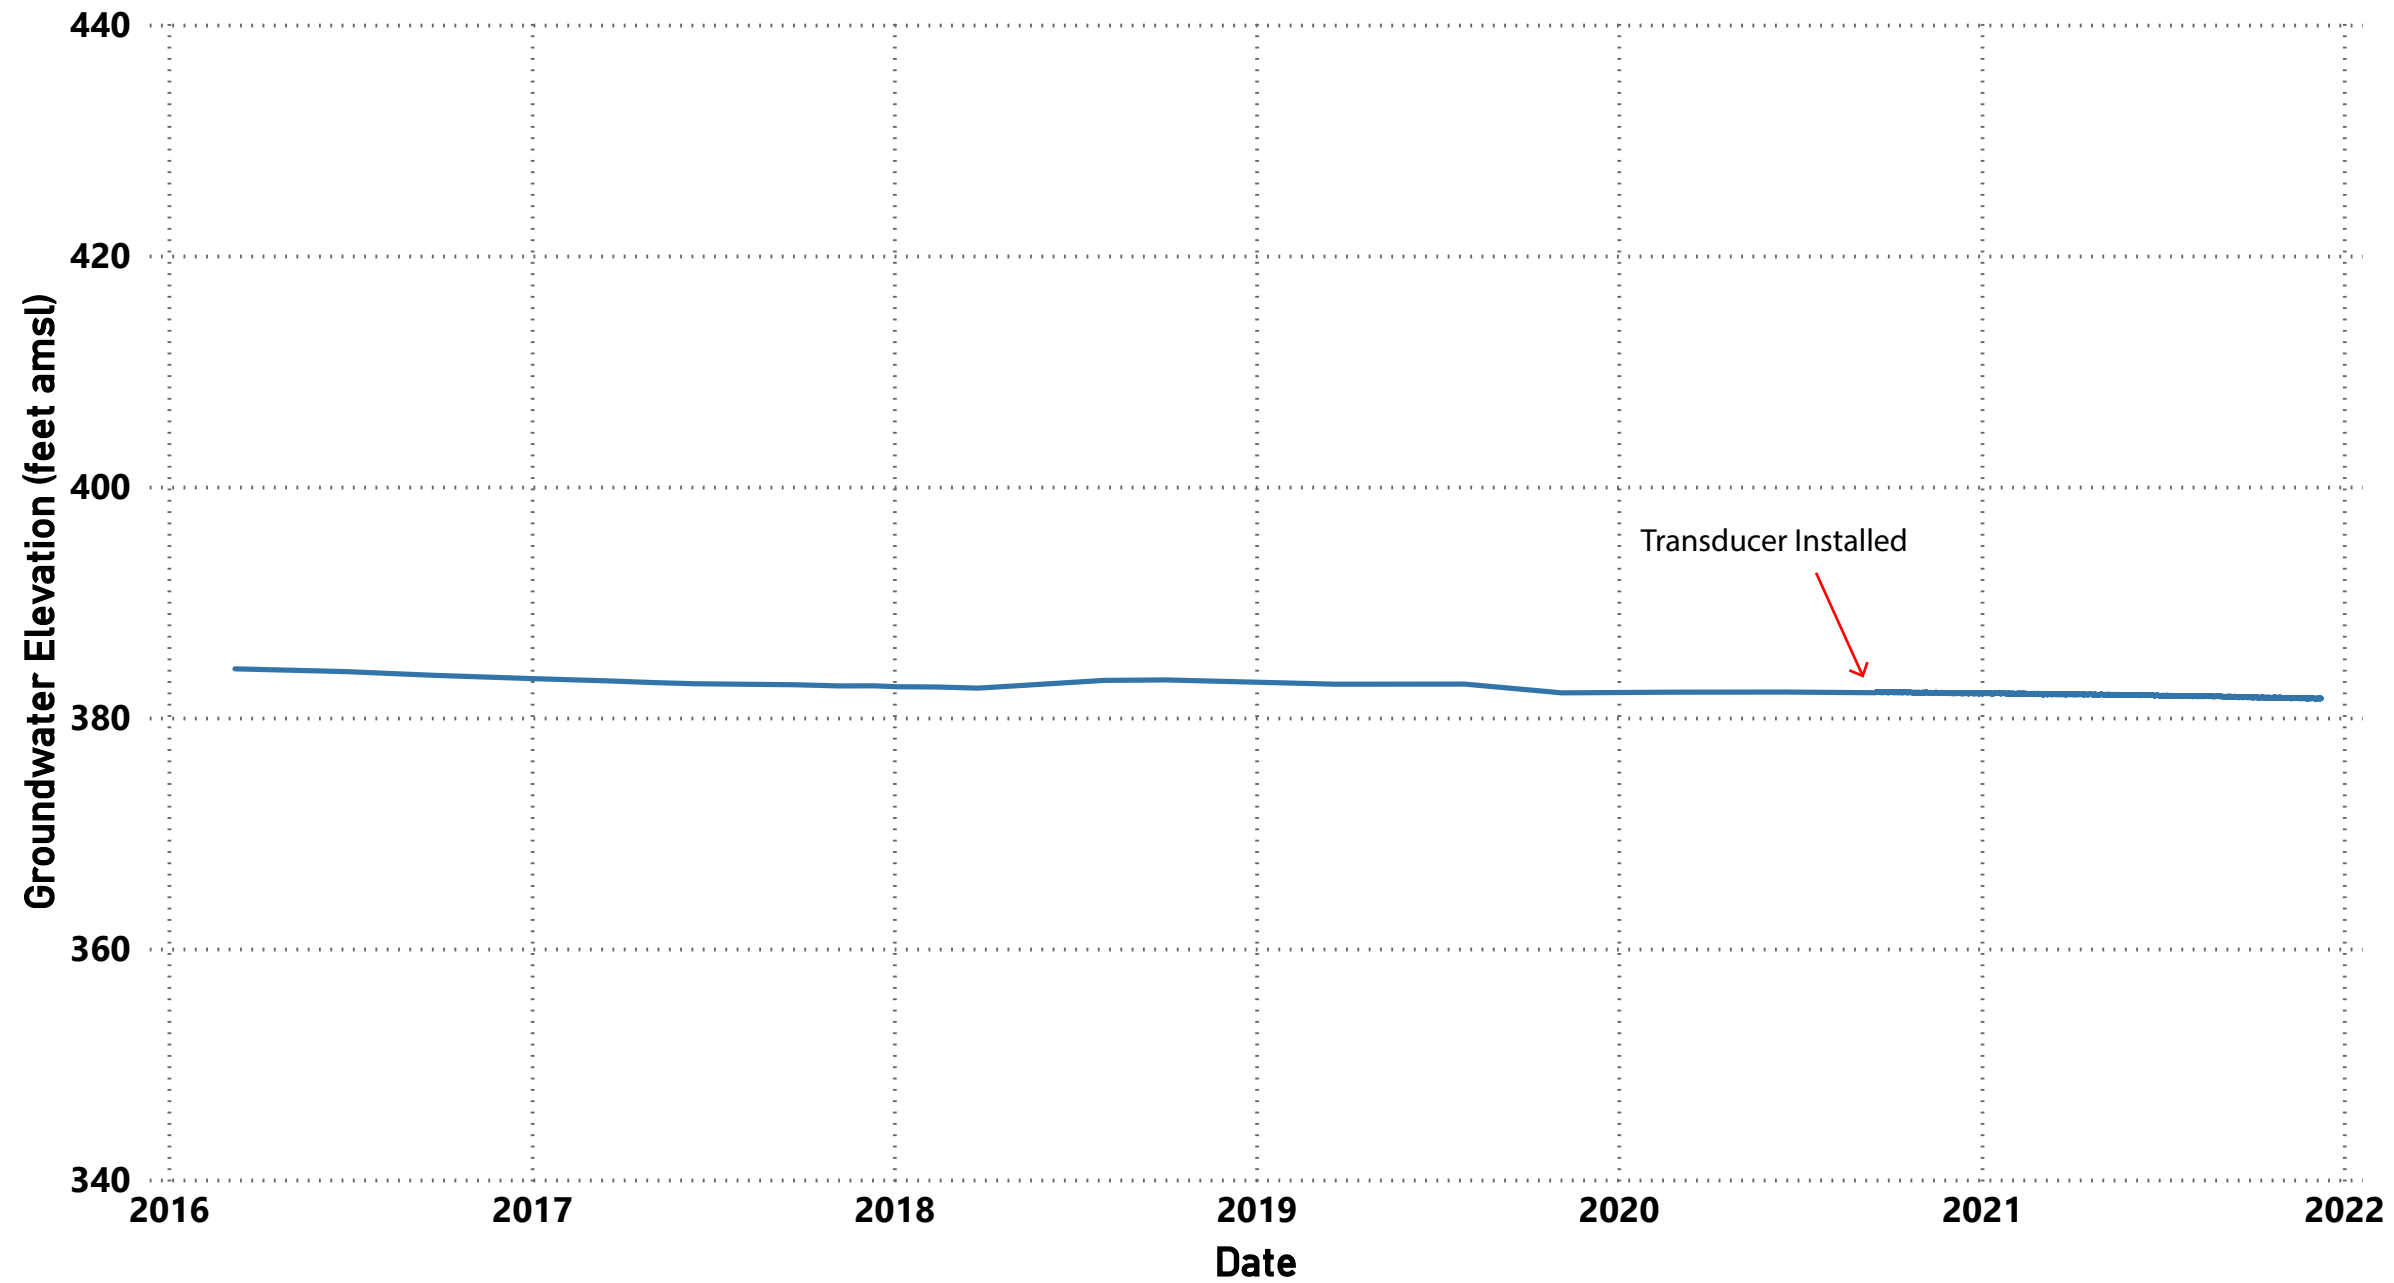
FIGURE 33
Hydrograph for Well SAHC
Careaga Formation Aquifer
San Antonio Basin GSA
2021 Annual Groundwater
Level Monitoring Report

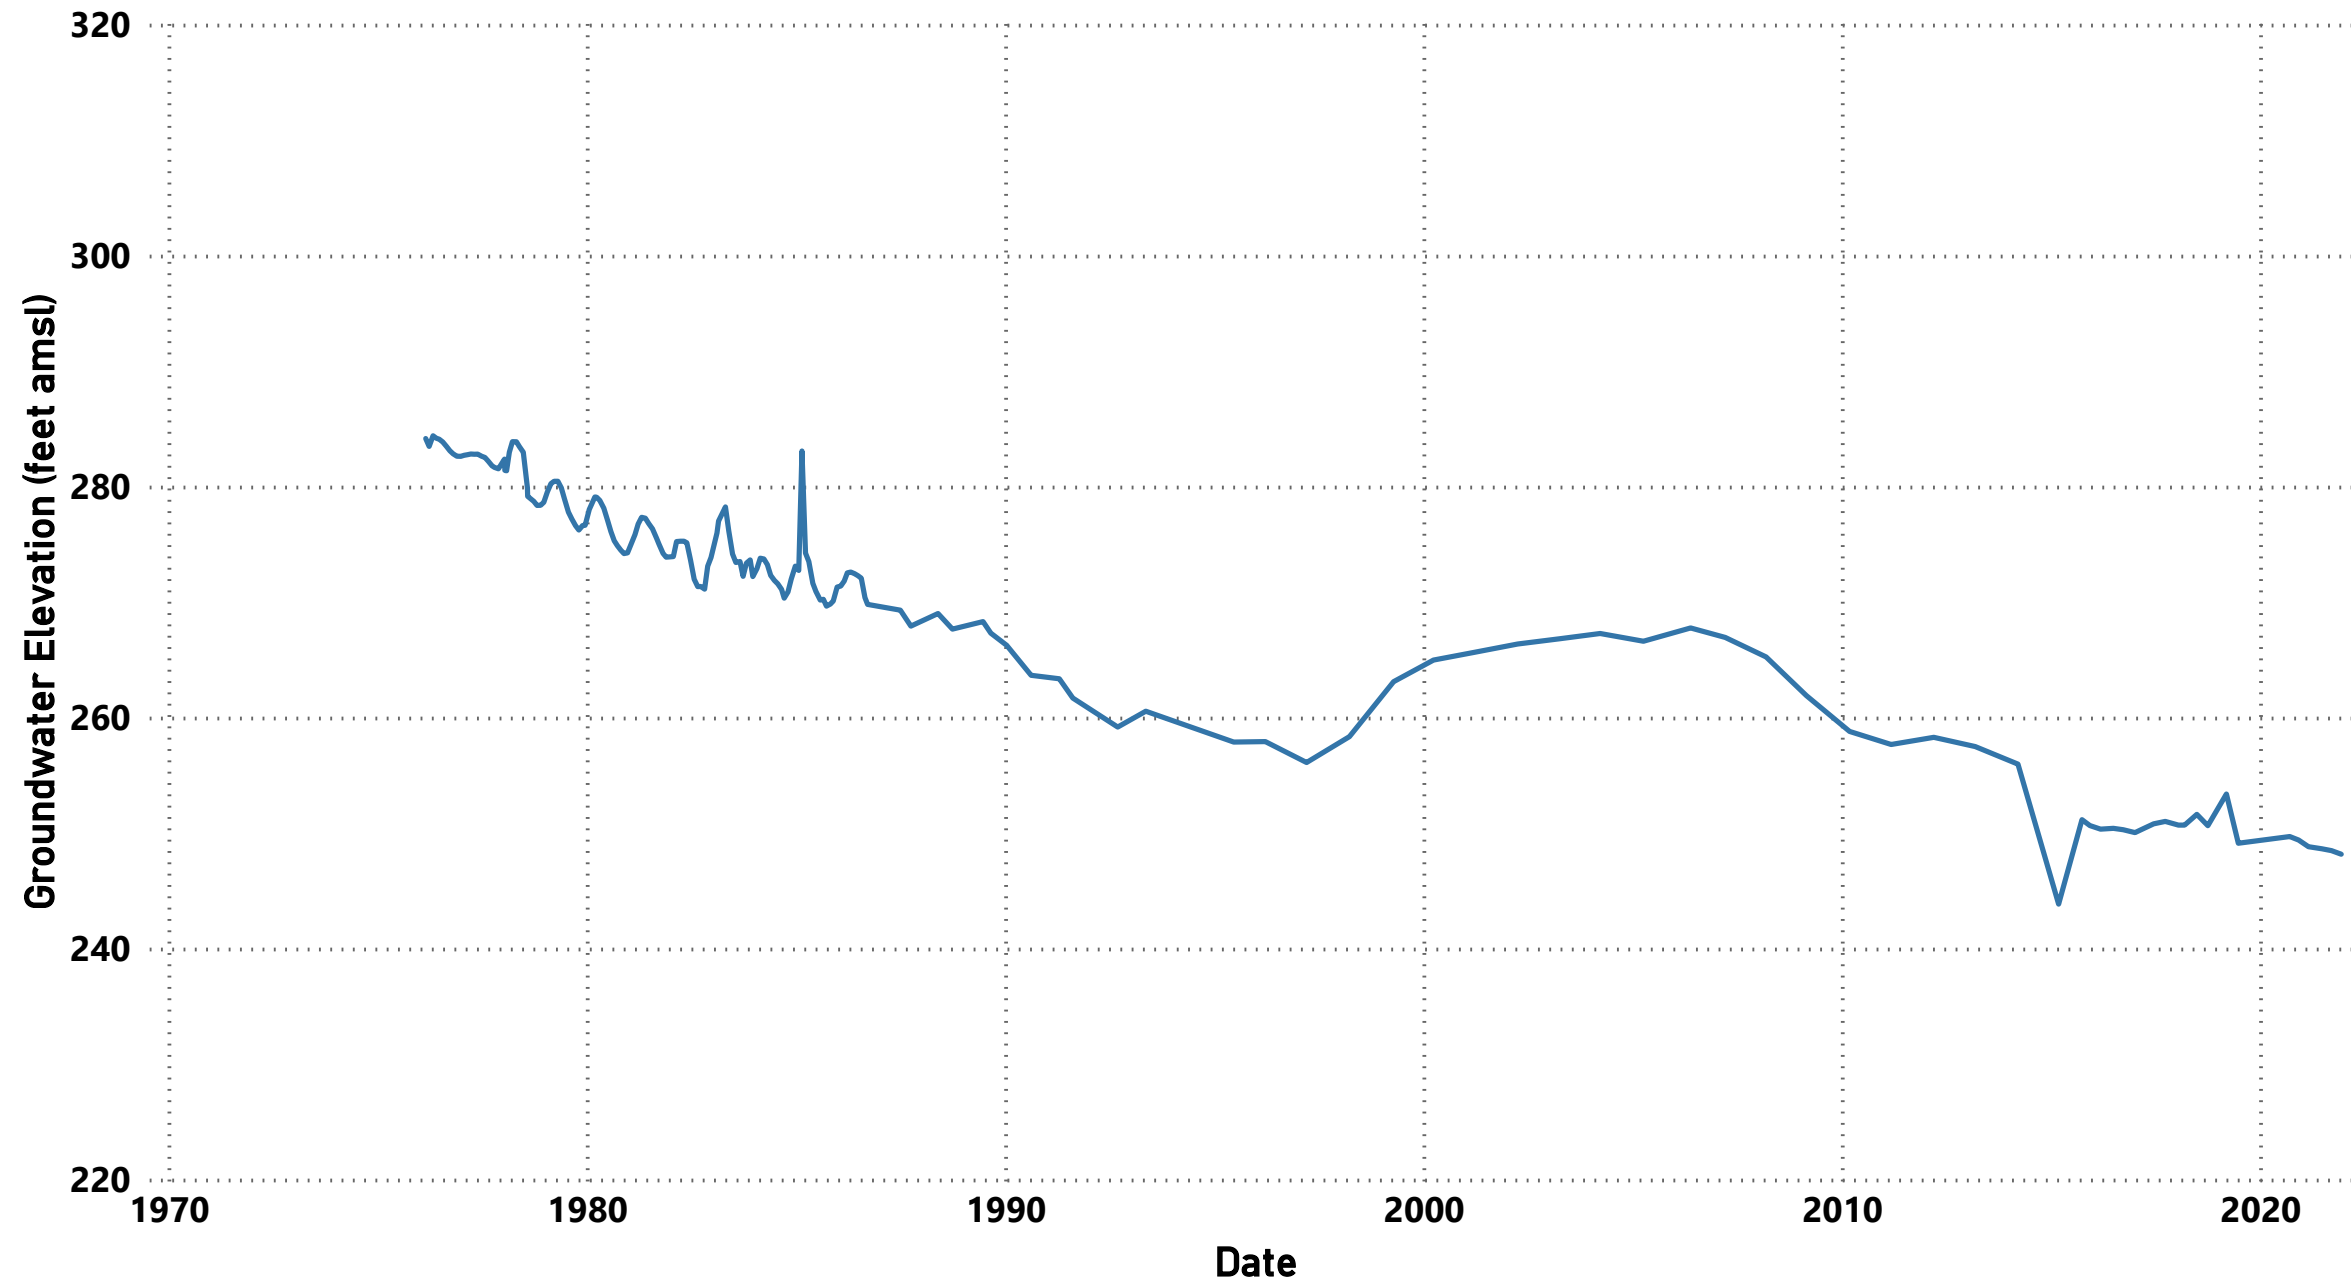
FIGURE 34
Hydrograph for Well 16G3
Careaga Formation Aquifer
 San Antonio Basin GSA
 2021 Annual Groundwater
 Level Monitoring Report

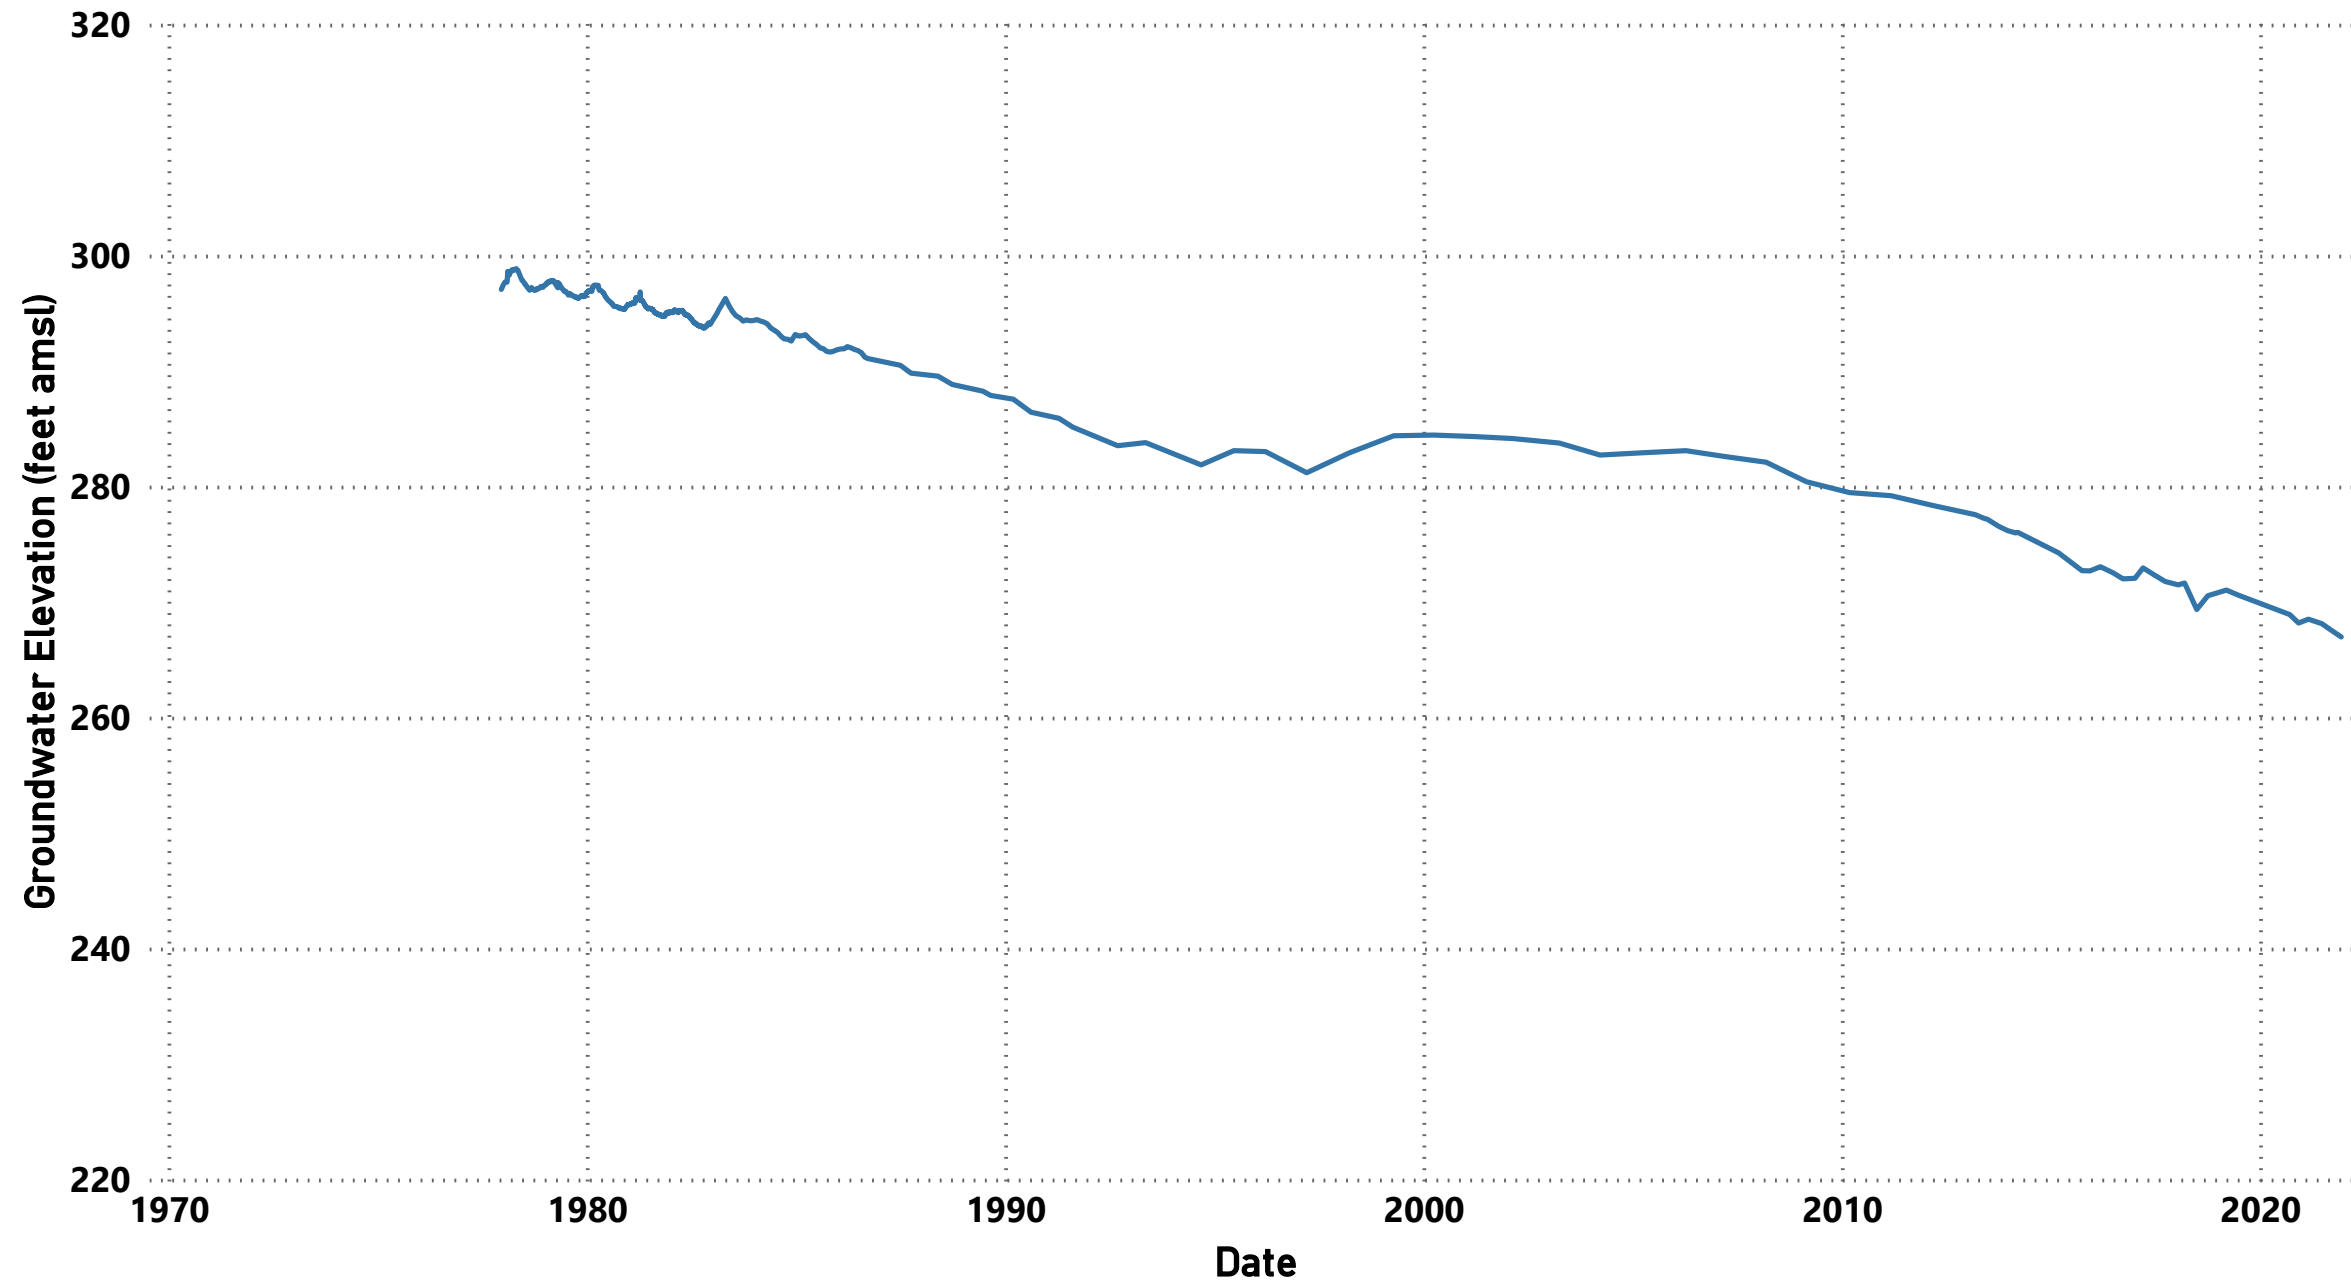
FIGURE 35
Hydrograph for Well 21A1
Careaga Formation Aquifer
San Antonio Basin GSA
2021 Annual Groundwater
Level Monitoring Report

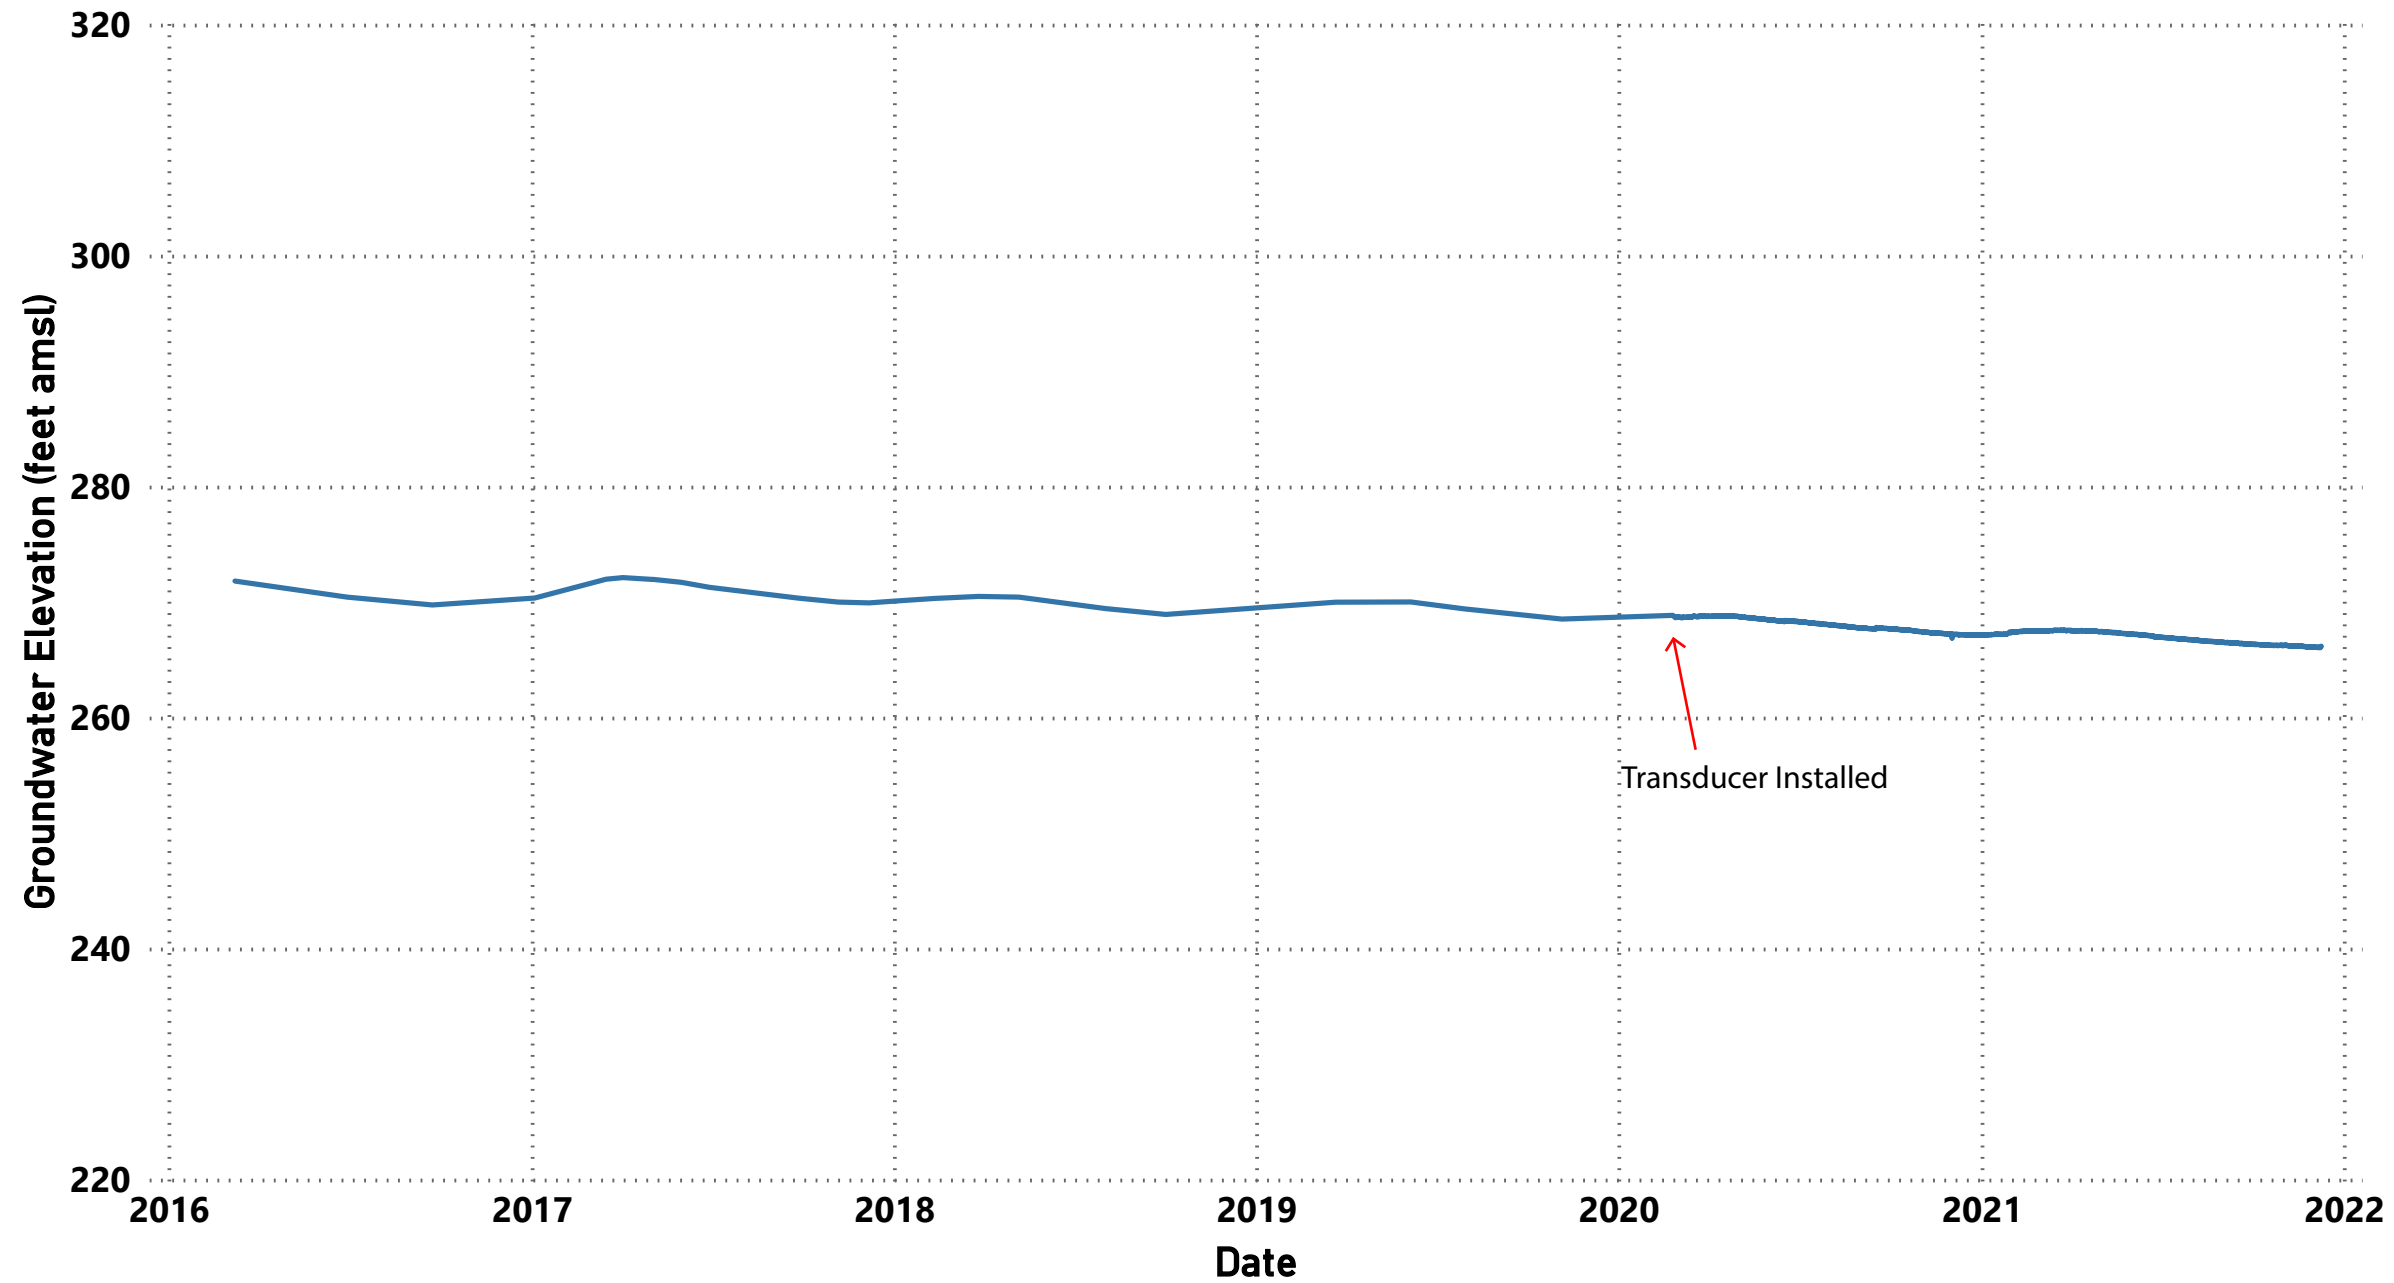
FIGURE 36
Hydrograph for Well SASA
Careaga Formation Aquifer
San Antonio Basin GSA
2021 Annual Groundwater
Level Monitoring Report

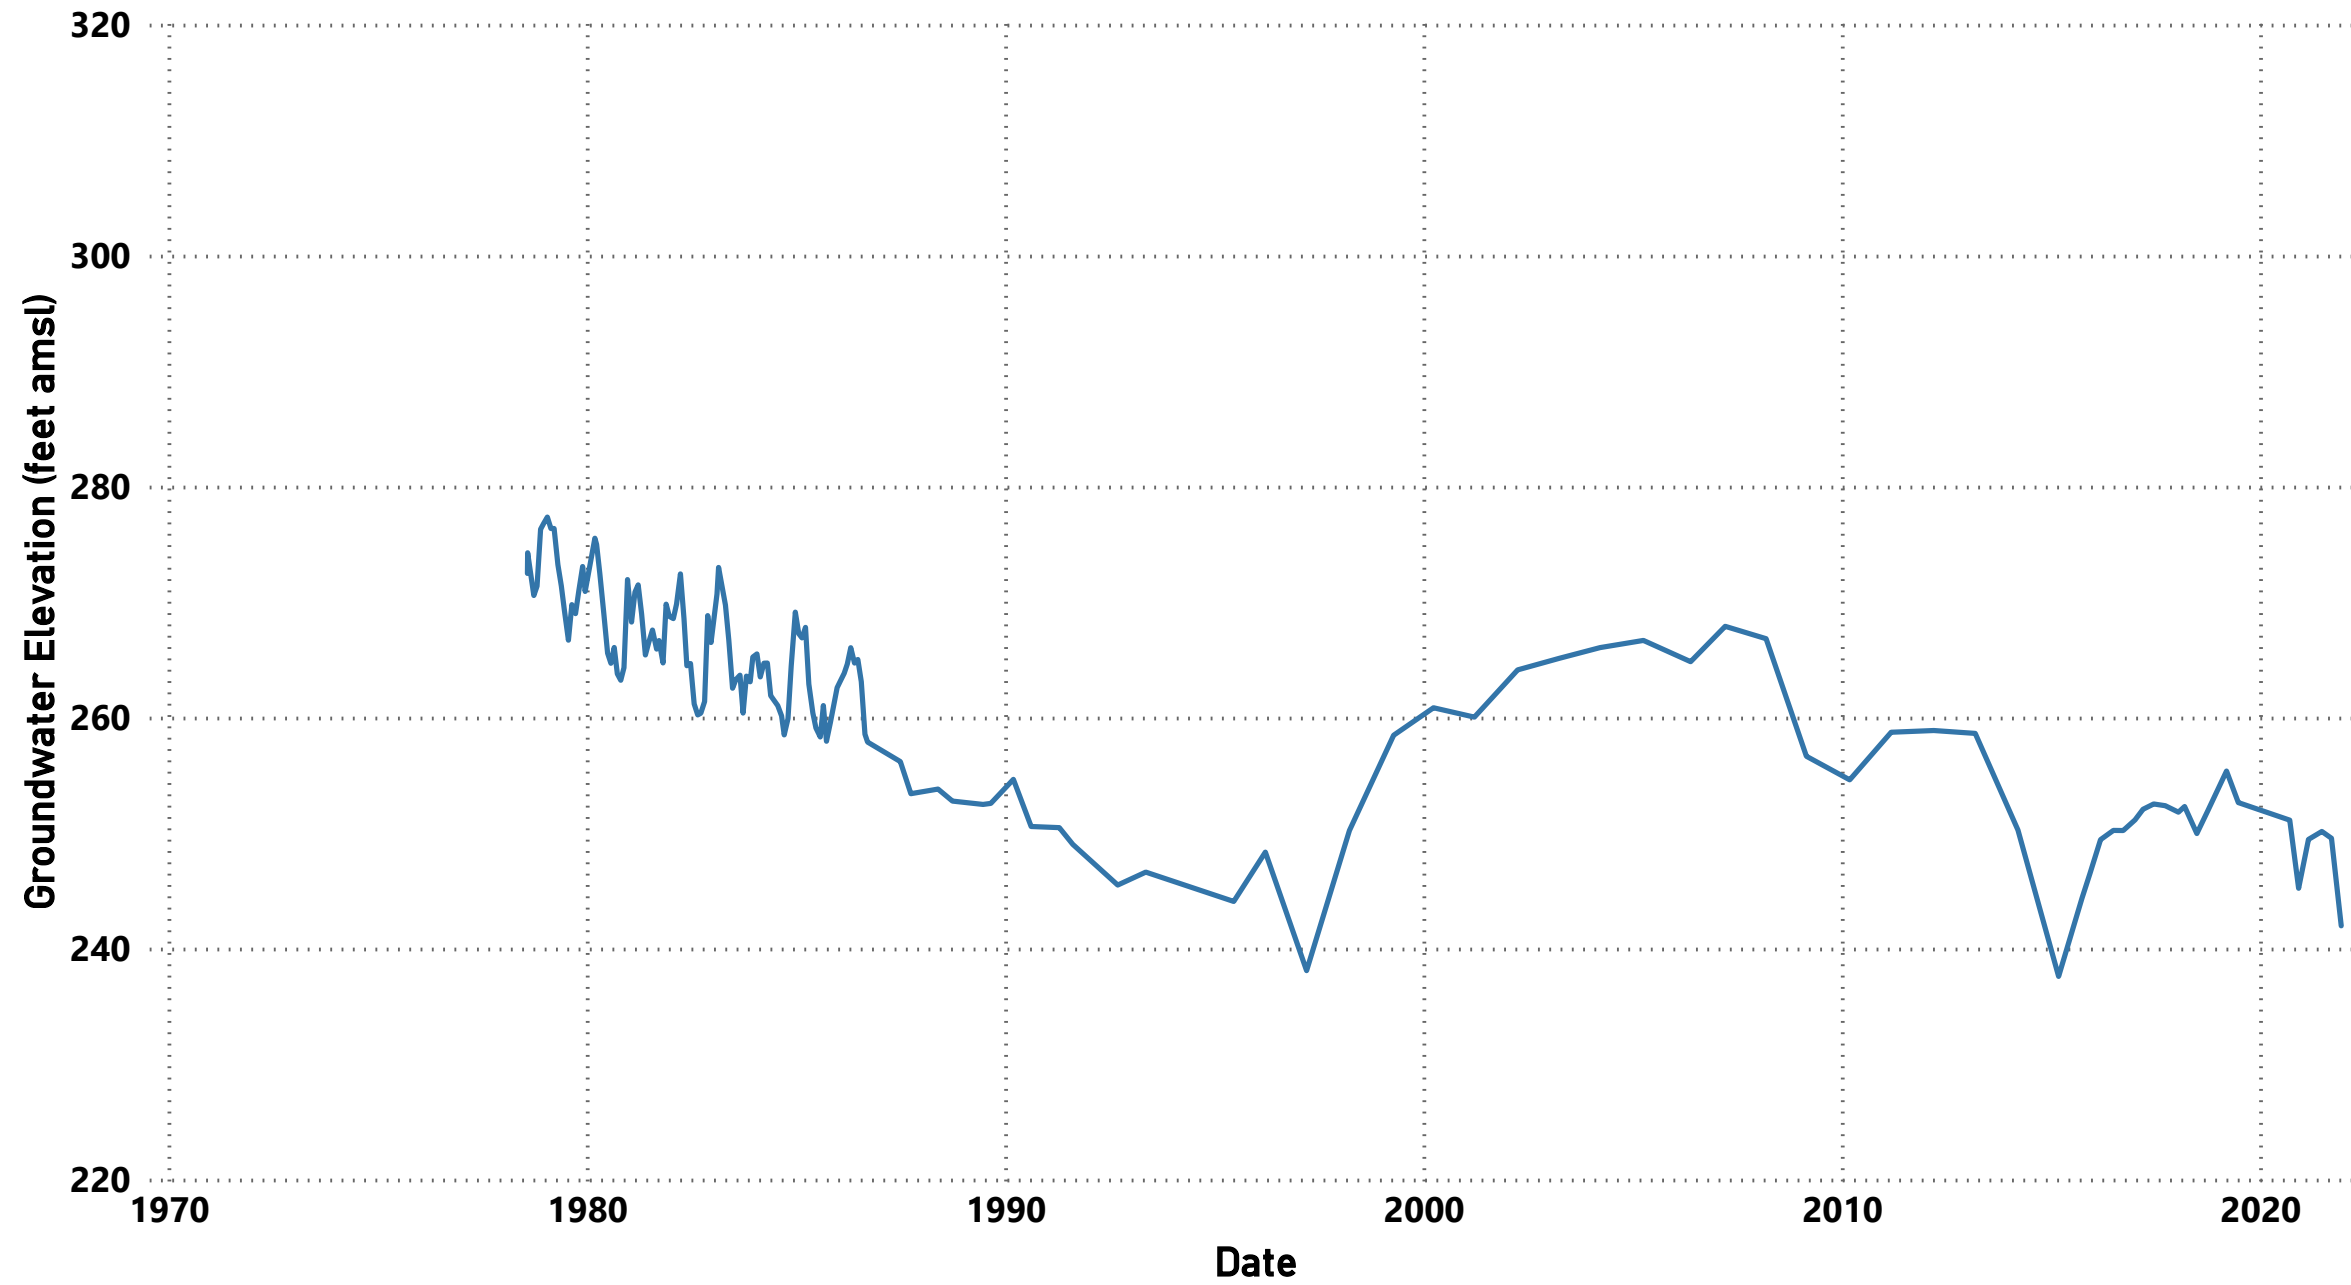
FIGURE 37
Hydrograph for Well 16F1
Careaga Formation Aquifer
 San Antonio Basin GSA
 2021 Annual Groundwater
 Level Monitoring Report

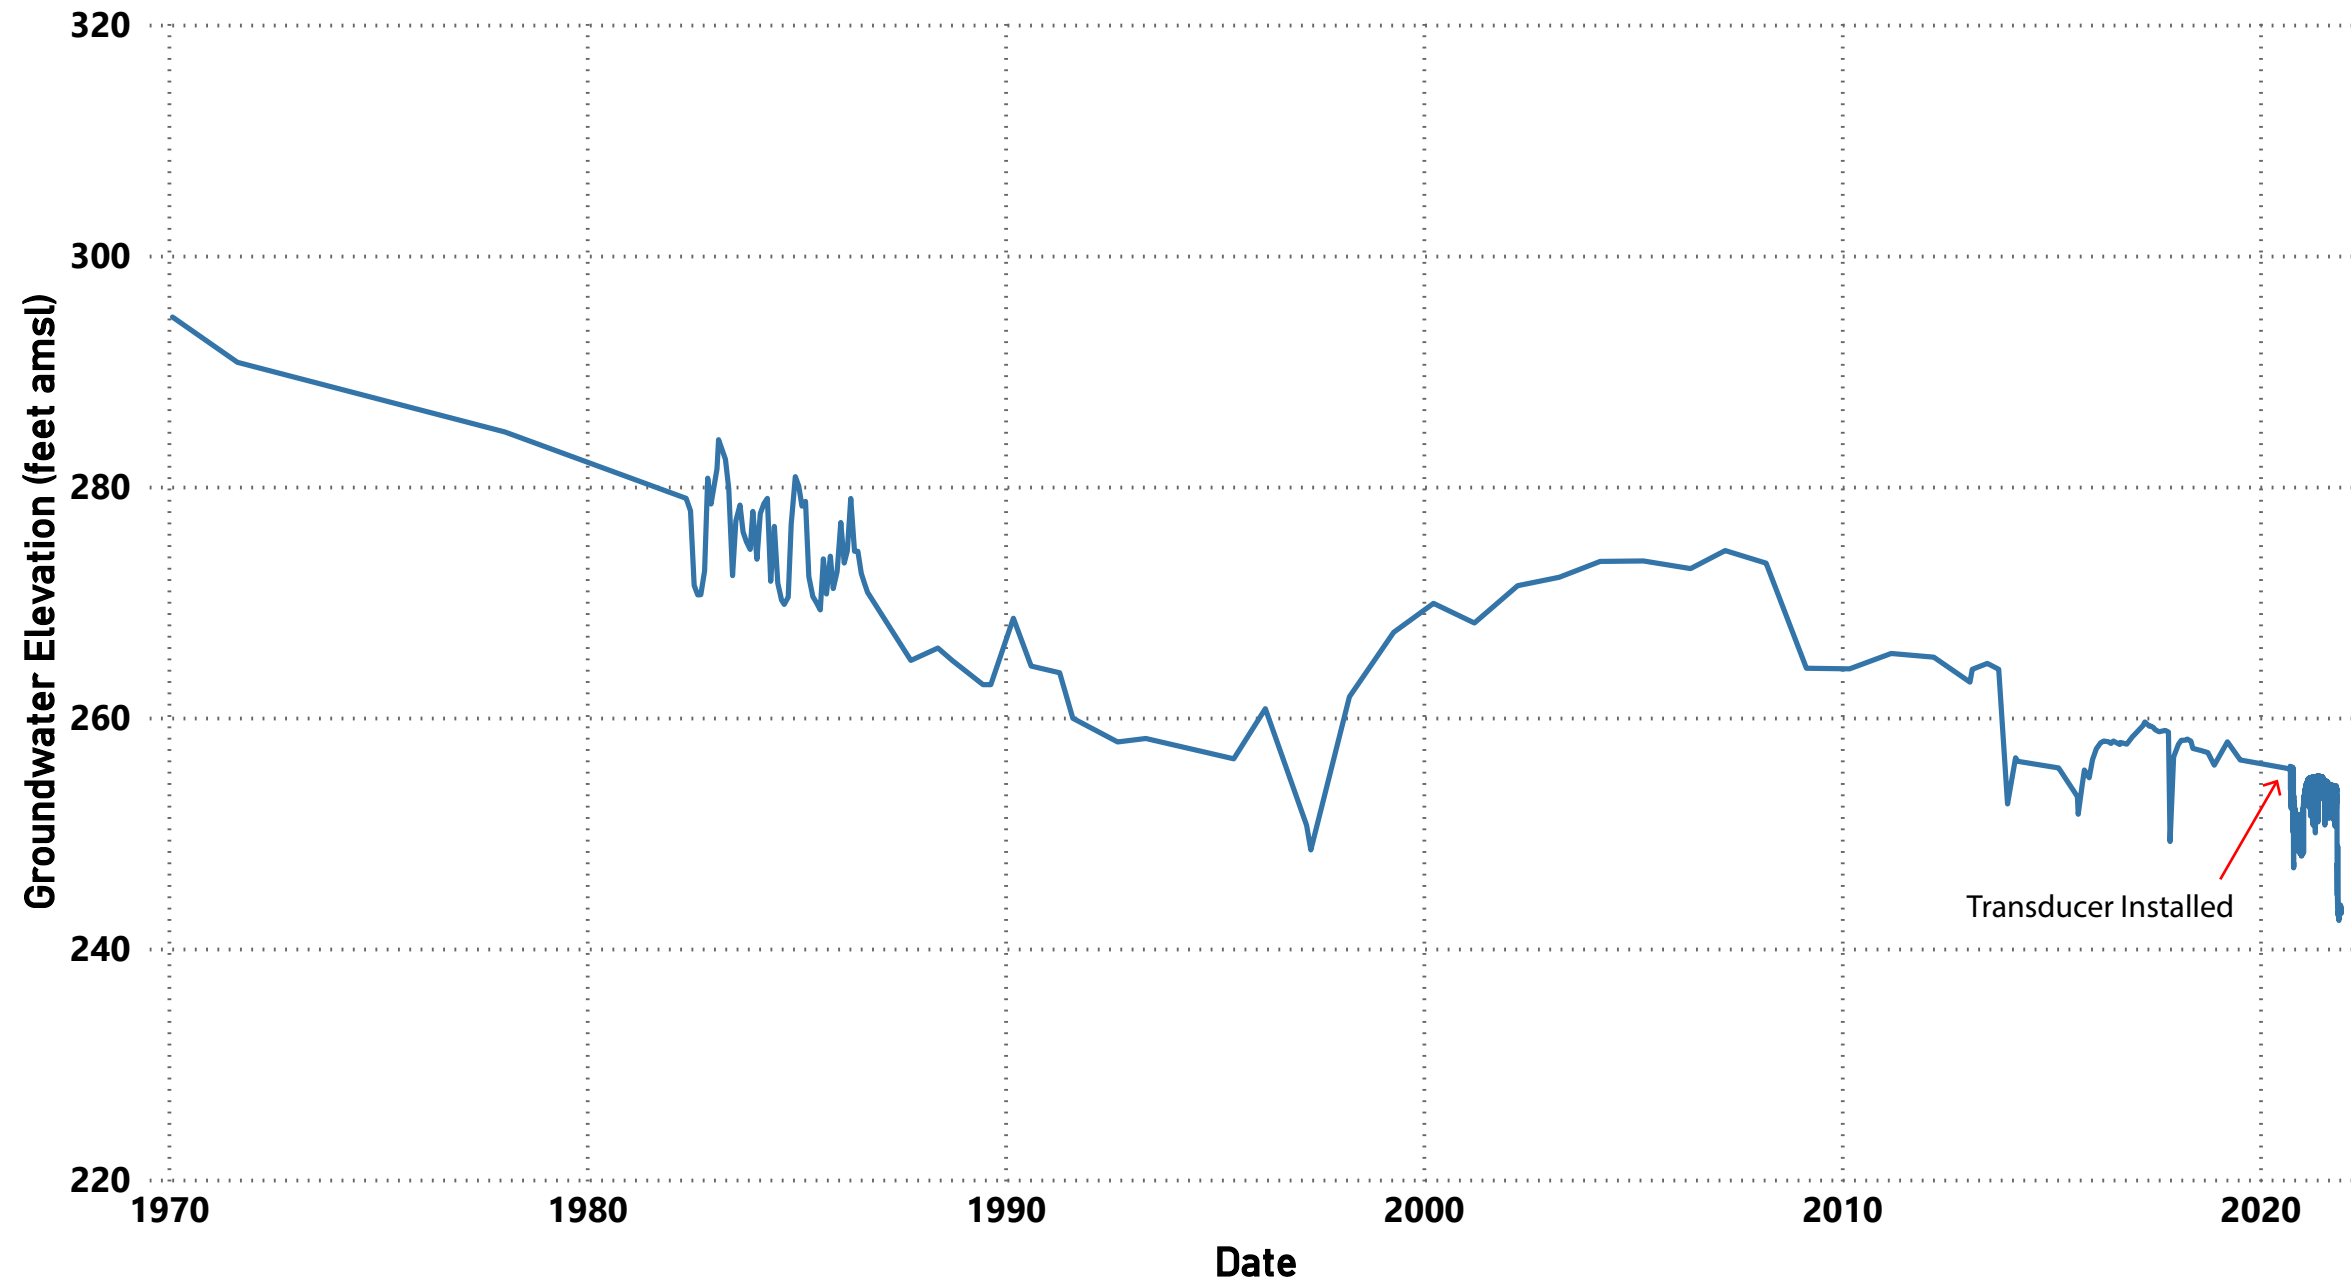
FIGURE 38
Hydrograph for Well 16C2
Careaga Formation Aquifer
 San Antonio Basin GSA
 2021 Annual Groundwater
 Level Monitoring Report

- Access to the Stephen's well was re-negotiated. Depth to water was measured using an airline and an air compressor.
- The transducer communication cable for well 16C2 was repaired by the vendor and re-installed on September 15th.
- Well 2N1 was not monitored because the access port could not be opened.
- The depth to water measurement for well 2R1 was flagged because it is believed to have been influenced by nearby pumping.
- A depth to water measurement was not collected from well 13C1, northeast of Los Alamos, because the well was undergoing repair.
- A depth to water measurement was not collected from well 17Q1, on the south side of Barka Slough, because of overgrown vegetation.
- A depth to water measurement was not collected from well 17K2, on the south side of Barka Slough, because of overgrown vegetation.

- Pumping activity in the Vandenberg well field during Q4 2020 and 2021 may have affected groundwater elevations in Wells 16C2 and 16C4, as shown in the continuous groundwater elevation data. The affect from pumping on groundwater levels was greater in 2021 than it was in 2020 (Figures 38 and 39).
