San Antonio Basin Groundwater Sustainability Agency

2021 Annual Groundwater Level Monitoring Report

January 28, 2022

GSI Water Solutions, Inc.

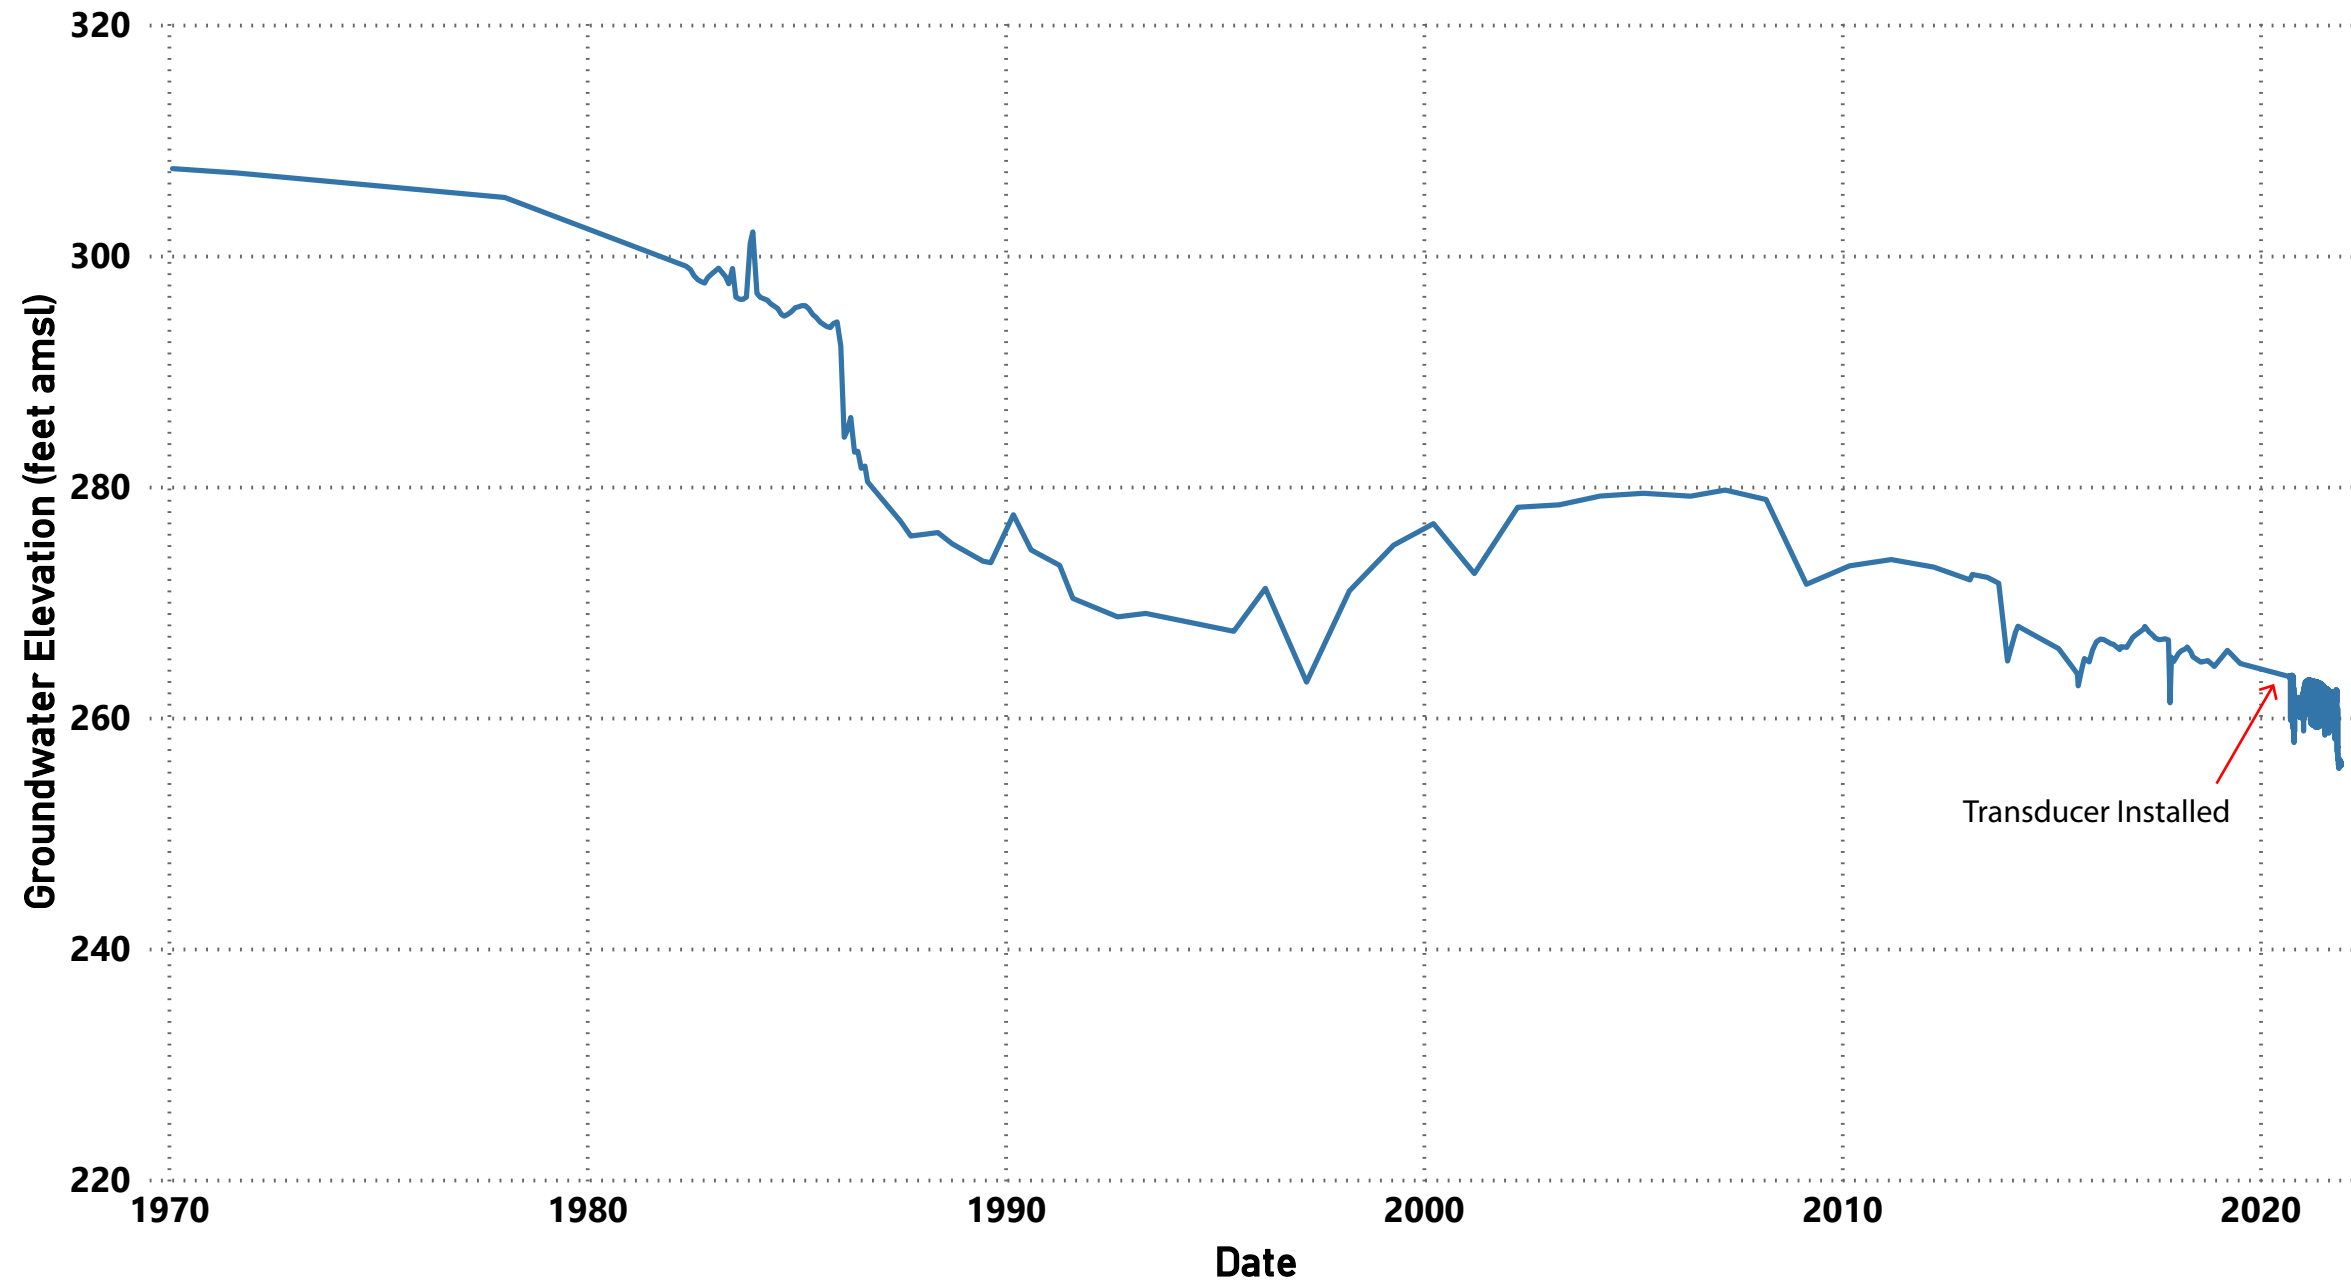
FIGURE 39
Hydrograph for Well 16C4
Careaga Formation Aquifer
San Antonio Basin GSA
2021 Annual Groundwater
Level Monitoring Report

- Well 17K2 on the south side of Barka Slough remained inaccessible due to overgrown vegetation.
- A water level measurement was not obtained from 13C1 because the pump was on.
- The transducer communication cable for well 16C4 was not working properly - the cable was sent into the supplier for repair.
- The water level in the Stephens Well (Kick On Ranch) was not measured because access had not been re-negotiated.

- Pumping activity in the Vandenberg well field during Q4 2020 and 2021 may have affected groundwater elevations in Wells 16C2 and 16C4, as shown in the continuous groundwater elevation data. The affect from pumping on groundwater levels was greater in 2021 than it was in 2020 (Figures 38 and 39).

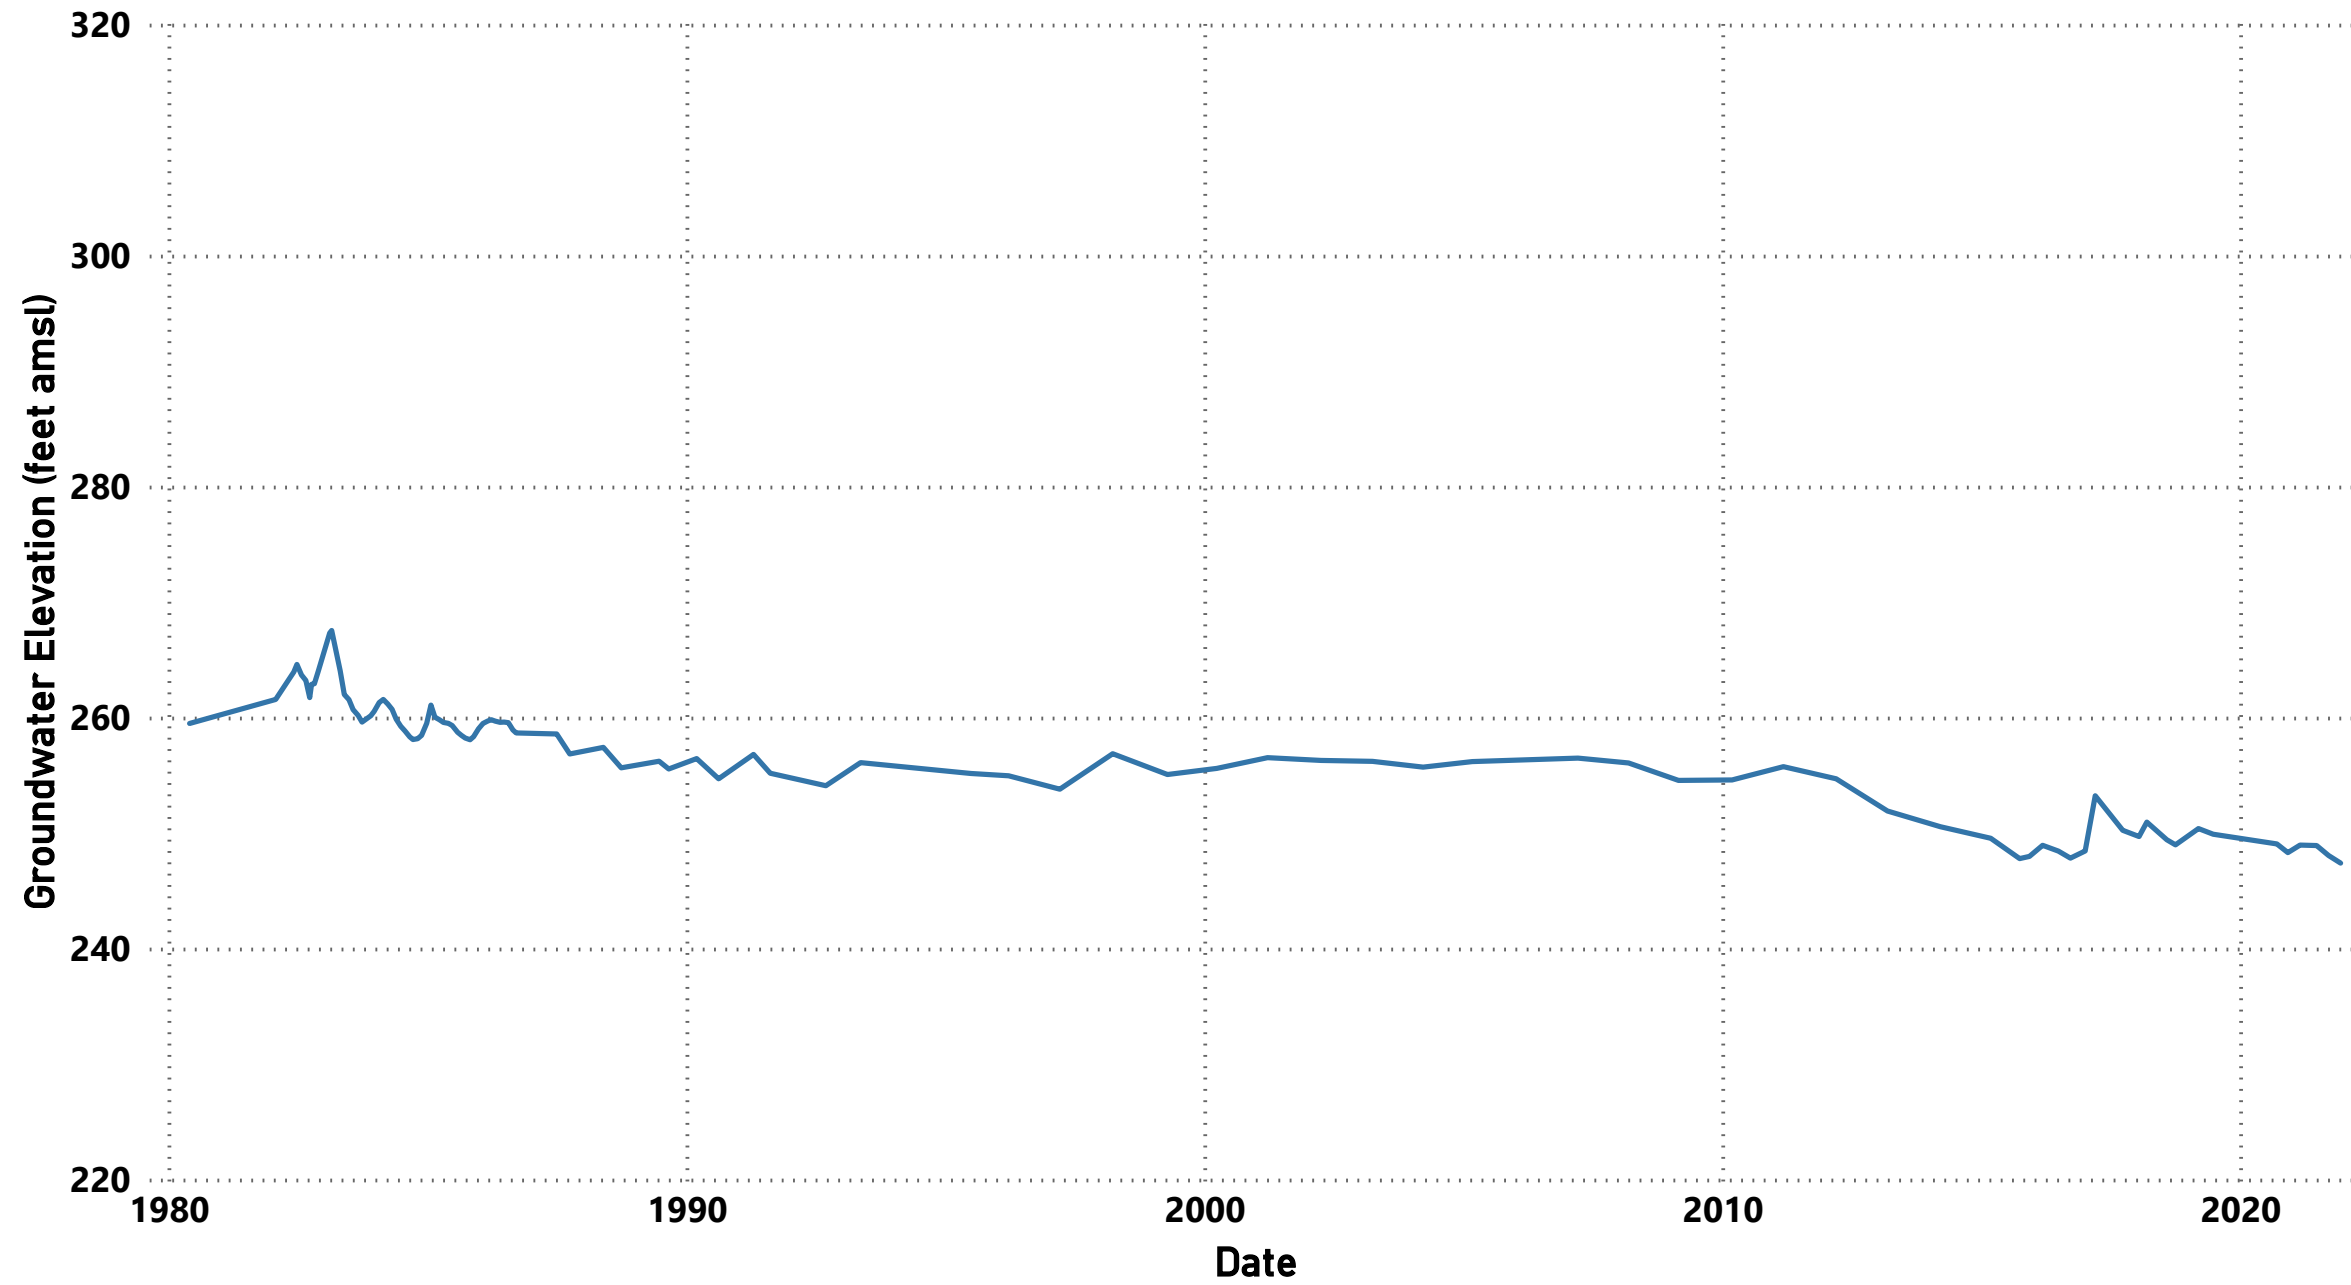
FIGURE 40
Hydrograph for Well 17H1
Careaga Formation Aquifer
San Antonio Basin GSA
2021 Annual Groundwater
Level Monitoring Report

Following each quarterly monitoring event, groundwater level data are provided to the SABGSA in an email monitoring report. Groundwater level measurements are housed within the SABGSA Data Management System and available upon request. Groundwater level trends observed since November 5, 2019, are consistent with historical trends; exhibiting a general decrease of groundwater elevations across the Basin. Water level measurements are presented in Table 1. Hydrographs from the wells in the monitoring network are included as Figures 6 through 43. The following noteworthy trends are observed in the hydrographs:

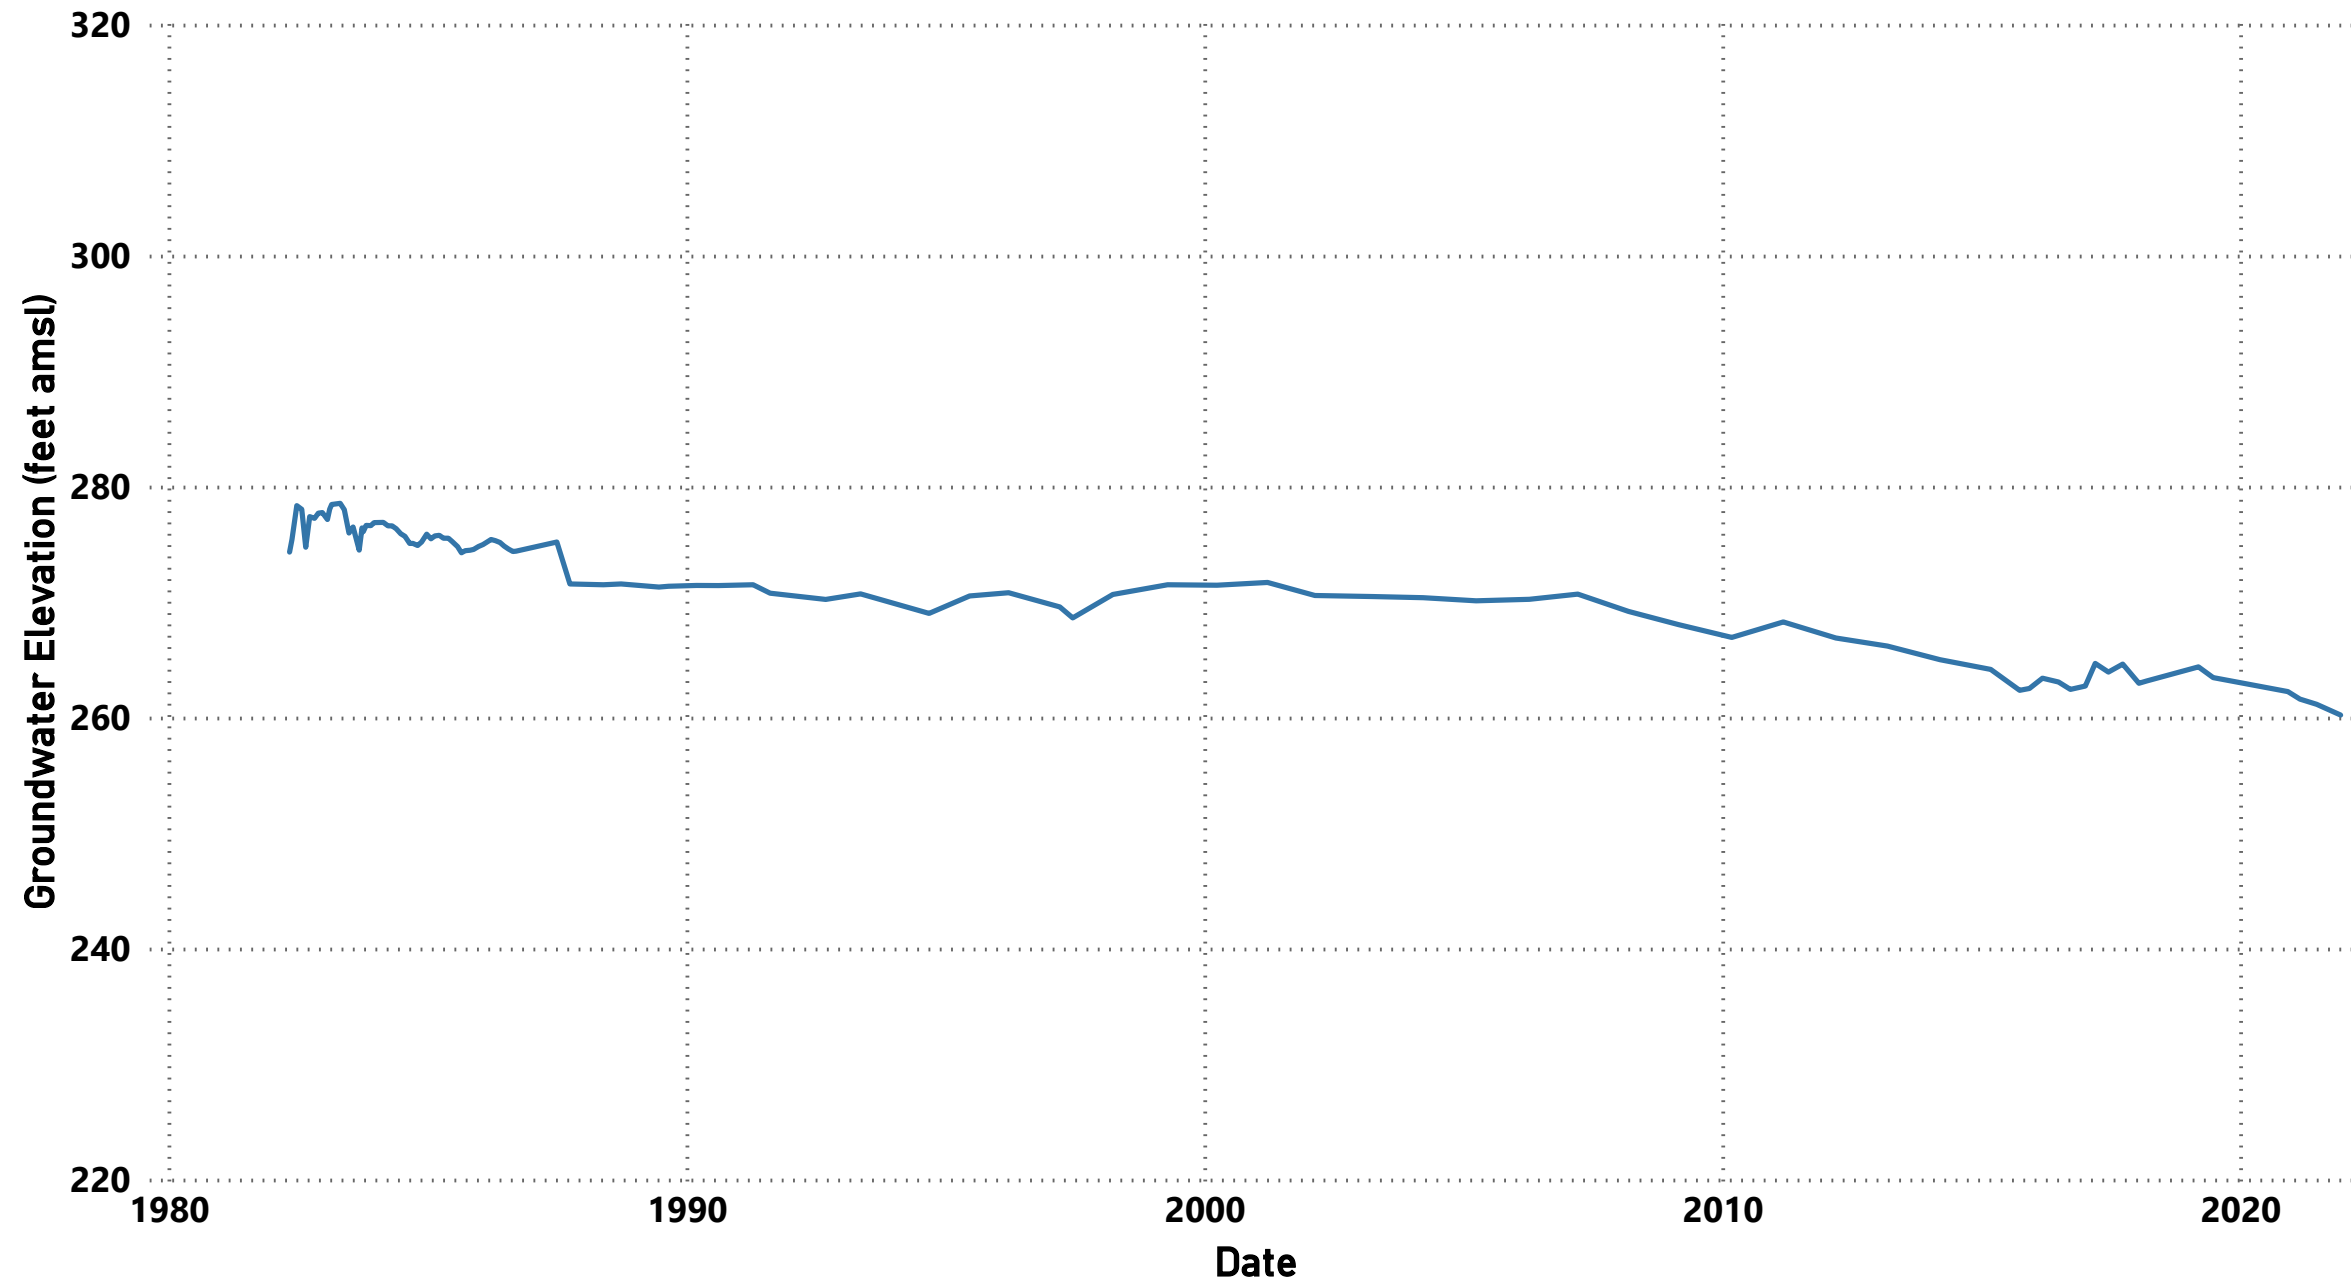
FIGURE 41
Hydrograph for Well 17Q1
Careaga Formation Aquifer
San Antonio Basin GSA
2021 Annual Groundwater
Level Monitoring Report

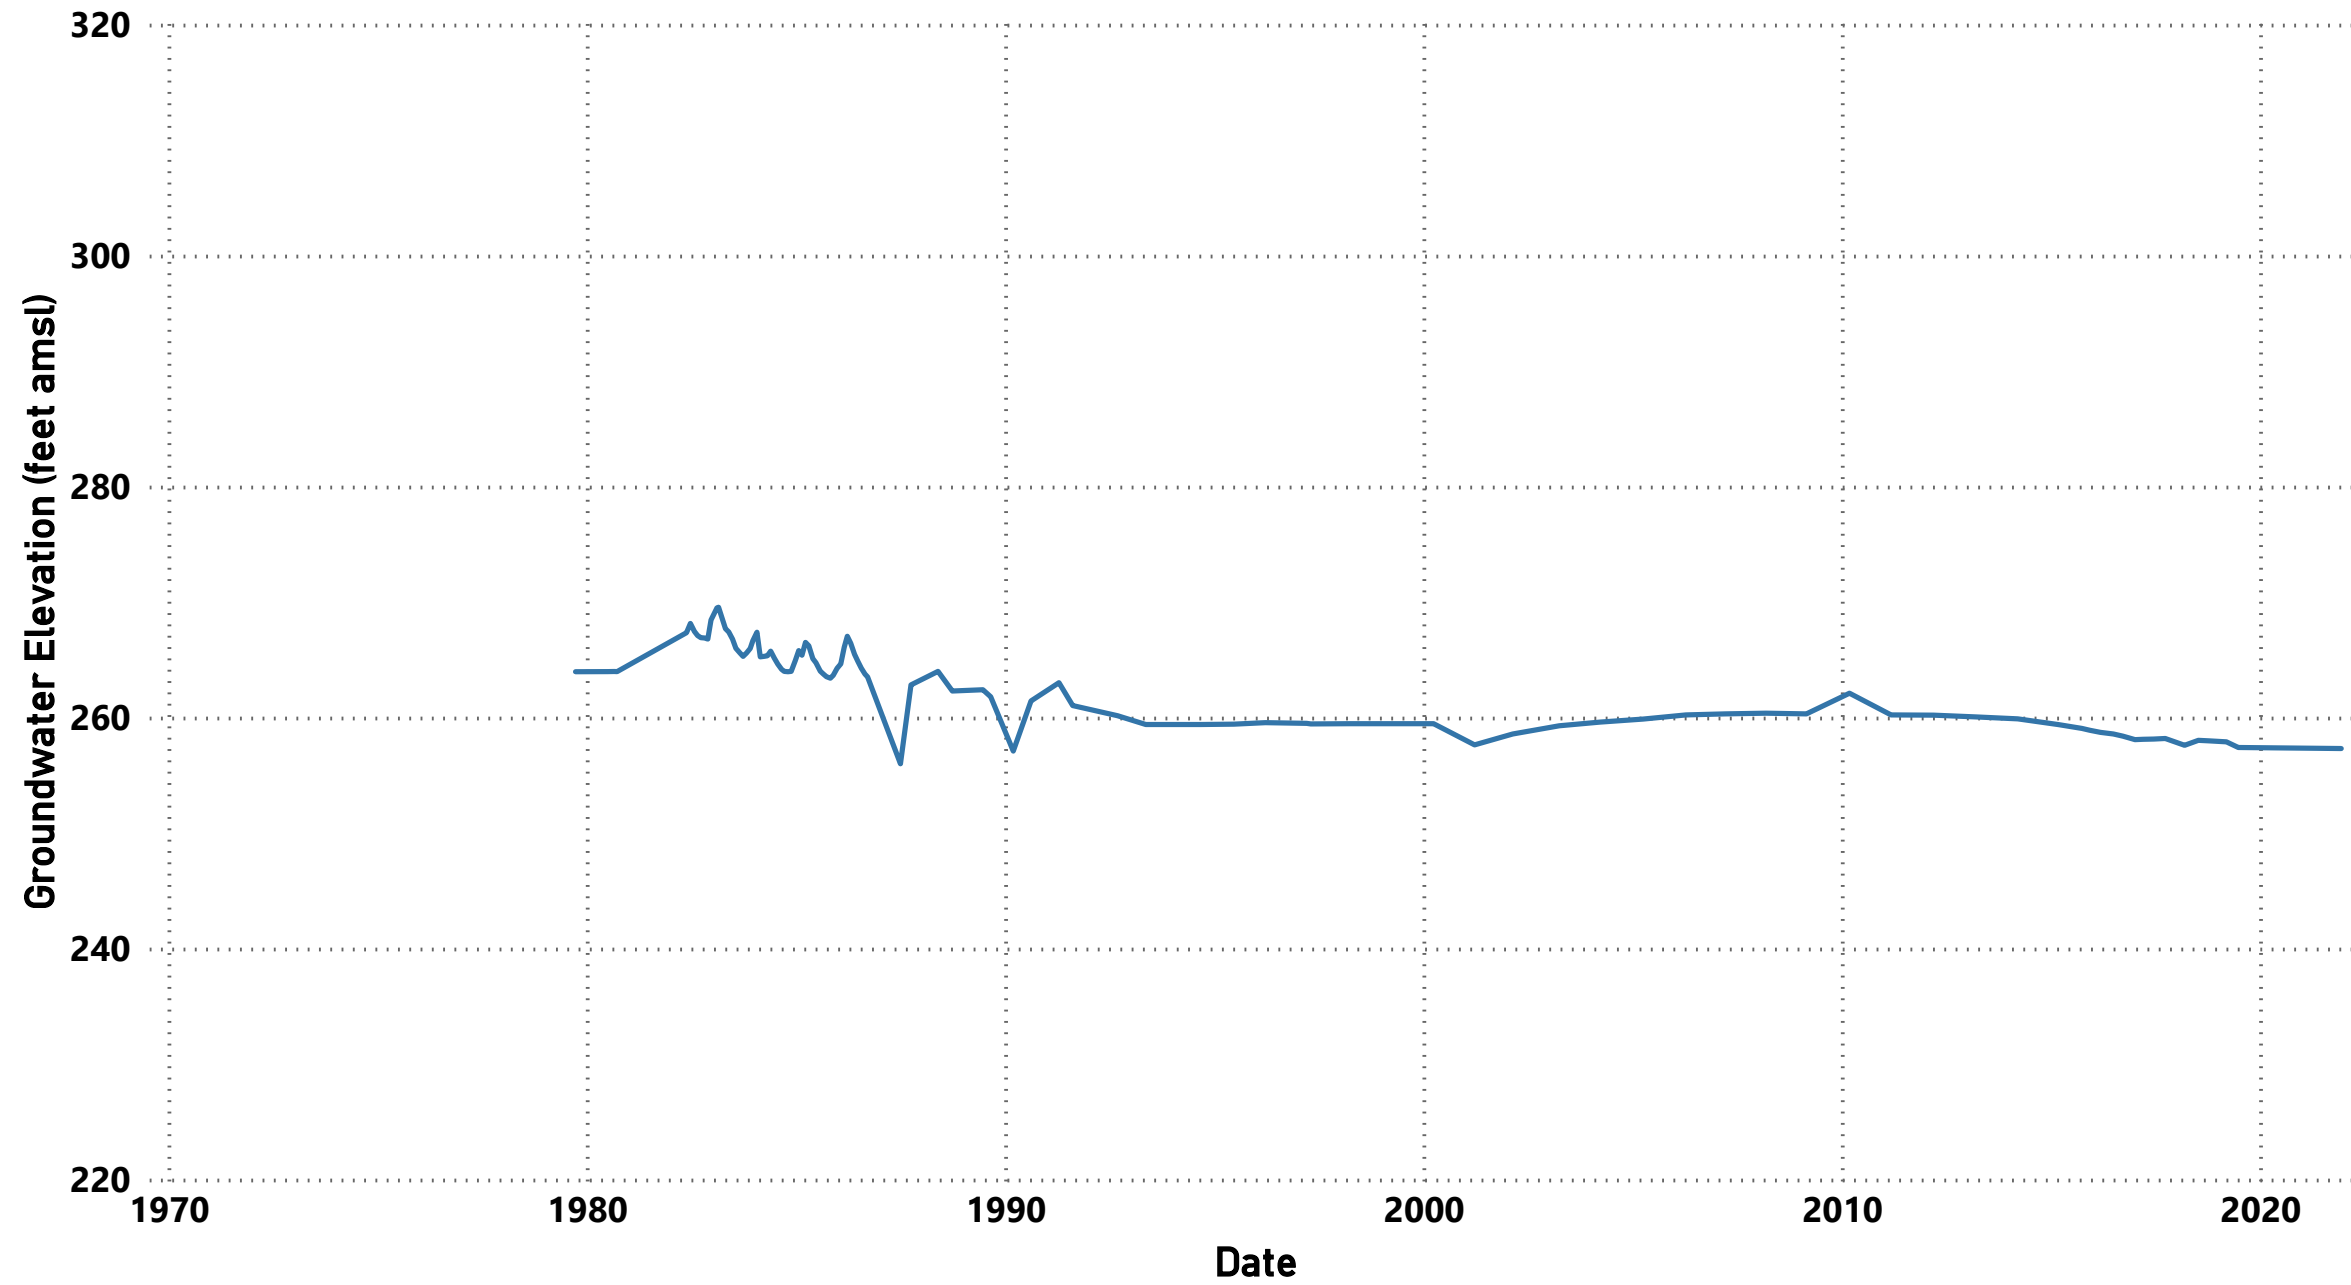
FIGURE 42
Hydrograph for Well 17K2
Careaga Formation Aquifer
San Antonio Basin GSA
2021 Annual Groundwater
Level Monitoring Report

- Access to the Stephen's well was re-negotiated. Depth to water was measured using an airline and an air compressor.
- The transducer communication cable for well 16C2 was repaired by the vendor and re-installed on September 15th.
- Well 2N1 was not monitored because the access port could not be opened.
- The depth to water measurement for well 2R1 was flagged because it is believed to have been influenced by nearby pumping.
- A depth to water measurement was not collected from well 13C1, northeast of Los Alamos, because the well was undergoing repair.
- A depth to water measurement was not collected from well 17Q1, on the south side of Barka Slough, because of overgrown vegetation.
- A depth to water measurement was not collected from well 17K2, on the south side of Barka Slough, because of overgrown vegetation.

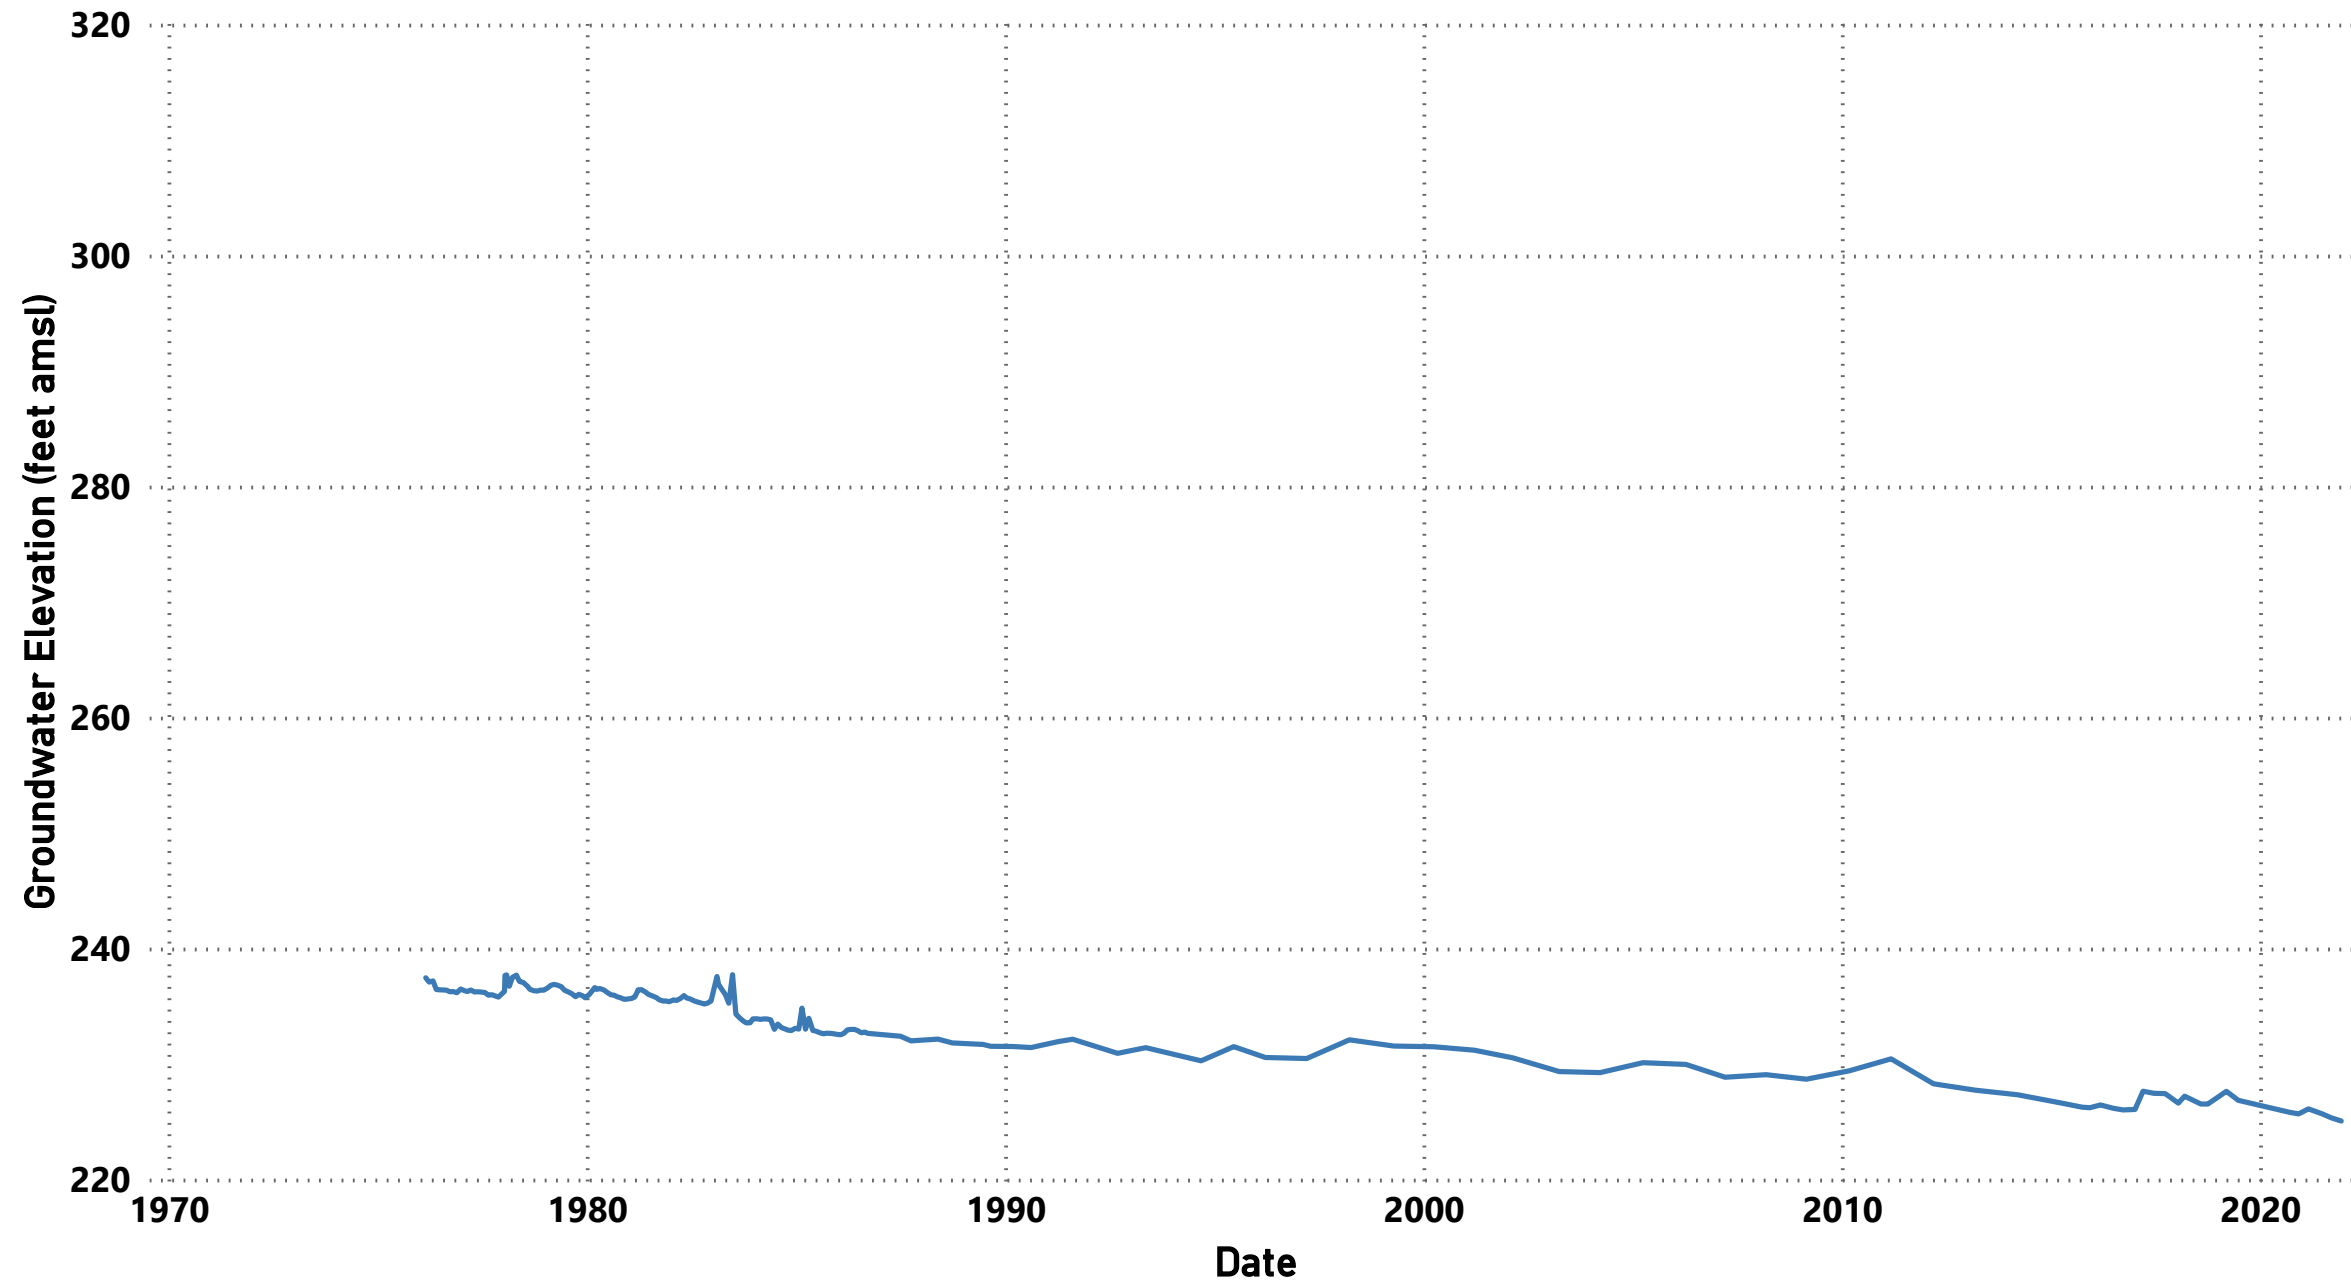
FIGURE 43
Hydrograph for Well 17E1
Careaga Formation Aquifer
San Antonio Basin GSA
2021 Annual Groundwater
Level Monitoring Report

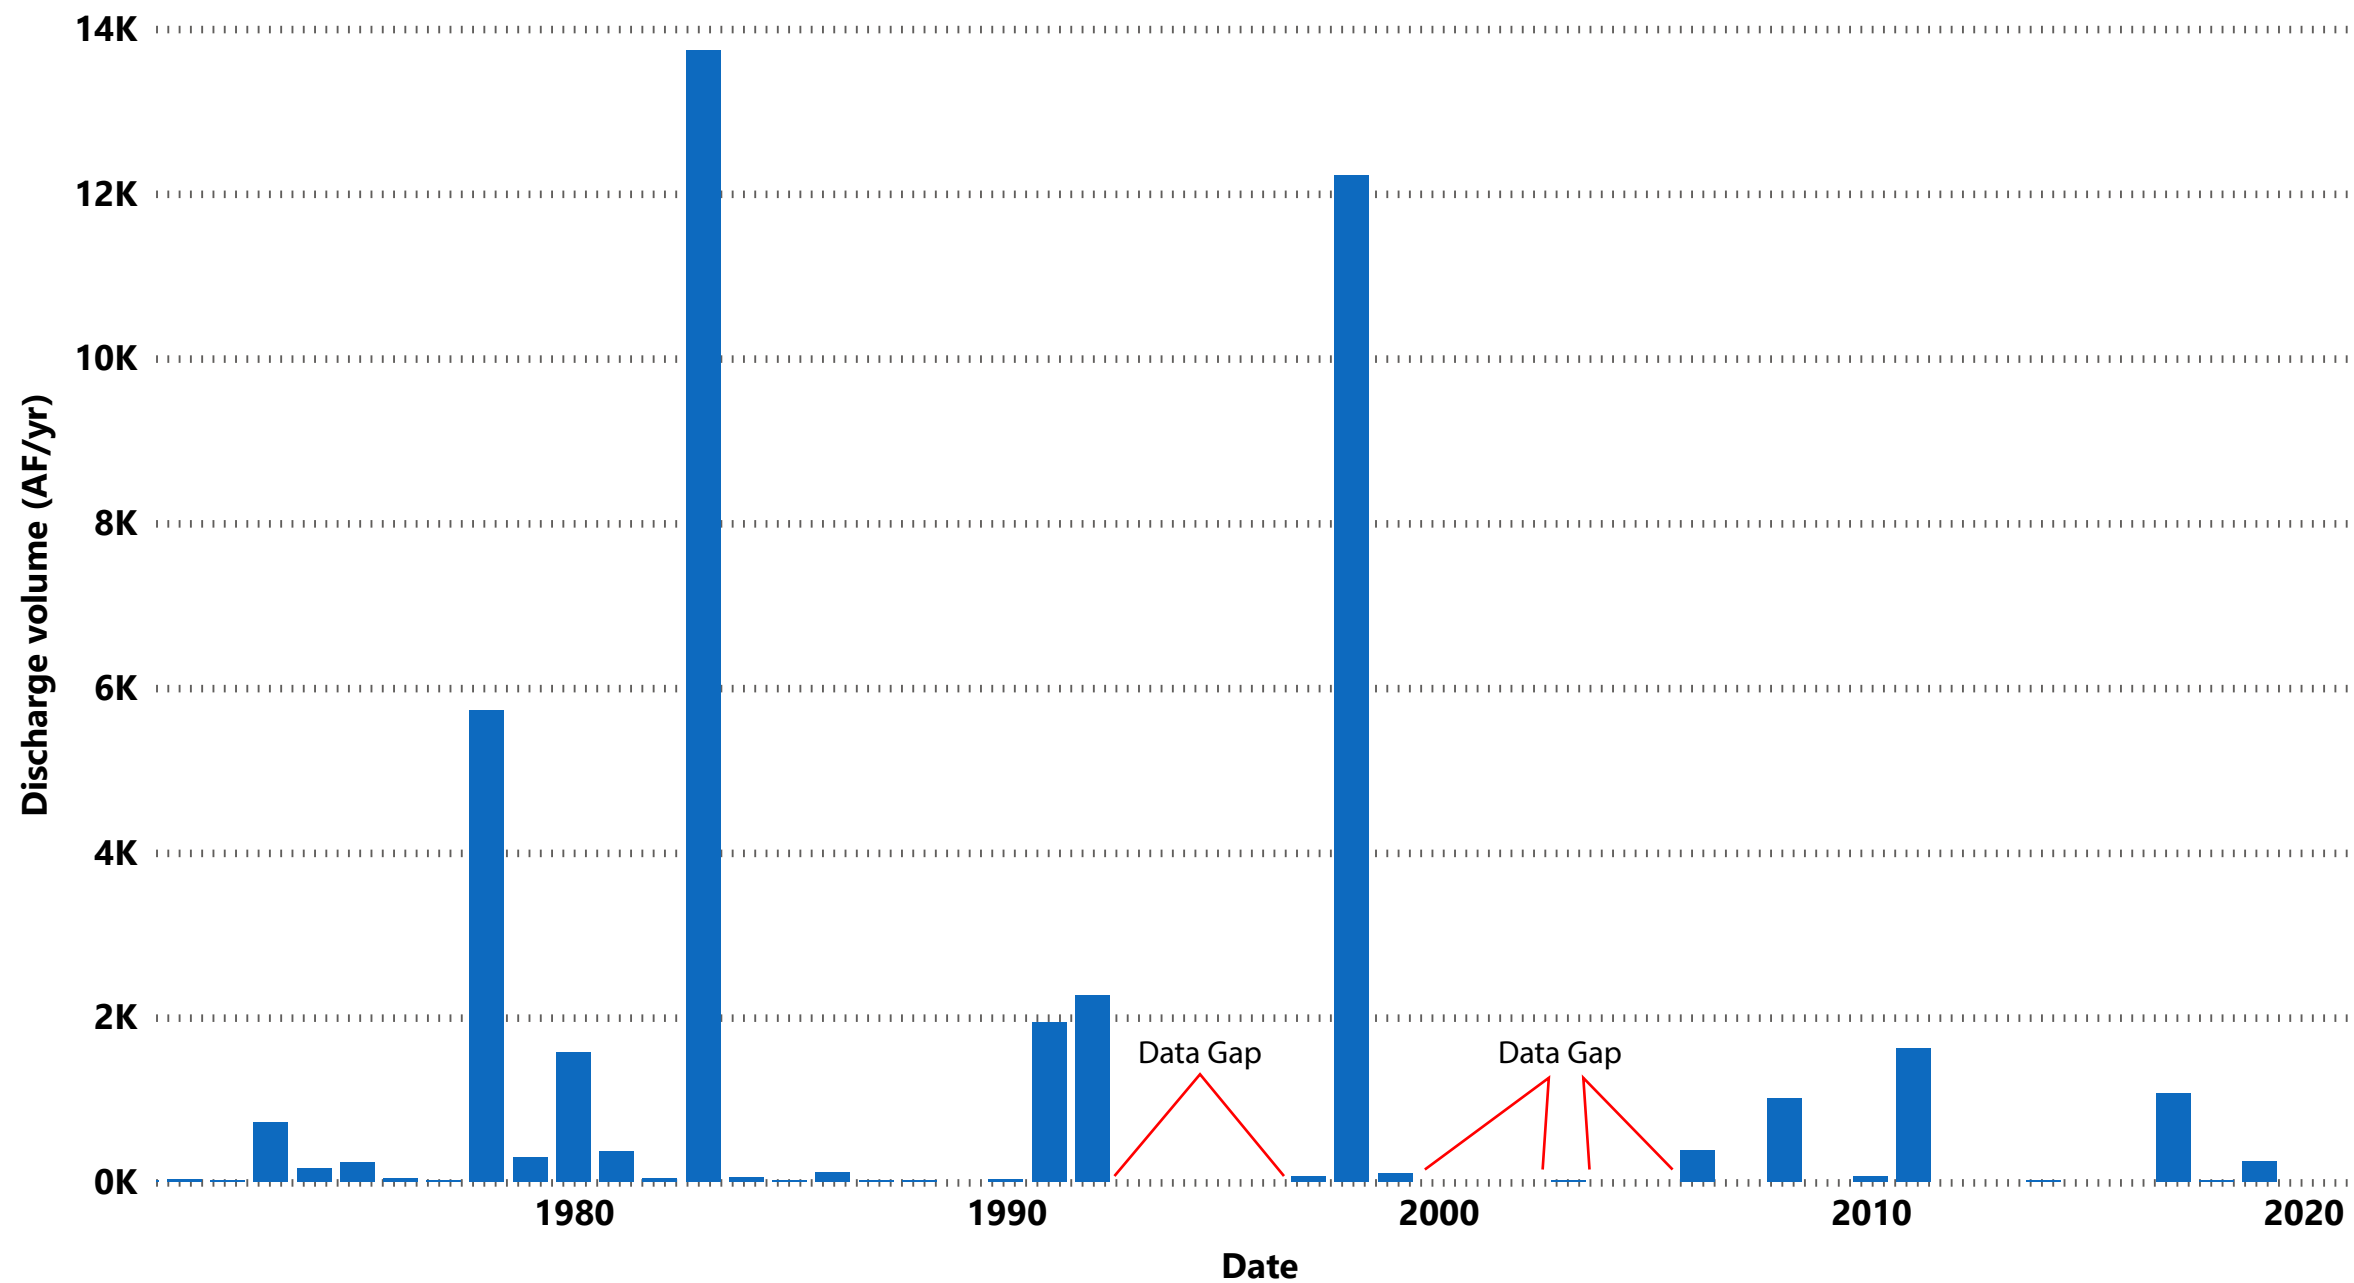
FIGURE 44

**Los Alamos Stream Gage
(11135800)**
San Antonio Basin GSA 2021
Annual Groundwater Level
Monitoring Report

Streamflow monitoring provides hydrologic information needed to better understand hydrologic conditions including surface water/groundwater interactions. The USGS currently manages two stream gages on San Antonio Creek. Stream gage 11135800 is located just east of Los Alamos, mounted on the Highway 101 bridge. Stream gage 11136100 is 2.5 miles downstream of Barka Slough (outside of the Basin boundary), mounted to a bridge on San Antonio Road. Hydrographs of annual discharge for both stream gages are presented in Figures 44 and 45.

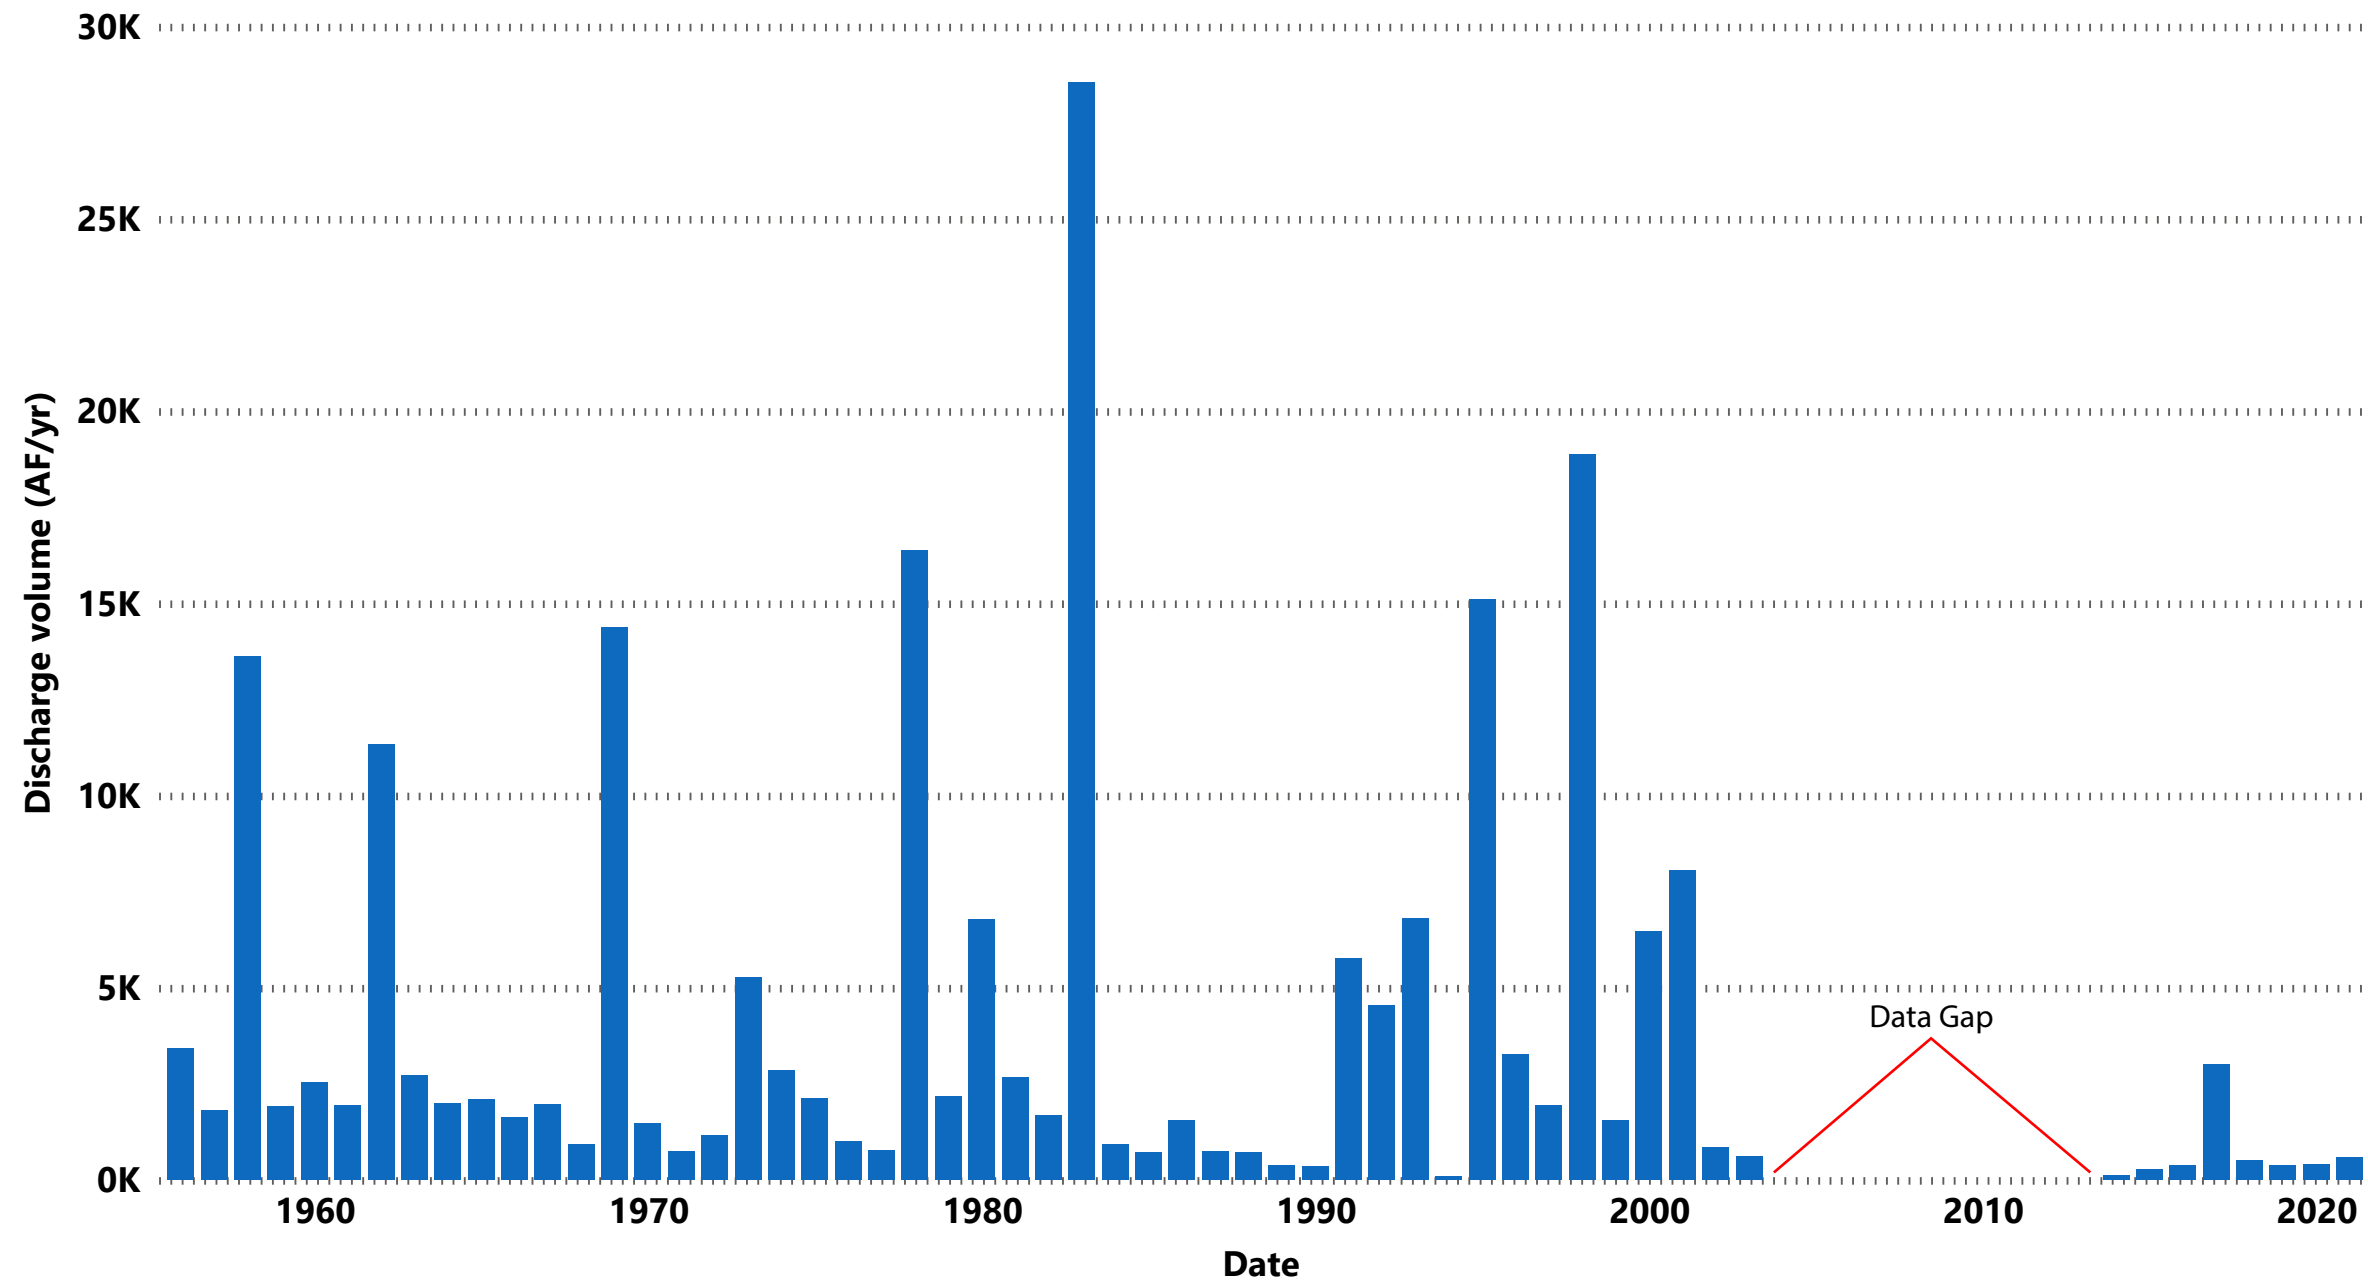
FIGURE 45
Casamalia Stream Gage
(11136100)
 San Antonio Basin GSA
 2021 Annual Groundwater
 Level Monitoring Report
