## **SAN ANTONIO BASIN GROUNDWATER SUSTAINABILITY AGENCY**

#### **BOARD OF DIRECTORS MEETING AGENDA**

## TECHNICAL MEMORANDUM

### San Antonio Creek Valley Groundwater Basin Quarterly Groundwater Level Monitoring – Third Quarter 2026

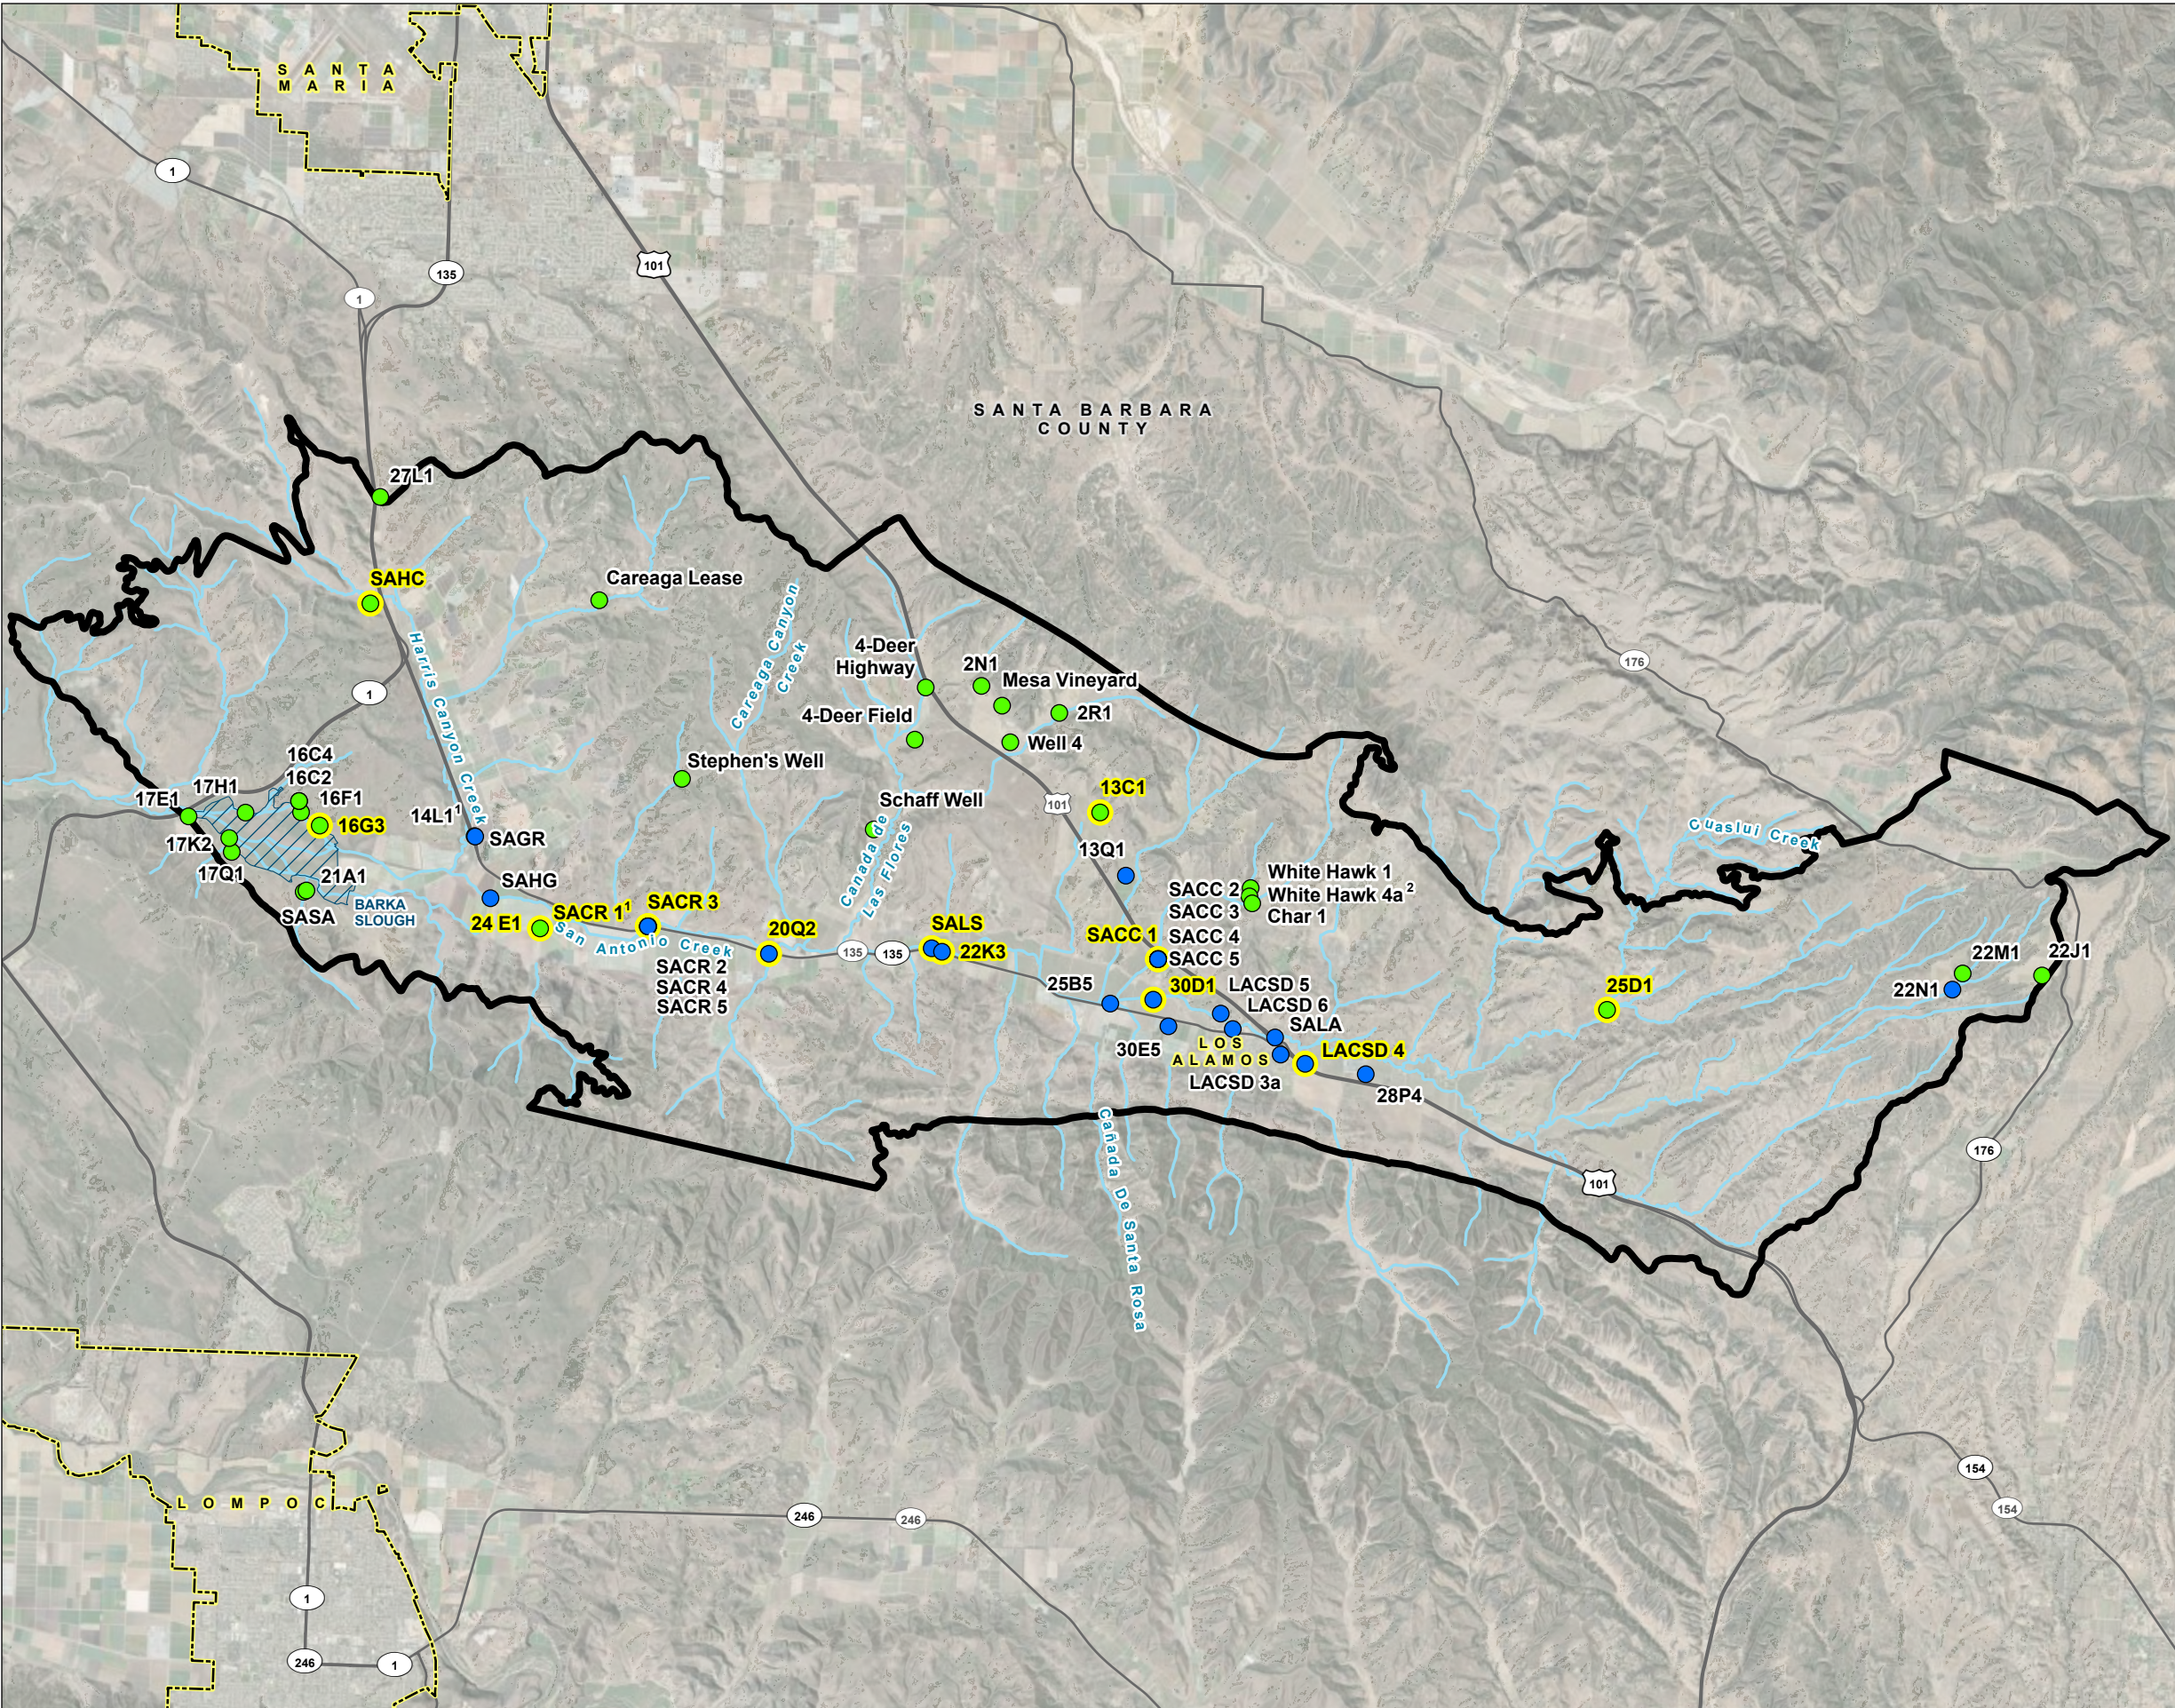
**FIGURE 1**  
**Wells Included in the**  
**San Antonio Creek Valley**  
**Groundwater Basin**  
**Groundwater Level Monitoring**  
**Network**

Figures:  
Figure 1. Wells Included in the San Antonio Creek Valley Groundwater Basin Groundwater Monitoring Network

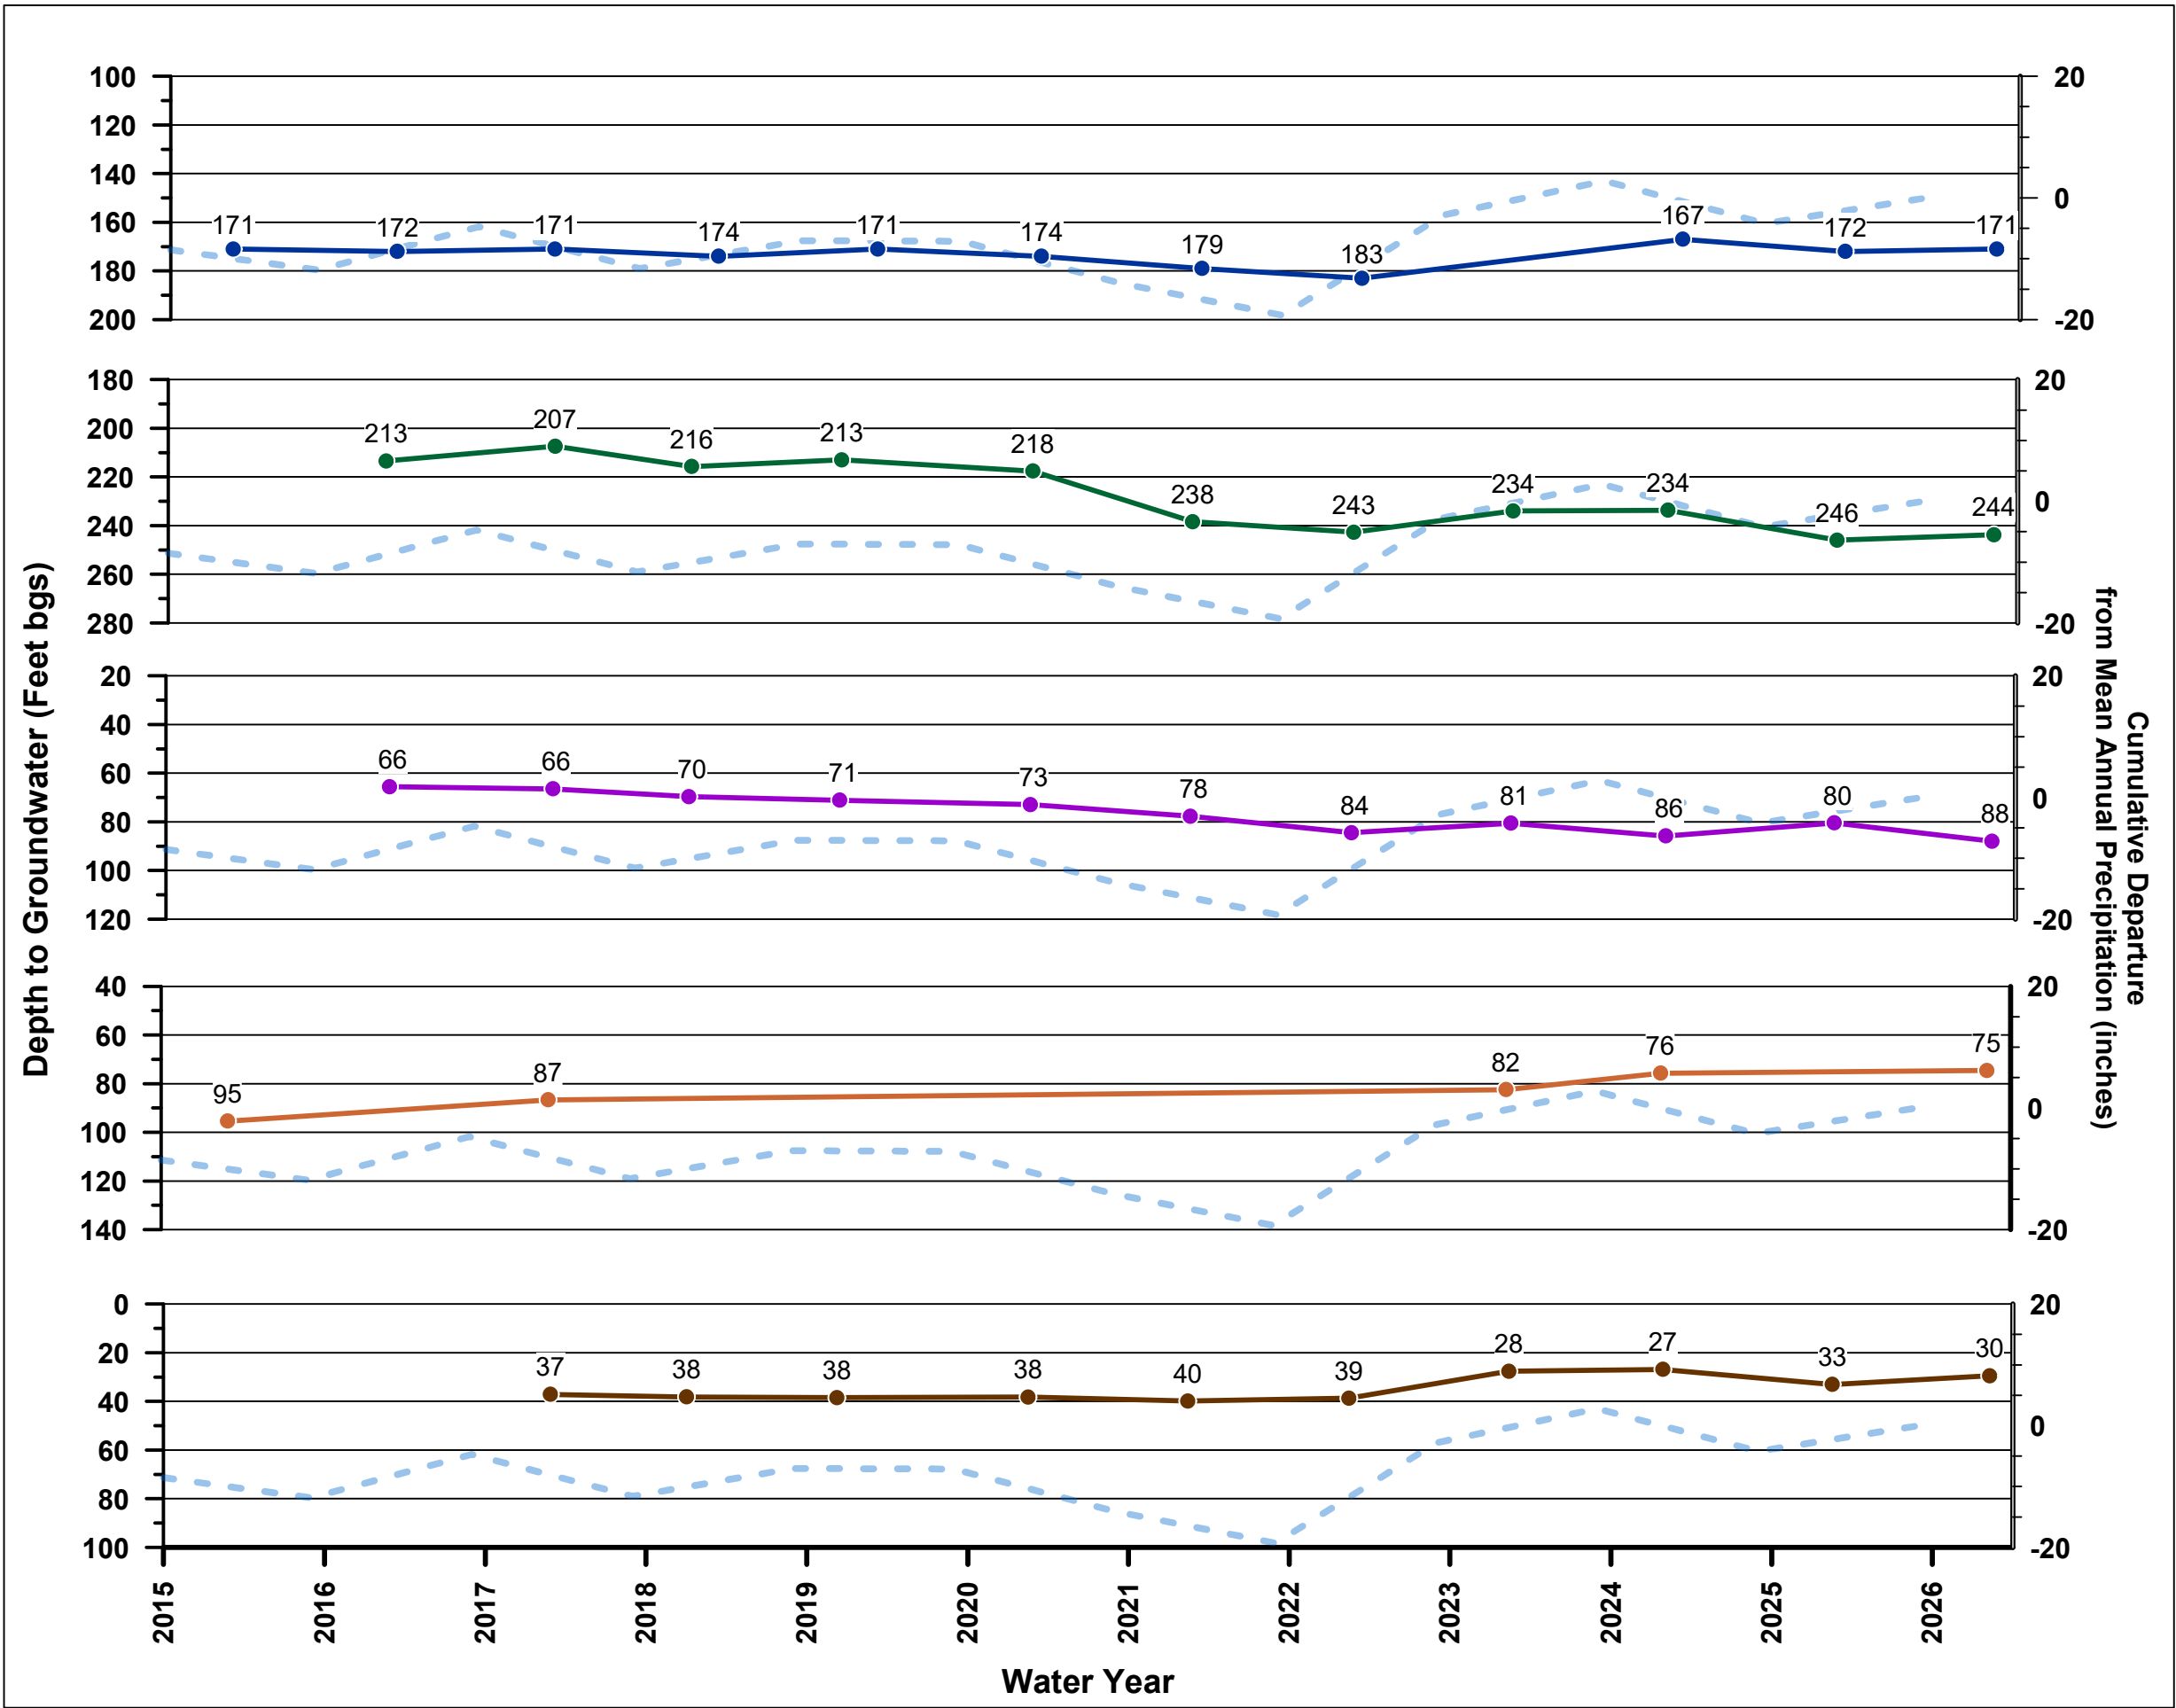
### Select Paso Robles Formation Hydrographs

1. SACR 1 and 14L1 are screened in the Careaga Sand.  
2. White Hawk 4 was destroyed in December 2023.  
Replacement well White Hawk 4a was constructed and completed in June 2024.

#### Third Quarter Groundwater Elevations
