TECHNICAL MEMORANDUM

San Antonio Creek Valley Groundwater Basin Quarterly Groundwater Level Monitoring – Second Quarter 2024

Date: June 17, 2024

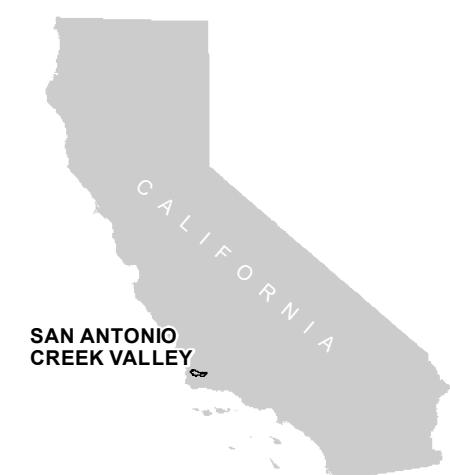
FIGURE 1

Figure:
Figure 1. Wells Included in the San Antonio Creek Valley Groundwater Basin Groundwater Monitoring Network

1. SACR 1 and 14L1 are screened in the Careaga Sand.
2. White Hawk 4 was destroyed in December 2023. Replacement well White Hawk 4a was constructed and completed in June 2024.

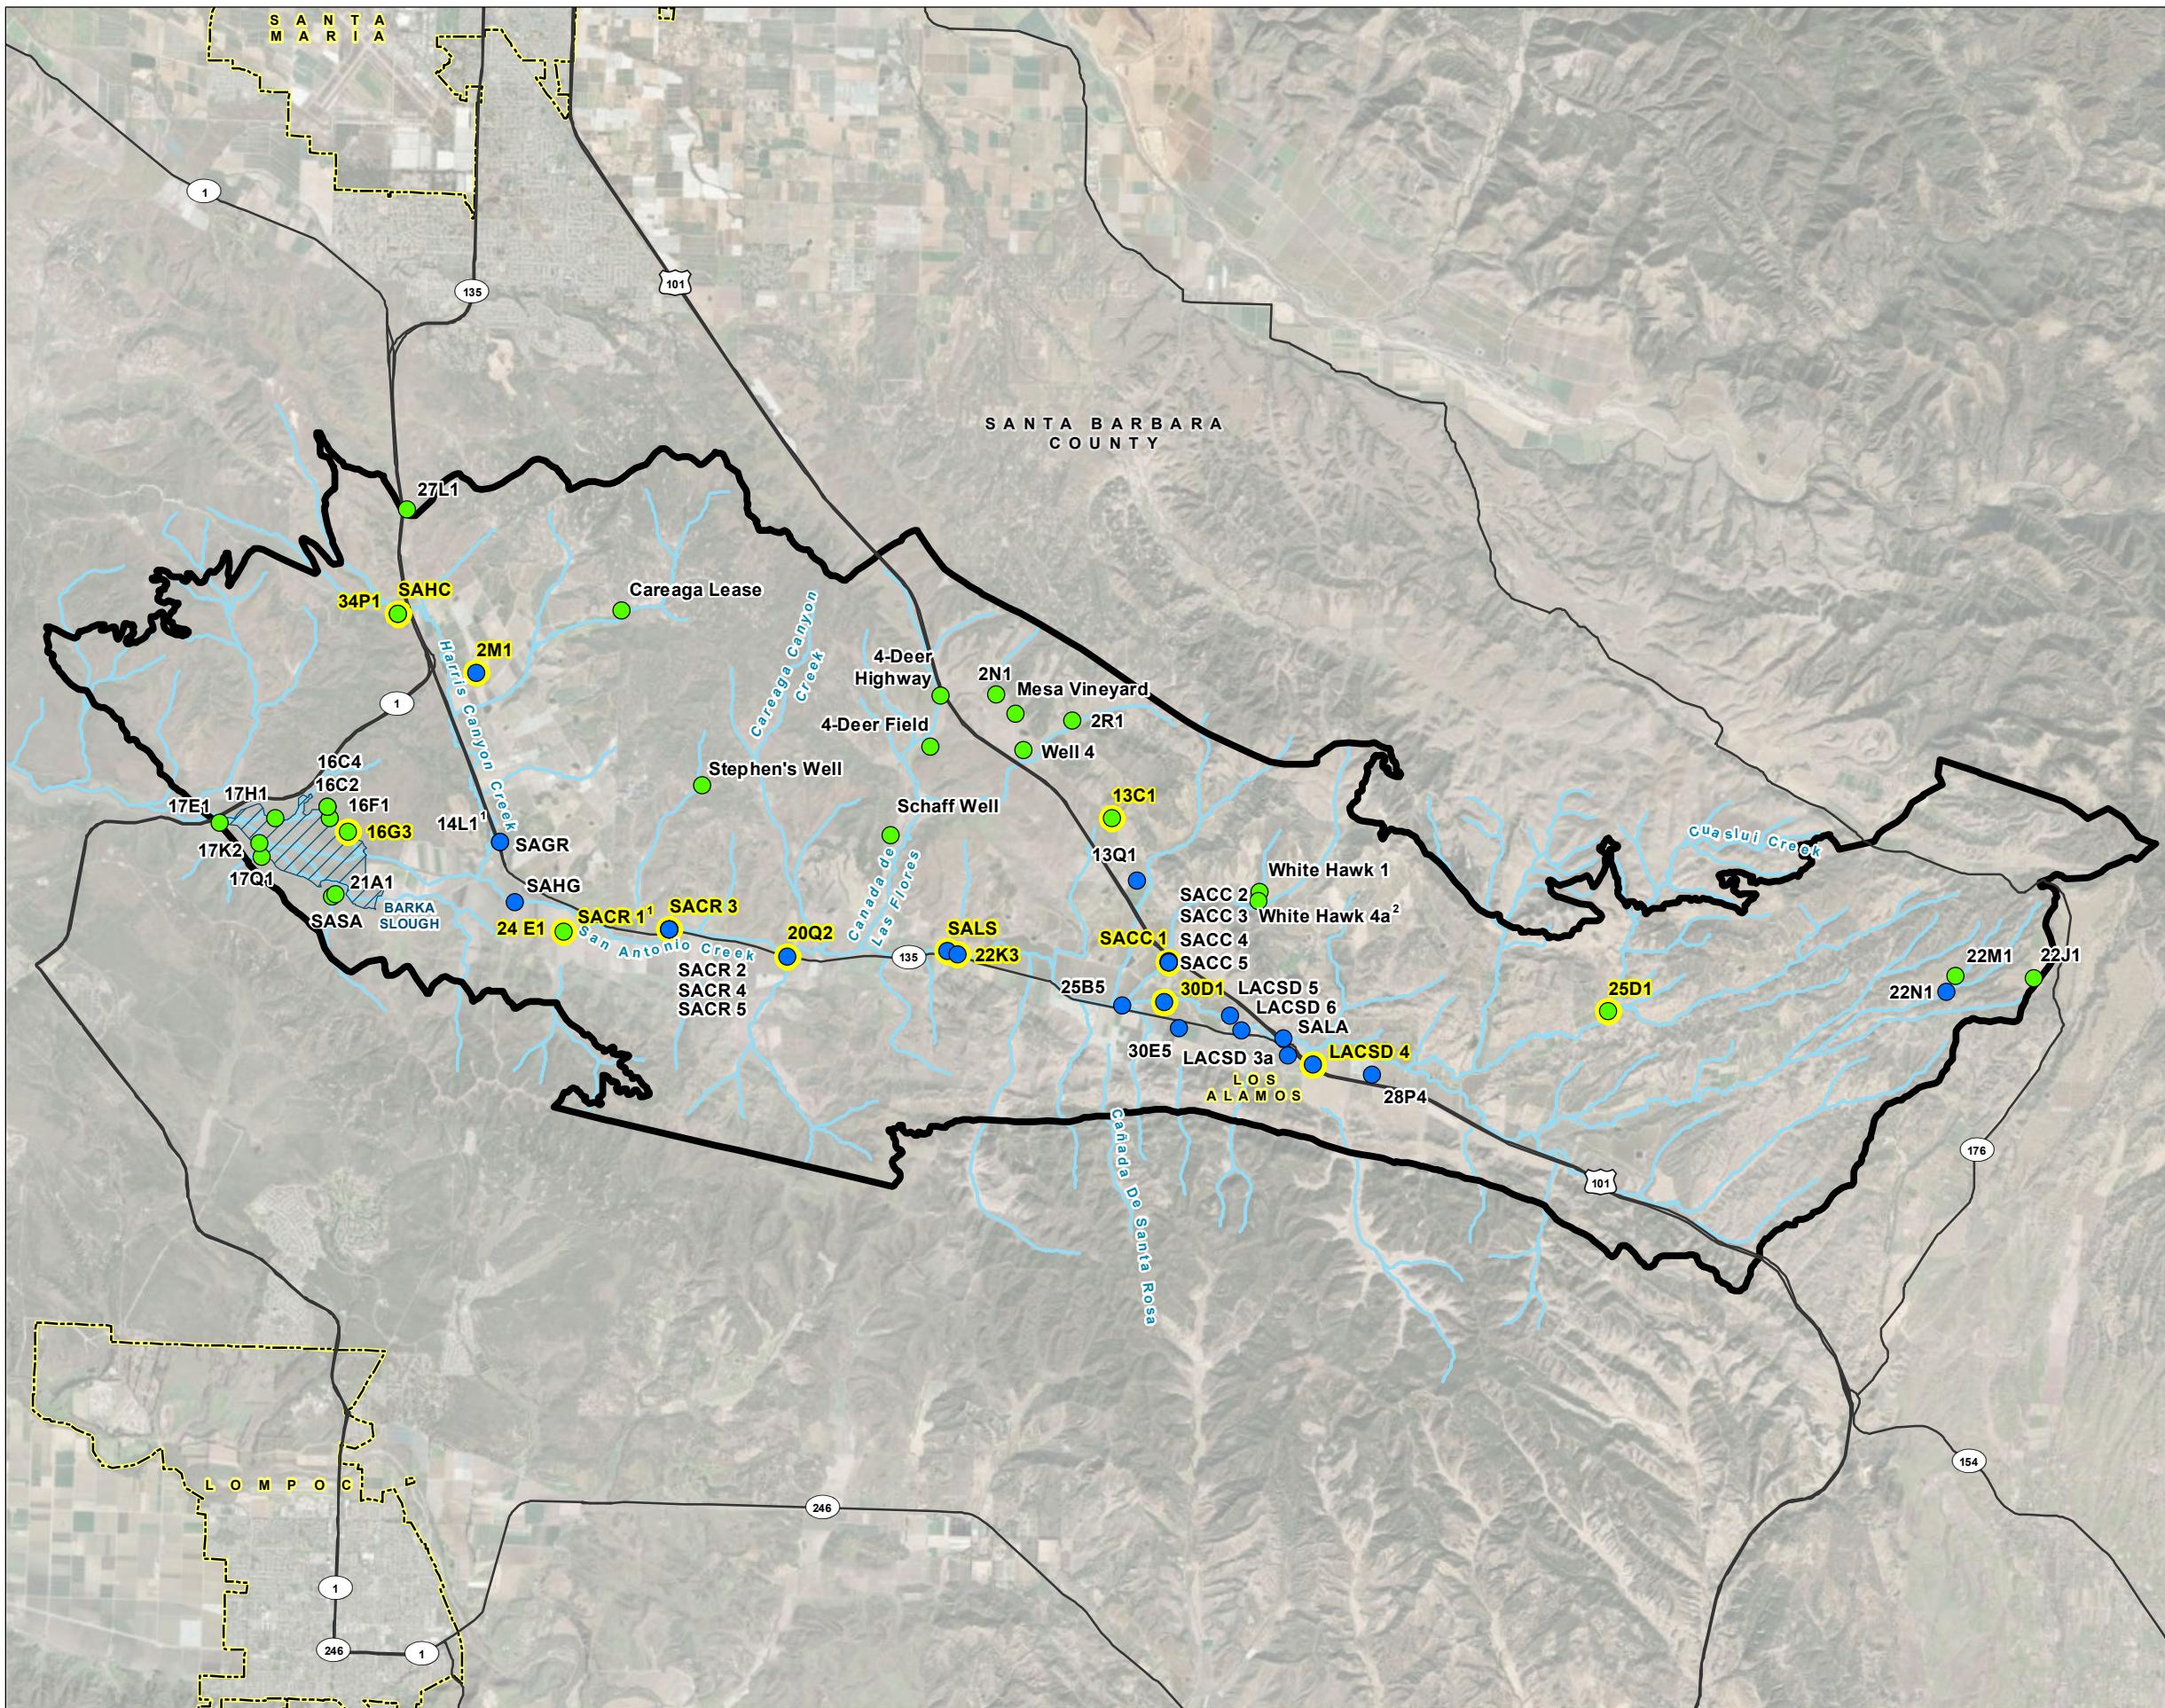
**Wells Included in the
San Antonio Creek Valley
Groundwater Basin
Groundwater Level Monitoring
Network**
